**LIMITED SITE INVESTIGATION REPORT**

**COOPERATIVE SERVICES  
HIGHWAY 75  
HUMBOLDT, MINNESOTA**

**MPCA PETROLEUM RELEASE #8669**

**AUGUST 20, 1998**

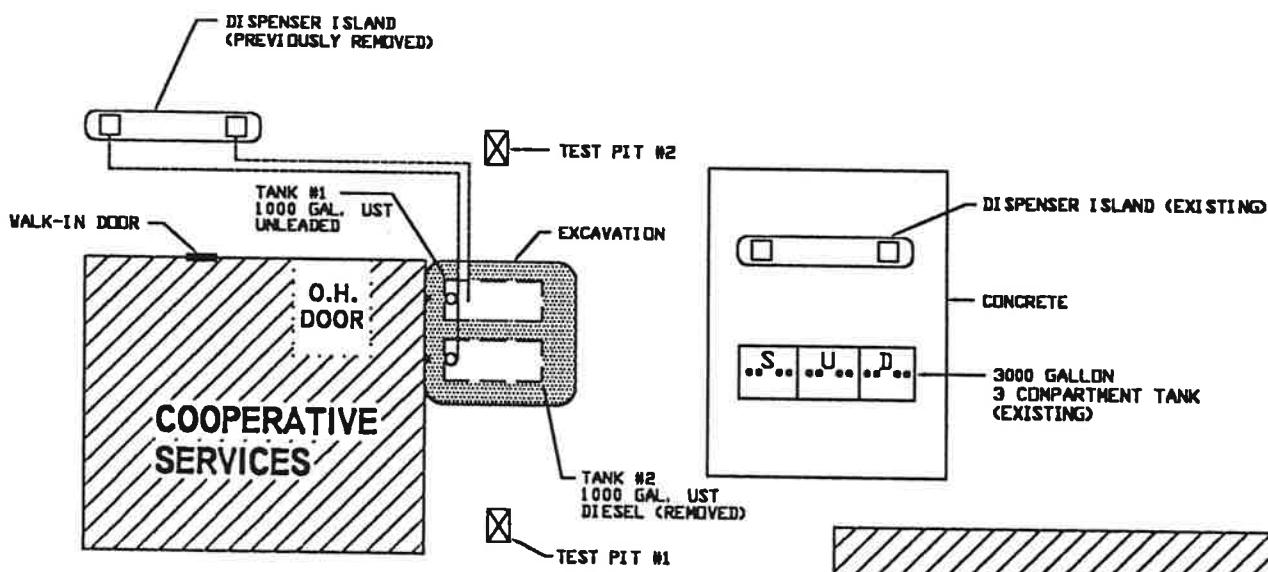
**COOPERATIVE SERVICES**  
HUMBOLT, MN  
EXCAVATION SITE PLOT PLAN  
GREAT PLAINS ENVIRONMENTAL  
JULY 1, 1997

The product and vent lines appeared to be in good condition with no obvious signs of leaking. The product lines were capped off and left in place. The vent lines were disconnected and removed.

The suspected source of the gasoline release was directly associated to the holes located along the bottom quadrant of the UST. The suspected source of the diesel release could have been associated with either overflowing of the UST or possibly leaking product lines.

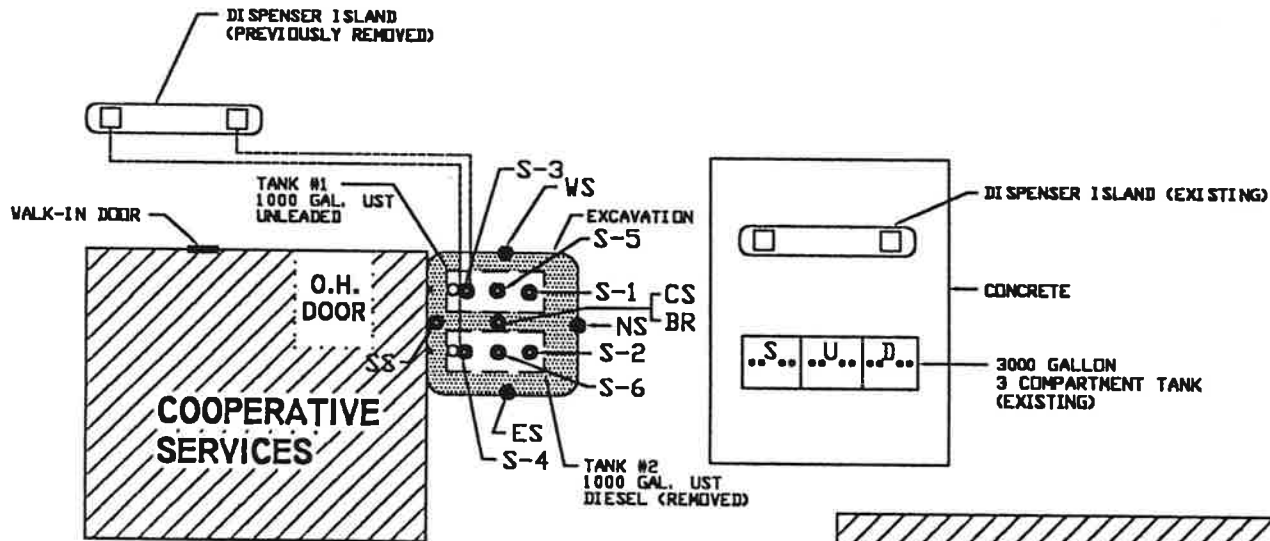
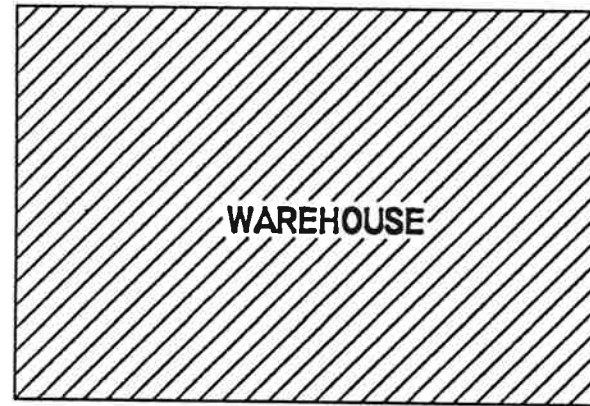
## FIGURE #4

**COOPERATIVE SERVICES**  
HUMBOLT, MN  
PID SITE PLOT PLAN  
GREAT PLAINS ENVIRONMENTAL  
JULY 1, 1997

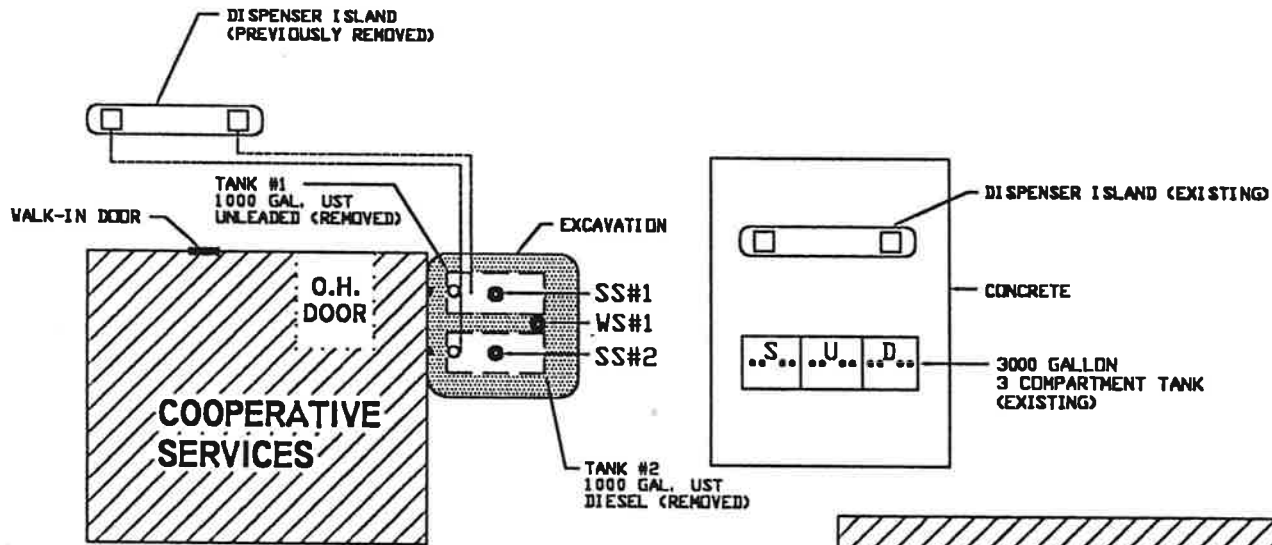
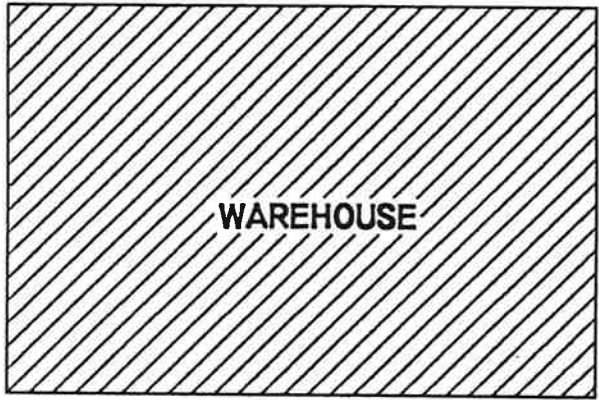
## FIGURE #5

**COOPERATIVE SERVICES**  
HUMBOLT, MN  
LABORATORY SITE PLOT PLAN  
*GREAT PLAINS ENVIRONMENTAL*  
JULY 1, 1997

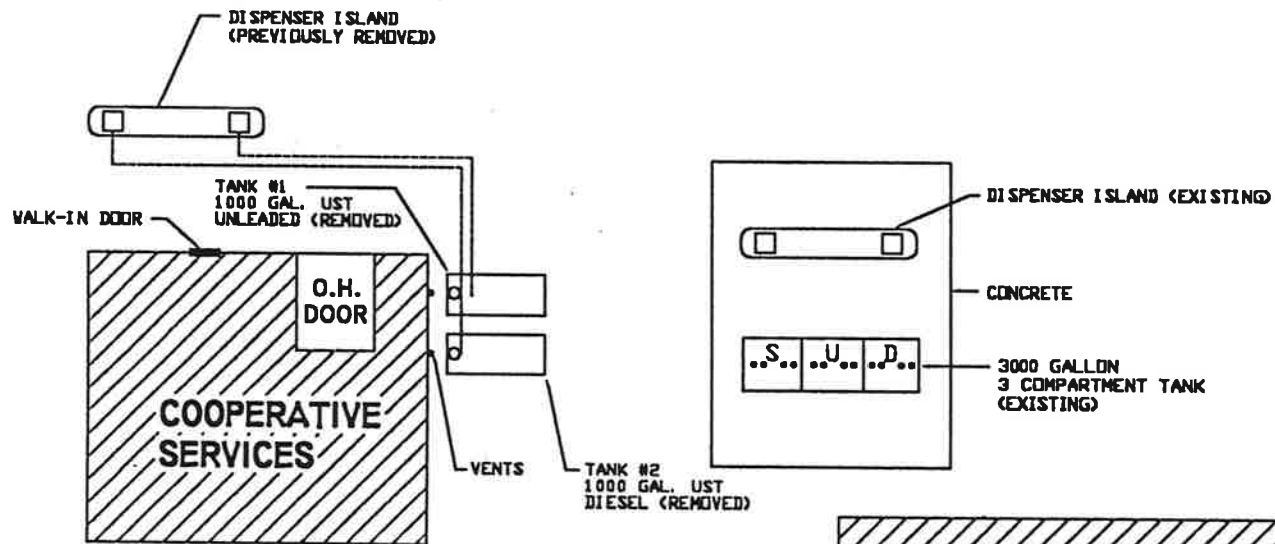
**COOPERATIVE SERVICES**  
HUMBOLT, MN  
CURRENT SITE PLOT PLAN  
GREAT PLAINS ENVIRONMENTAL  
JULY 1, 1997

The product and vent lines were removed during the excavation of the two USTs. *Figure #3 and #4* illustrate the current and previous utilization of the release site.

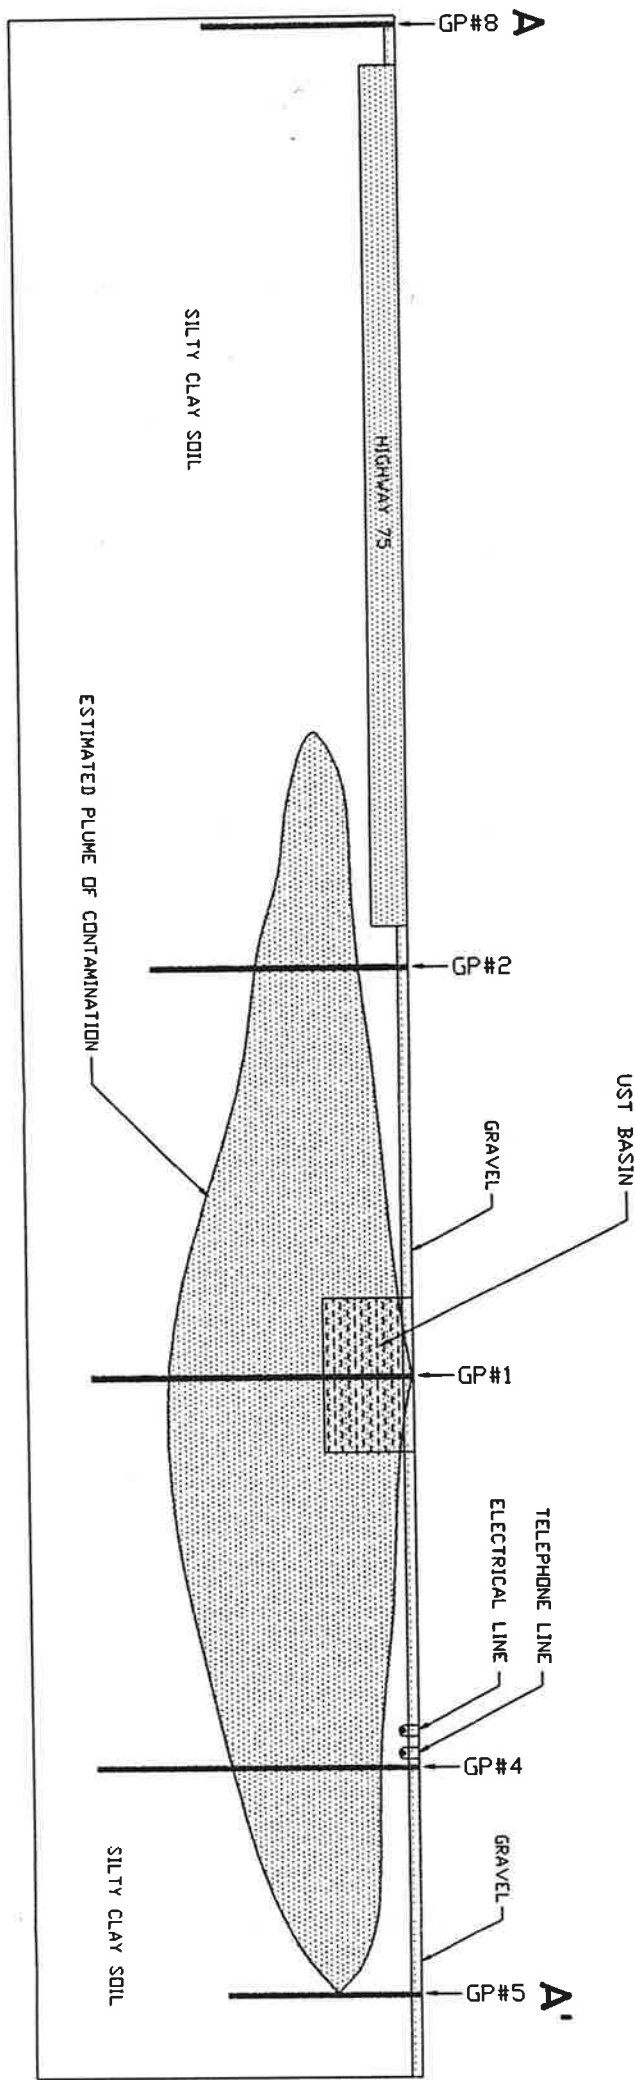
Description  
GEOLOGIC CROSS SECTION A-A'

Customer: COOPERATIVE SERVICES	
Location: HUMBOLDT, MN	
Date: 12/22/98	Scale: 1' = 15'
Drawing #203AGPE	Project # 16298
