RE: Annual Monitoring Report Submittal for the former Dittmer Oil  
Company site in Fairfax, Minnesota (Leaksite #00001940)

**ANNUAL MONITORING REPORT  
FORMER DITTMER OIL COMPANY  
FAIRFAX, MINNESOTA**

**GME PROJECT NO. C-2373-D  
MAY 3, 1996**

RE: Annual Monitoring Report for the former Dittmer Oil Company site located at the intersection of Highways 4 and 19 in Fairfax, Minnesota (MPCA Leaksite #1940)

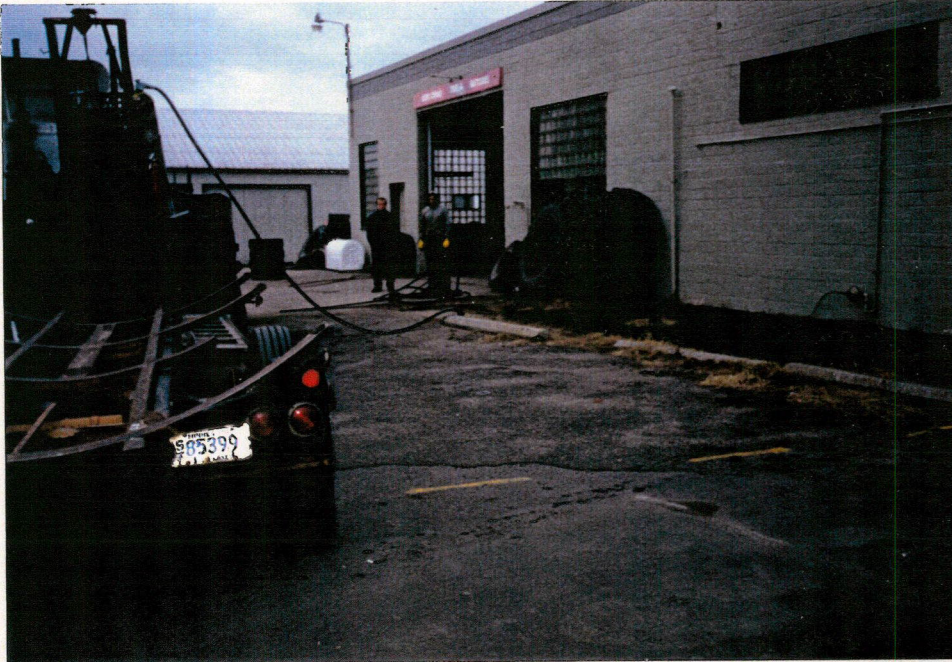
PHOTOGRAPH 1  
DESCRIPTION \_\_\_\_\_

View of east side of  
station store prior to  
excavating. Photograph  
taken facing south-  
southwest.

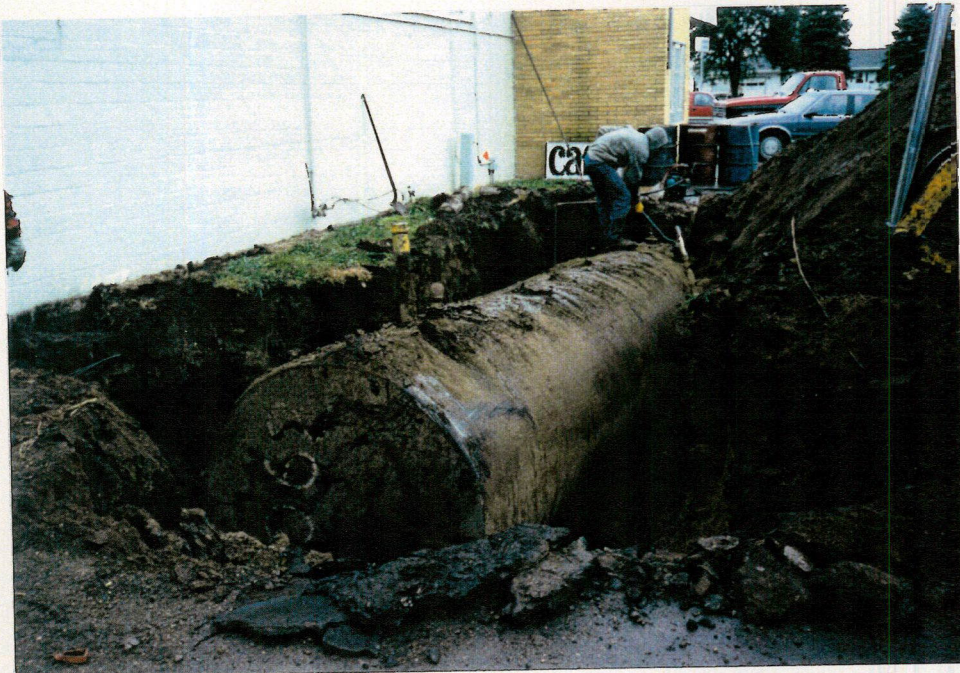
PHOTOGRAPH 2  
DESCRIPTION \_\_\_\_\_

View of 4000 gallon UST  
while excavating.

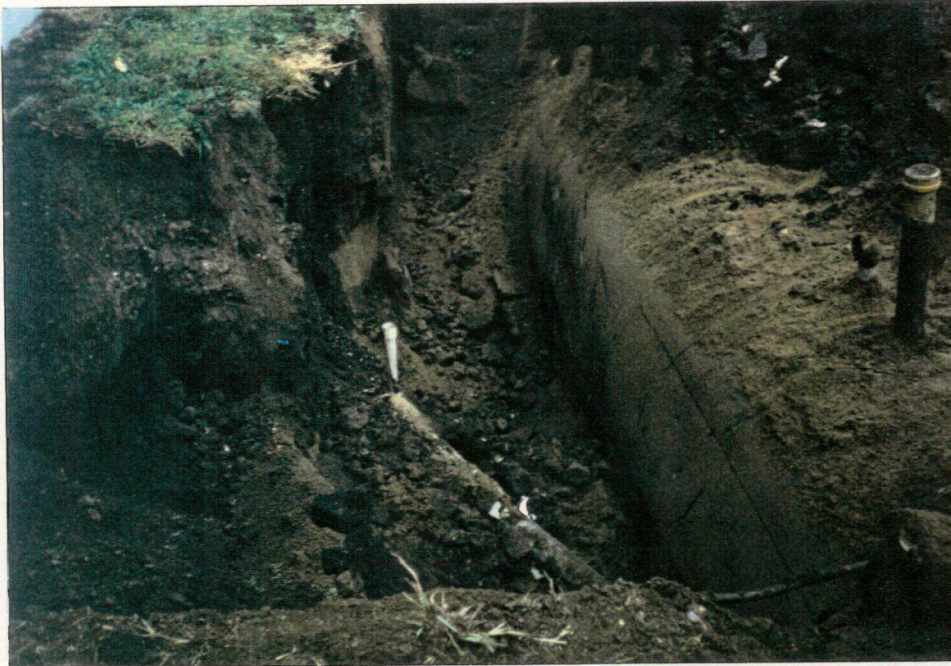
PHOTOGRAPH 3  
DESCRIPTION \_\_\_\_\_

View of 4000 gallon UST.  
Note PVC pipe on left  
side of tank; this is  
the SE Well that was  
abandoned.

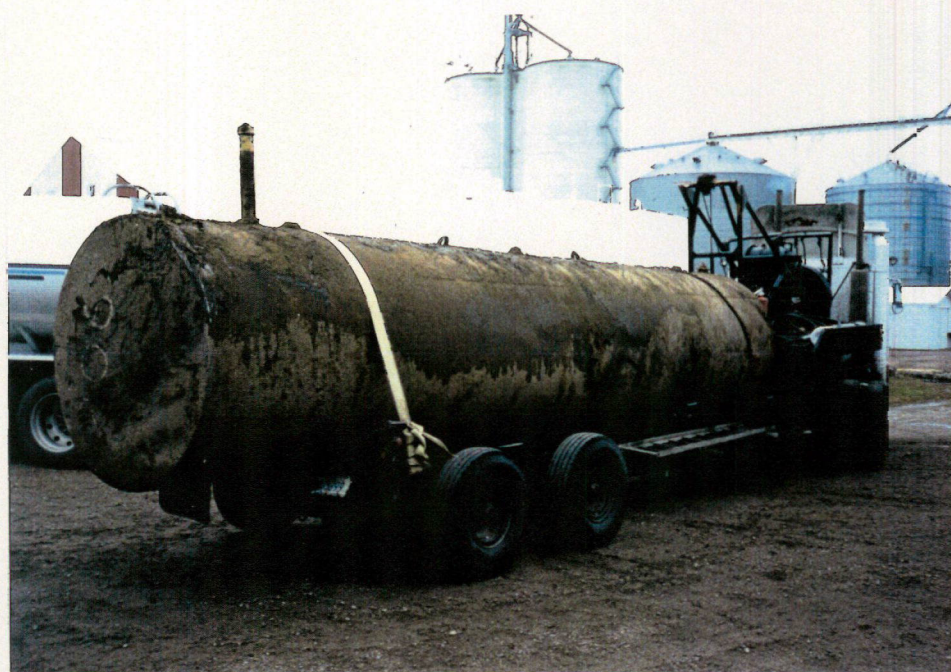
PHOTOGRAPH 4  
DESCRIPTION \_\_\_\_\_

**Condition:** The tank was in good condition with no apparent holes in the tank shell.

View of 4000 gallon UST  
after removal.
