Re: Active Sub-Slab Venting System Modification Work Plan
MN Bio Business Center, Rochester, MN

On behalf of the City of Rochester and Landmark Environmental, LLC (Landmark) has prepared this Active Sub-Slab Venting System Modification Work Plan (Work Plan) for the above referenced property (Property). The Property location map is included as **Figure 1**. This Work Plan includes the results from pre-mitigation diagnostic testing conducted on the existing venting system on March 23, 2015. Based on the pre-mitigation diagnostic testing results, this Work Plan includes the proposed design modifications to convert the existing passive venting system to an active vapor mitigation system (VMS). This Work Plan is being submitted to the Minnesota Pollution Control Agency (MPCA) Voluntary Investigation and Cleanup (VIC) Program for review and approval.

Pre-Mitigation Diagnostic Testing Photos
MN Bio Business Center
Rochester, MN

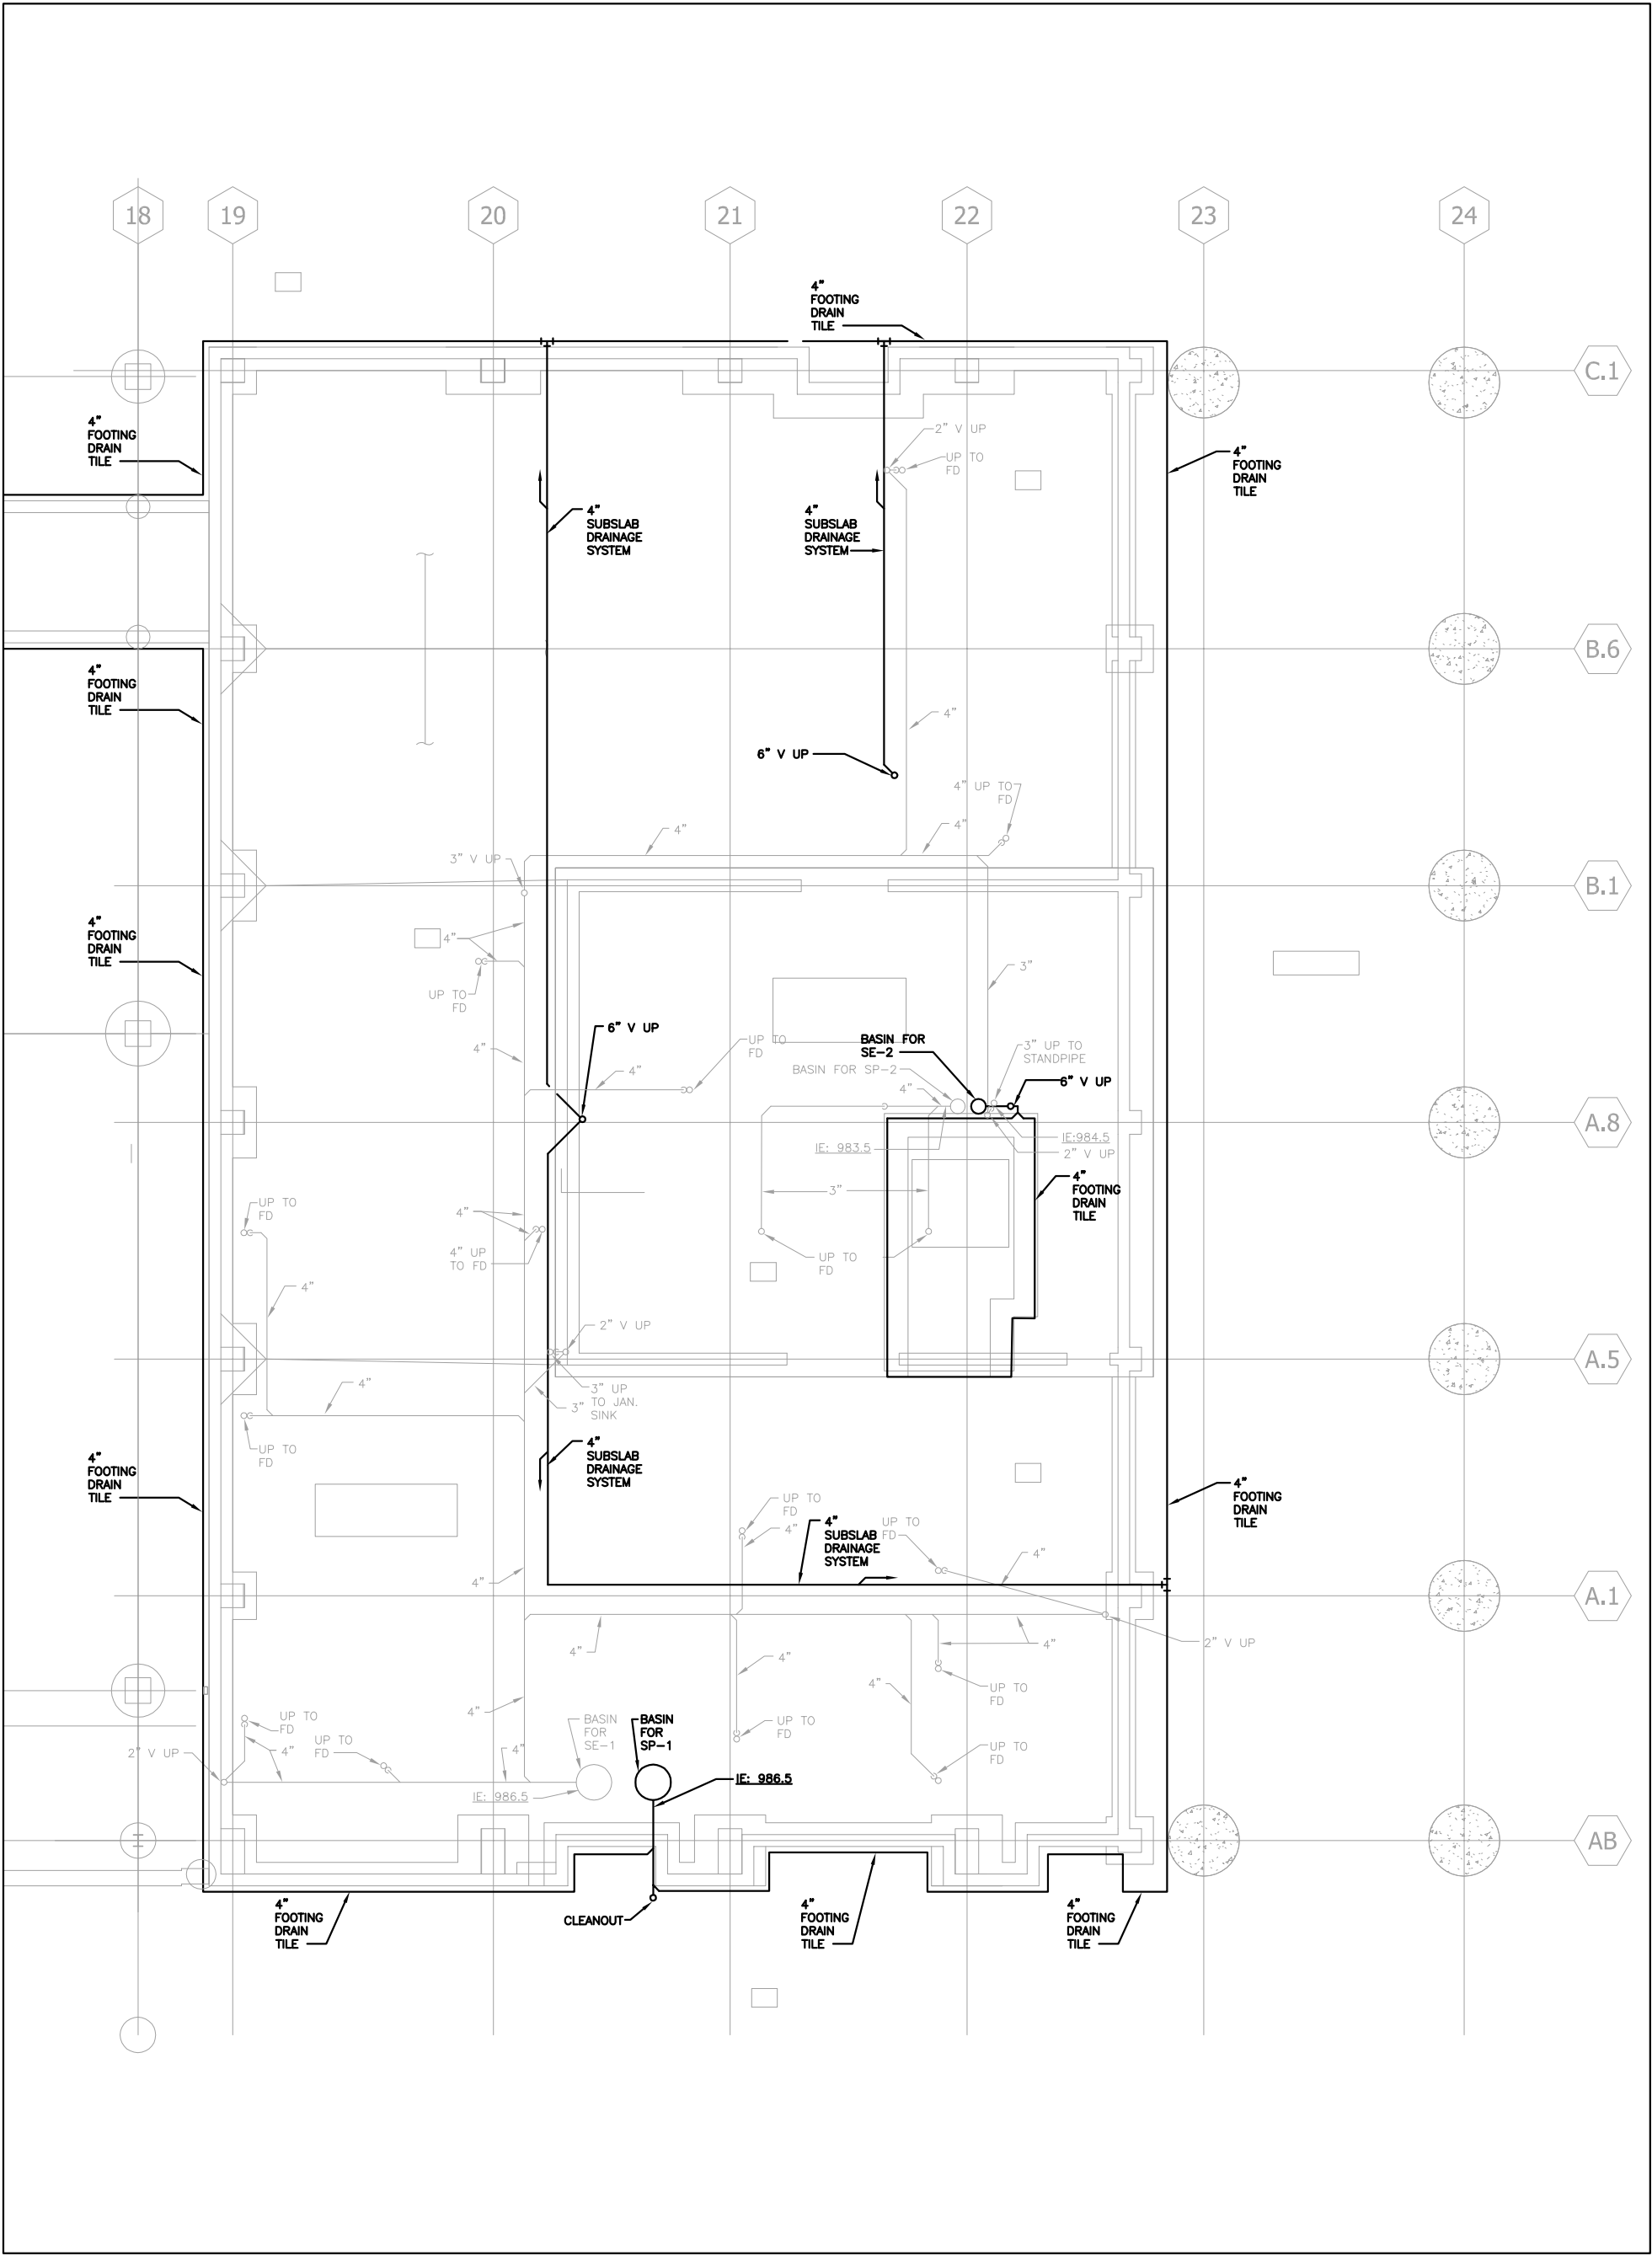
FIGURE 2
BASEMENT LEVEL SUB-SLAB - FOUNDATION VENTING AND DRAINAGE SYSTEM ASBUILT DRAWING

NOTE: Drawing provided by HGA; however, the venting system was designed by Landmark Environmental LLC.

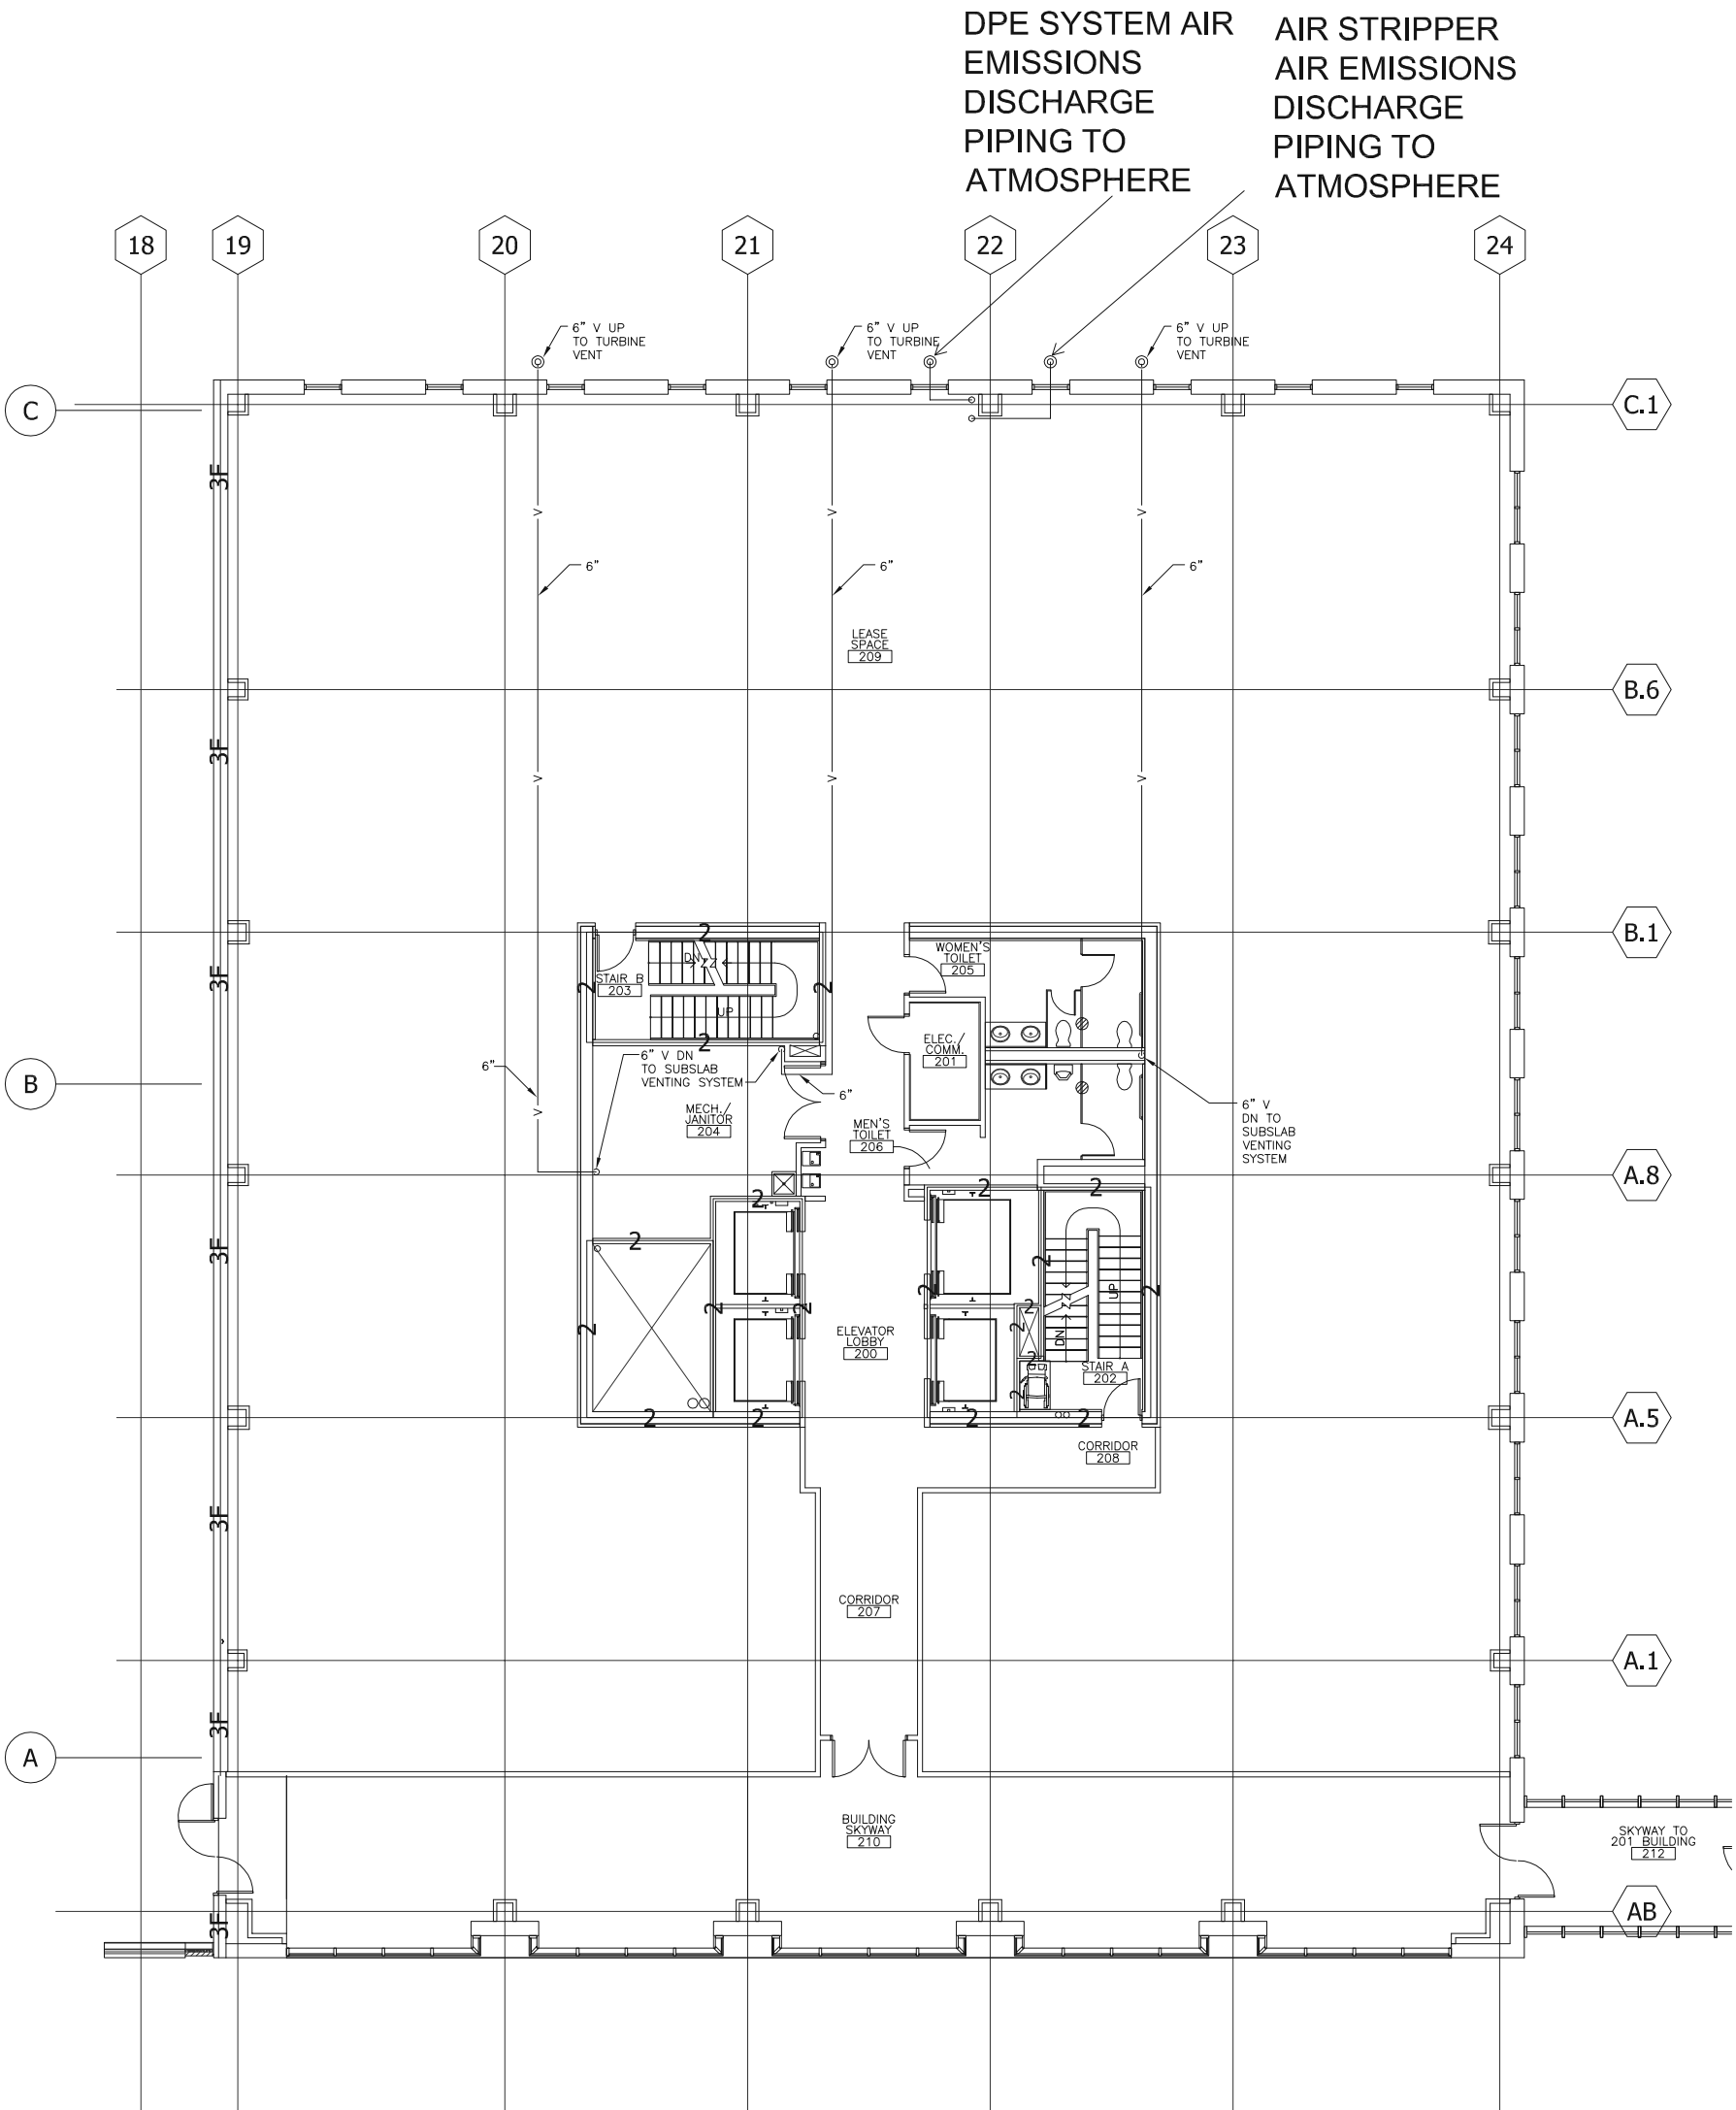
FIGURE 4
SECOND FLOOR - FOUNDATION VENTING AND DPE SYSTEM
ASBUILT DRAWING

NOTE: Drawing provided by HGA; however, the venting and DPE systems were designed by Landmark Environmental, LLC.

Pre-mitigation diagnostic testing activities were conducted by Landmark on March 23, 2015. The goal of the diagnostic testing was to assess the suitability of converting the existing passive venting system to an active VMS; to measure the pressure field extension as a function of applied vacuum at the stacks of each venting system; and, to specify the type of fans required for each existing venting system stack to provide adequate pressure field extension. Photos of the pre-mitigation diagnostic testing activities are shown in **Attachment 1**. **Figure 2** shows the basement level sub-slab – foundation venting and drainage system asbuilt drawing. **Figure 3** shows the basement asbuilt drawing with venting system riser piping sample ports V-1 through V-4, along with the Landmark soil gas (LSG) sampling locations LSG-7 through LSG-10. Sample ports V-1 through V-4 are located at a height of approximately 5 feet above the basement slab, and LSG-7 through 10 are located approximately 8 feet above the basement slab. Venting system V-4, shown on **Figure 3**, is actually located below the first floor slab and not below basement slab venting systems, V-1 through V-3. Pressure readings were collected at each of these locations during the pre-mitigation diagnostic testing event. **Figure 4** shows the second floor – foundation venting and DPE system asbuilt drawing.

The diagnostic testing process involved temporarily removing the turbine vent from each of the three 6-inch venting system PVC pipes shown in **Figure 4** and temporarily connecting an AMG Force and/or Fury fan to the outlet pipe. These fans were selected for testing based on its high

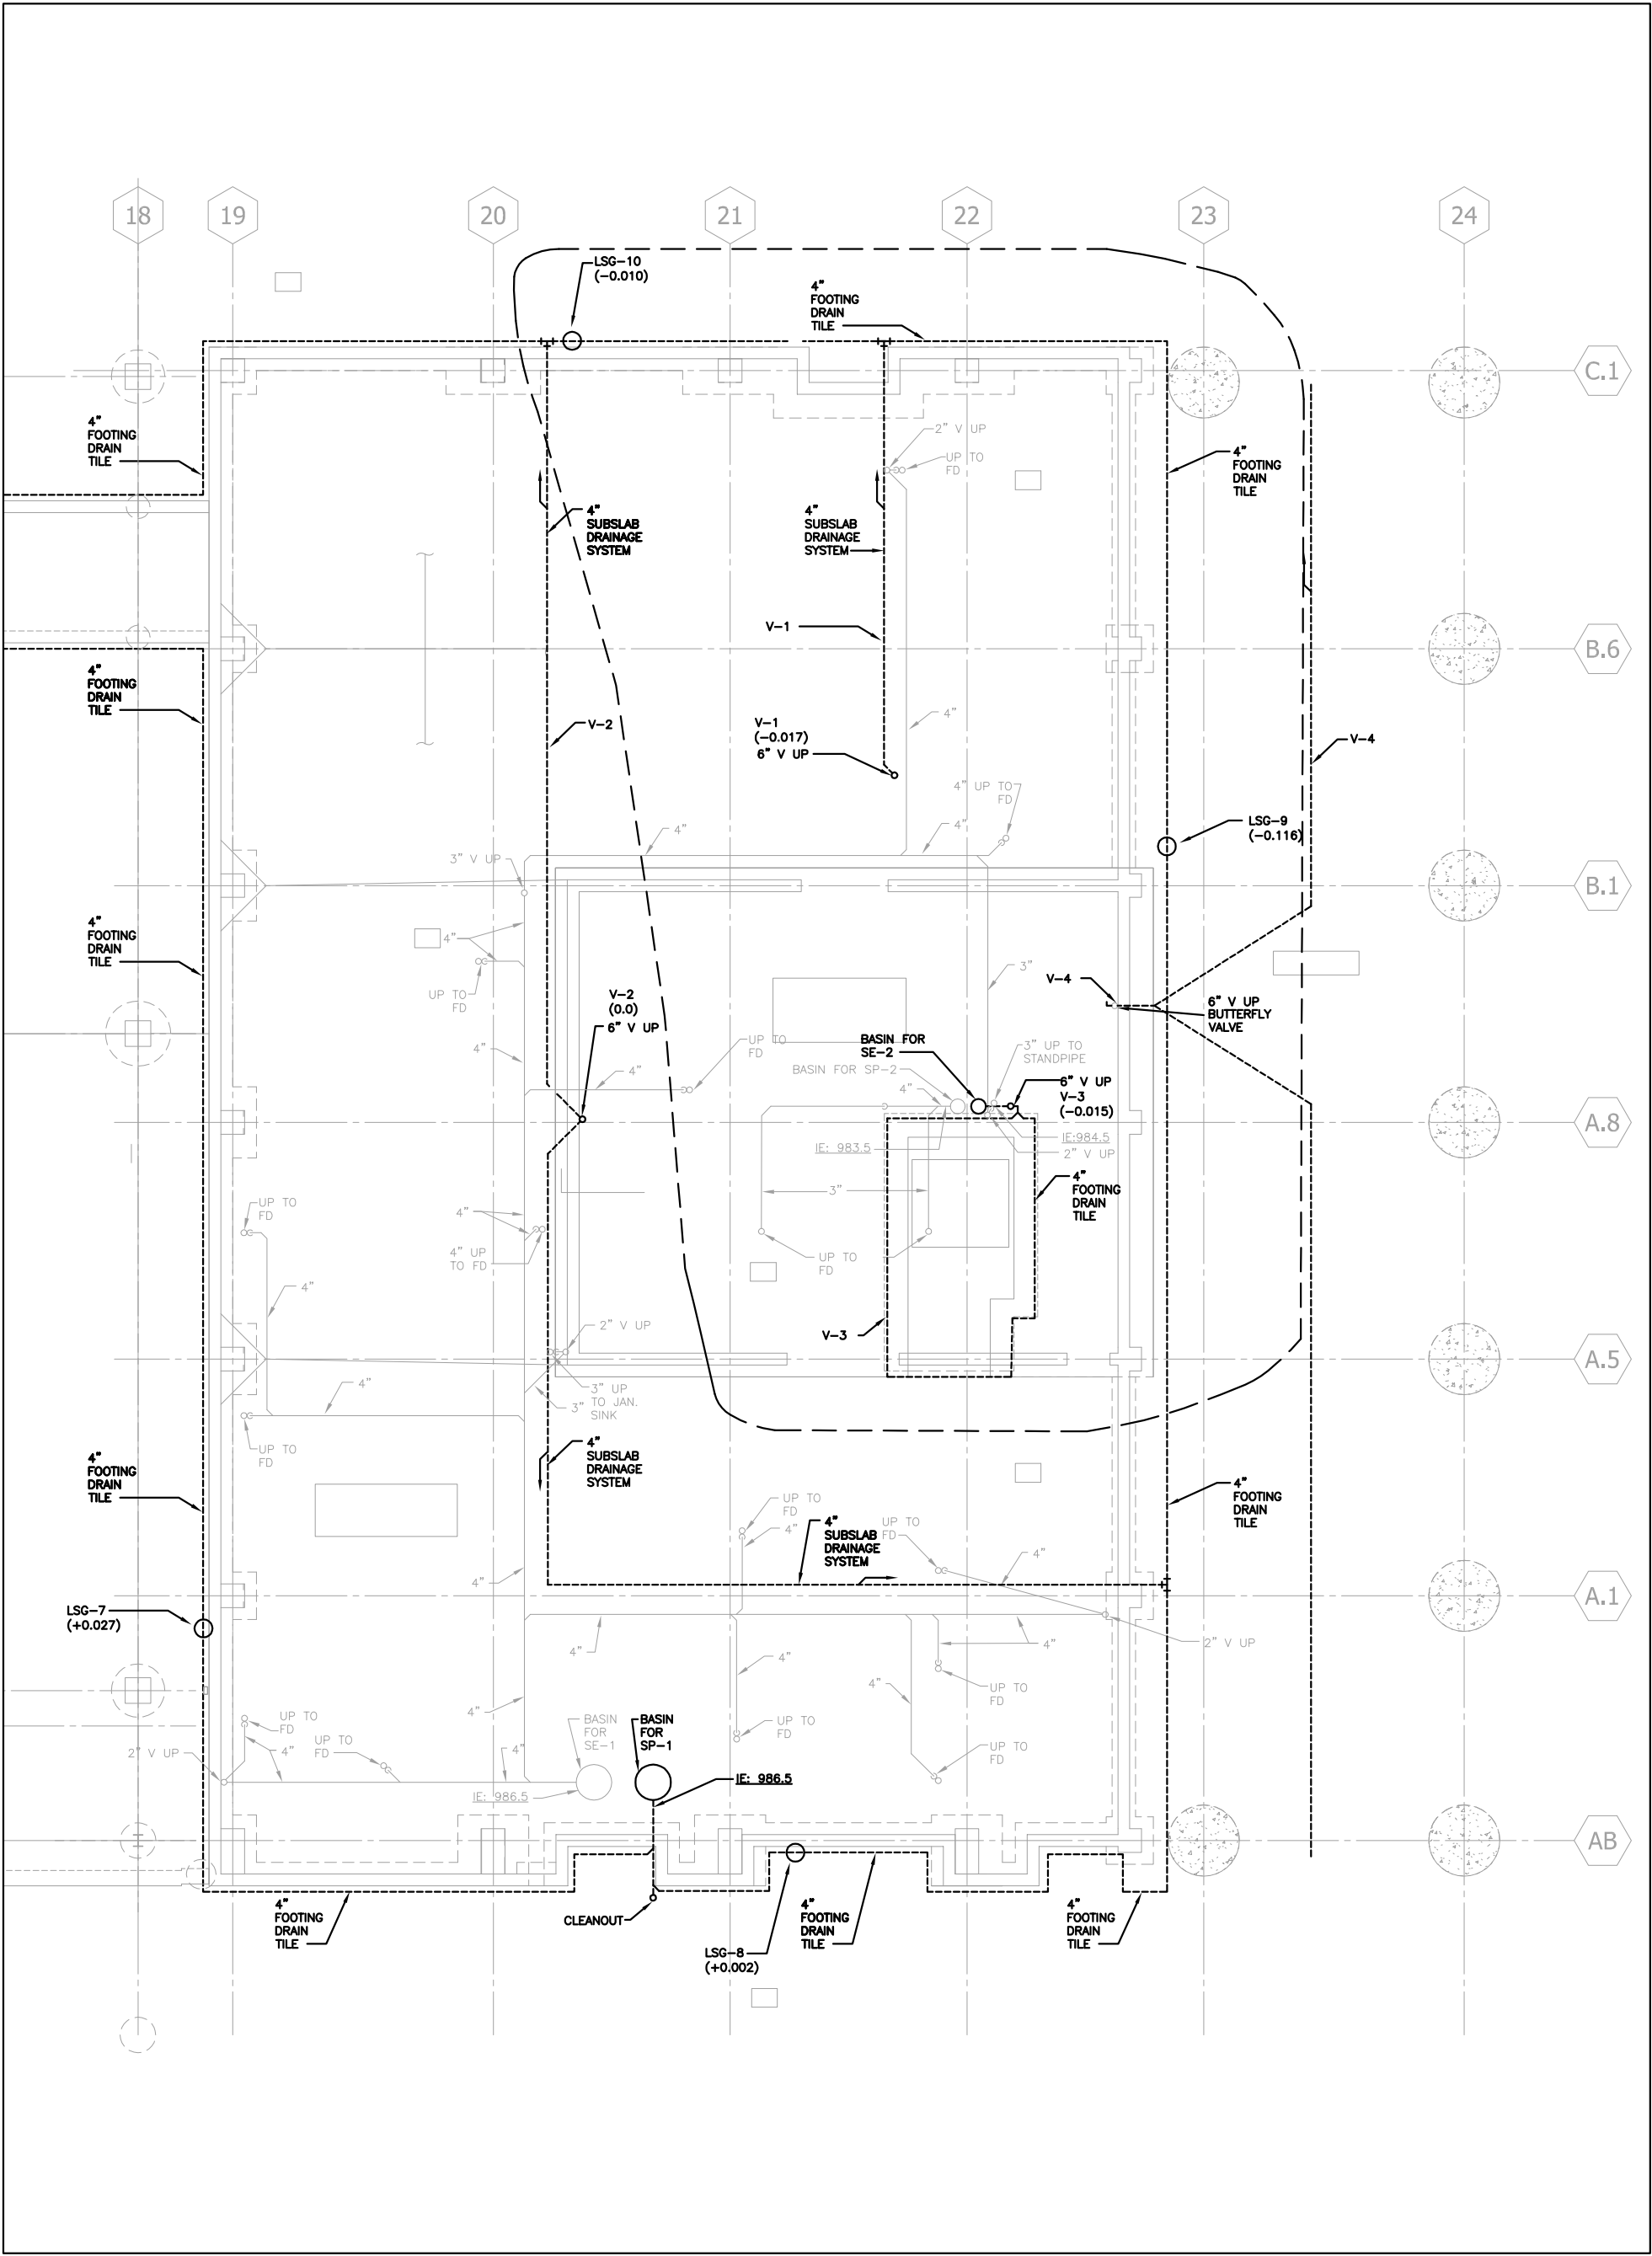
FIGURE 5
BASEMENT LEVEL ASBUILT DRAWING AND V-4
PRE-MITIGATION DIAGNOSTIC TESTING RESULTS
221 FIRST AVENUE S.W.
ROCHESTER, MINNESOTA

NOTE:
1) Drawing provided by HGA; however, the venting system was designed by Landmark Environmental LLC.
2) AMG Force fan was used for pre-mitigation diagnostic testing for V-4.

An AMG Force fan was tested on system V-4 with the pressure field extension readings as shown on **Figure 5**. The fan pressure reading was -1.5 inches of water column (in. WC) with riser pipe readings ranging from 0 to -0.017 in. WC and pressure field extension readings from LSG-7 through LSG-10 ranging from -0.116 to 0.027 in WC. The pre-mitigation diagnostic testing results are provided in **Table 1**.

Based on the AMG Force blower curve, at a vacuum of -1.5 in WC the flow rate was approximately 215 cubic feet per minute (cfm), and near the maximum flow rate of 233 cfm and minimum pressure of 1 in. WC for the fan. The AMG Fury fan was used for the remaining tests based on its operational characteristics consisting of a maximum pressure of -2.7 in WC and maximum flow rate of 417 cfm.

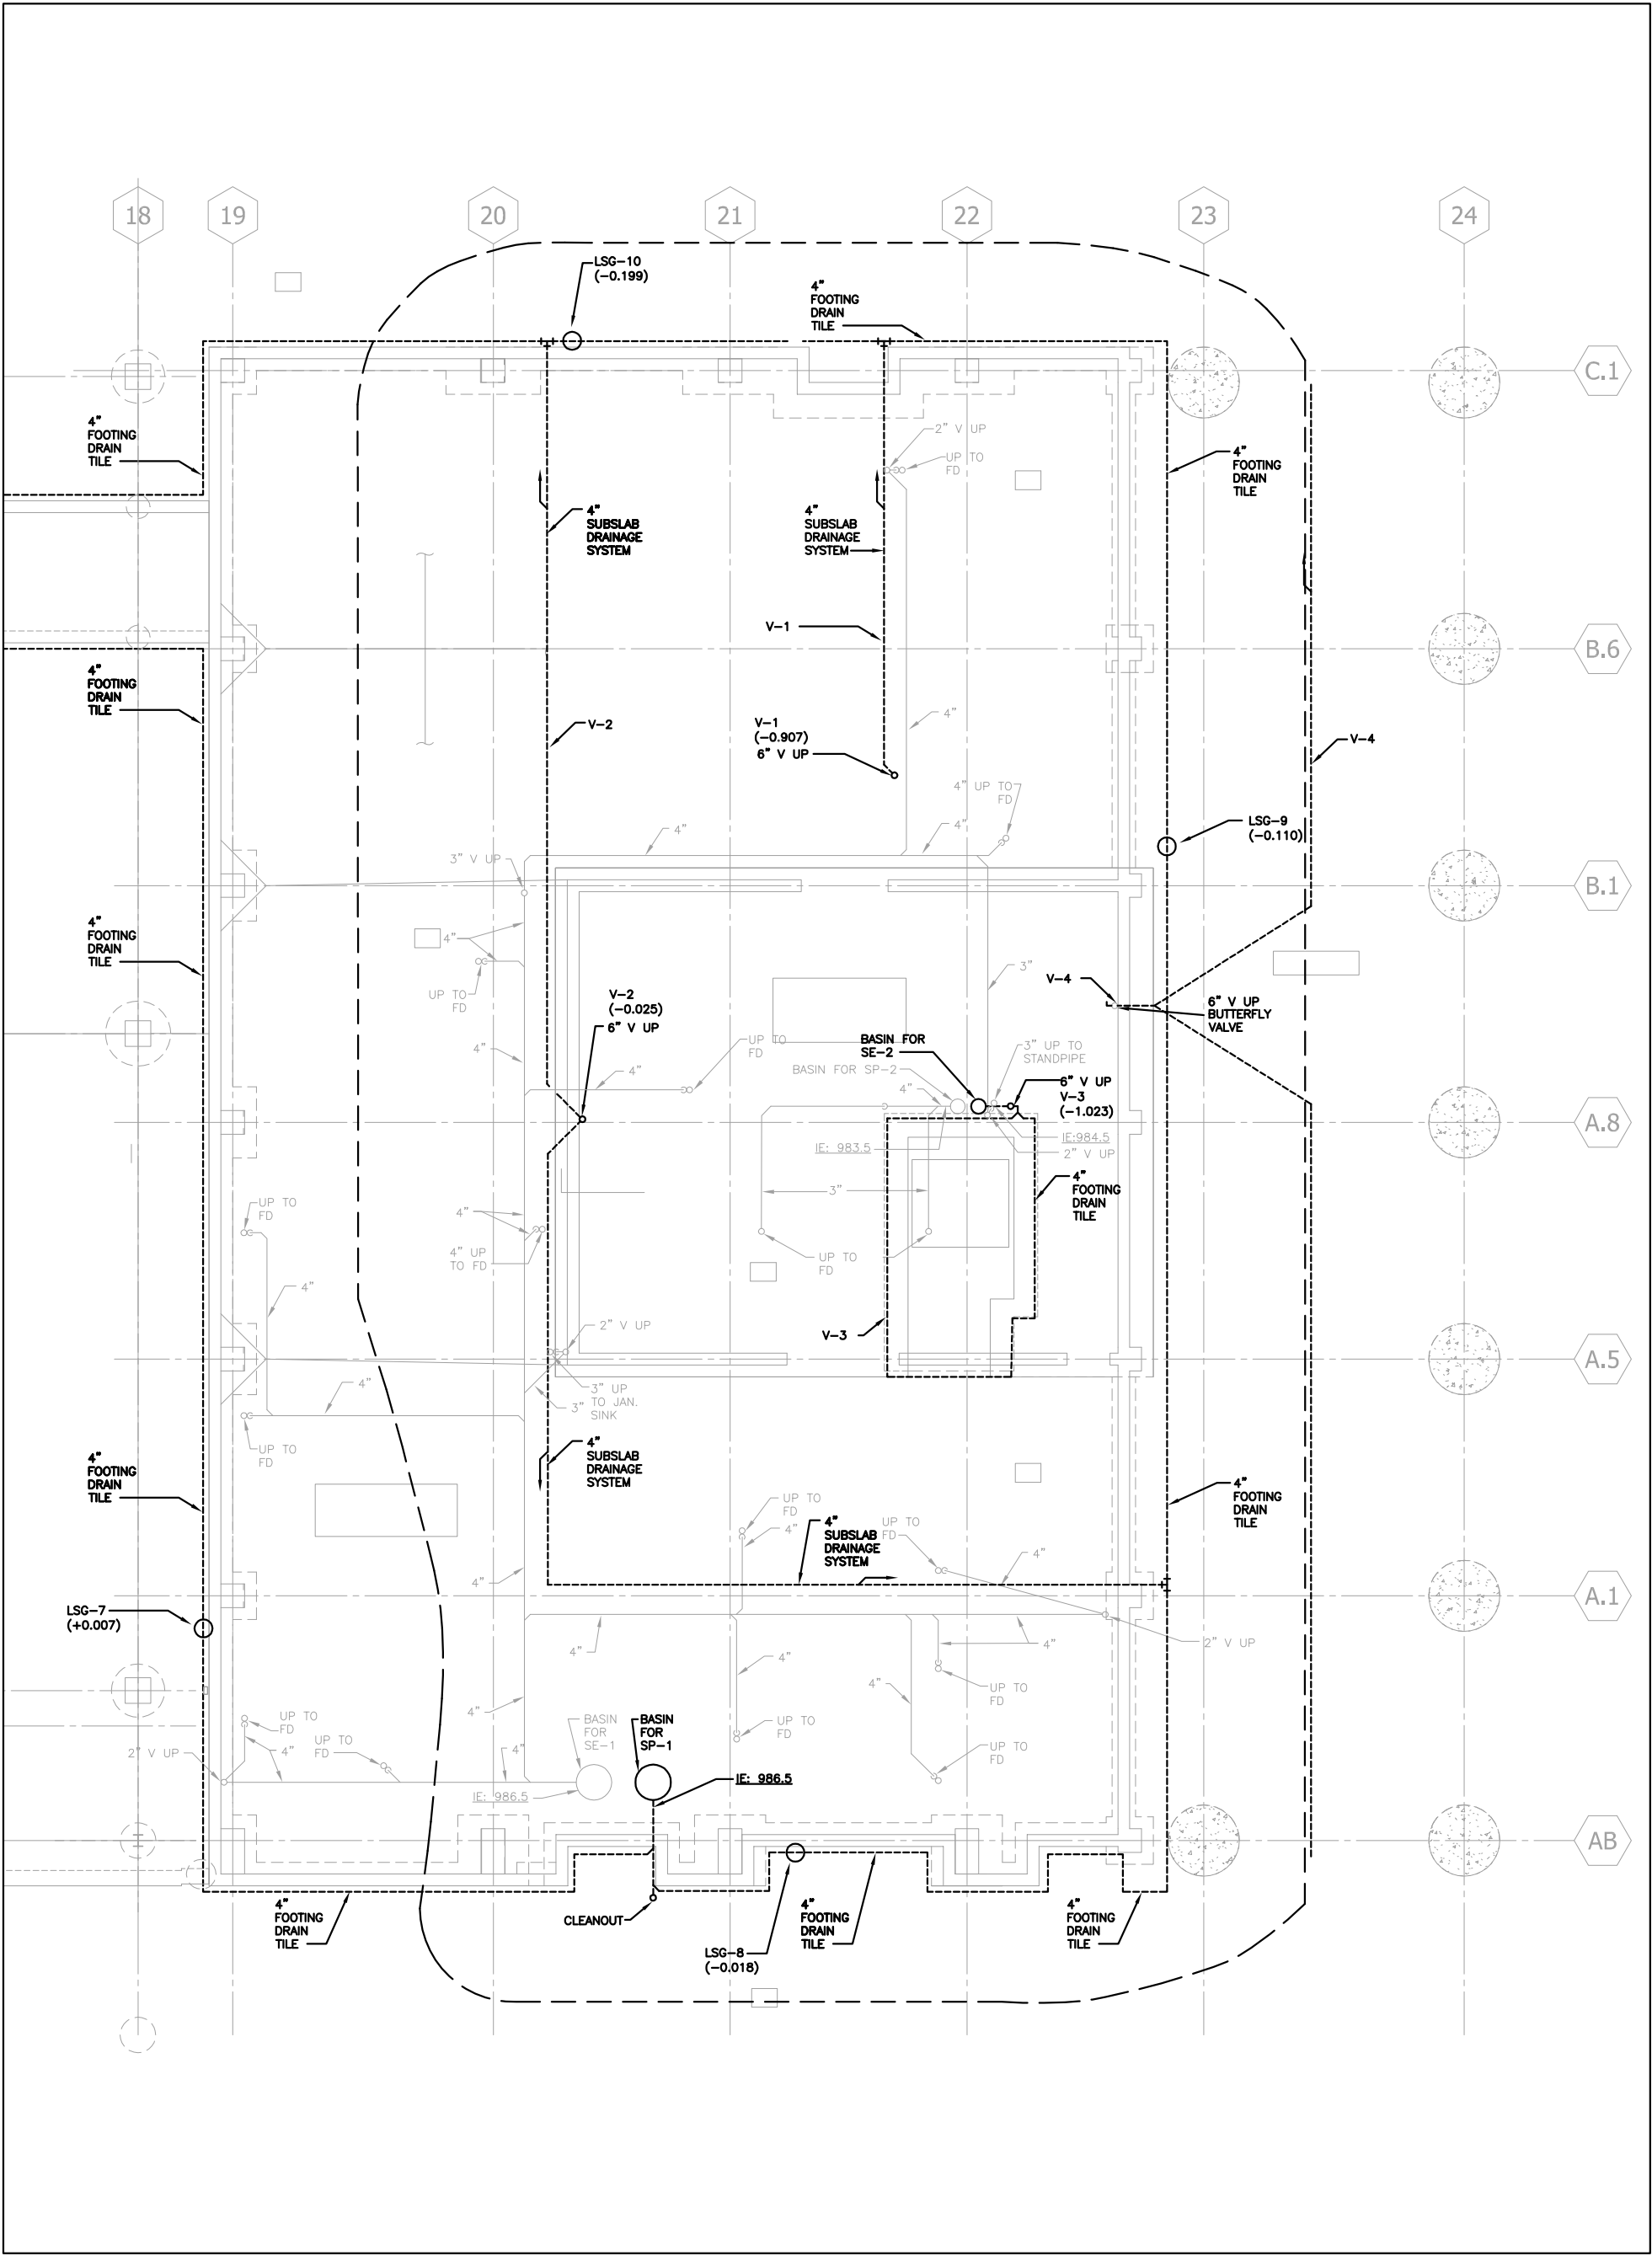
FIGURE 6
BASEMENT LEVEL ASBUILT DRAWING AND V-1 and V-3
PRE-MITIGATION DIAGNOSTIC TESTING RESULTS

NOTE:
1) Drawing provided by HGA; however, the venting system was designed by Landmark Environmental LLC.
2) AMG Fury fan was used for pre-mitigation diagnostic testing for V-1 & V-3.

Figure 6 shows the pressure field extension while testing the AMG Fury fan on the stack for venting systems V-1 and V-3. The fan pressure reading was -1.5 in. WC with a corresponding blower curve flow rate of 270 cfm. The riser pipe readings ranged from -0.025 to -1.023 in. WC and pressure field extension readings from LSG-7 through LSG-10 ranged from 0.007 to -0.110 in WC. The pre-mitigation diagnostic testing results are provided in **Table 1**.

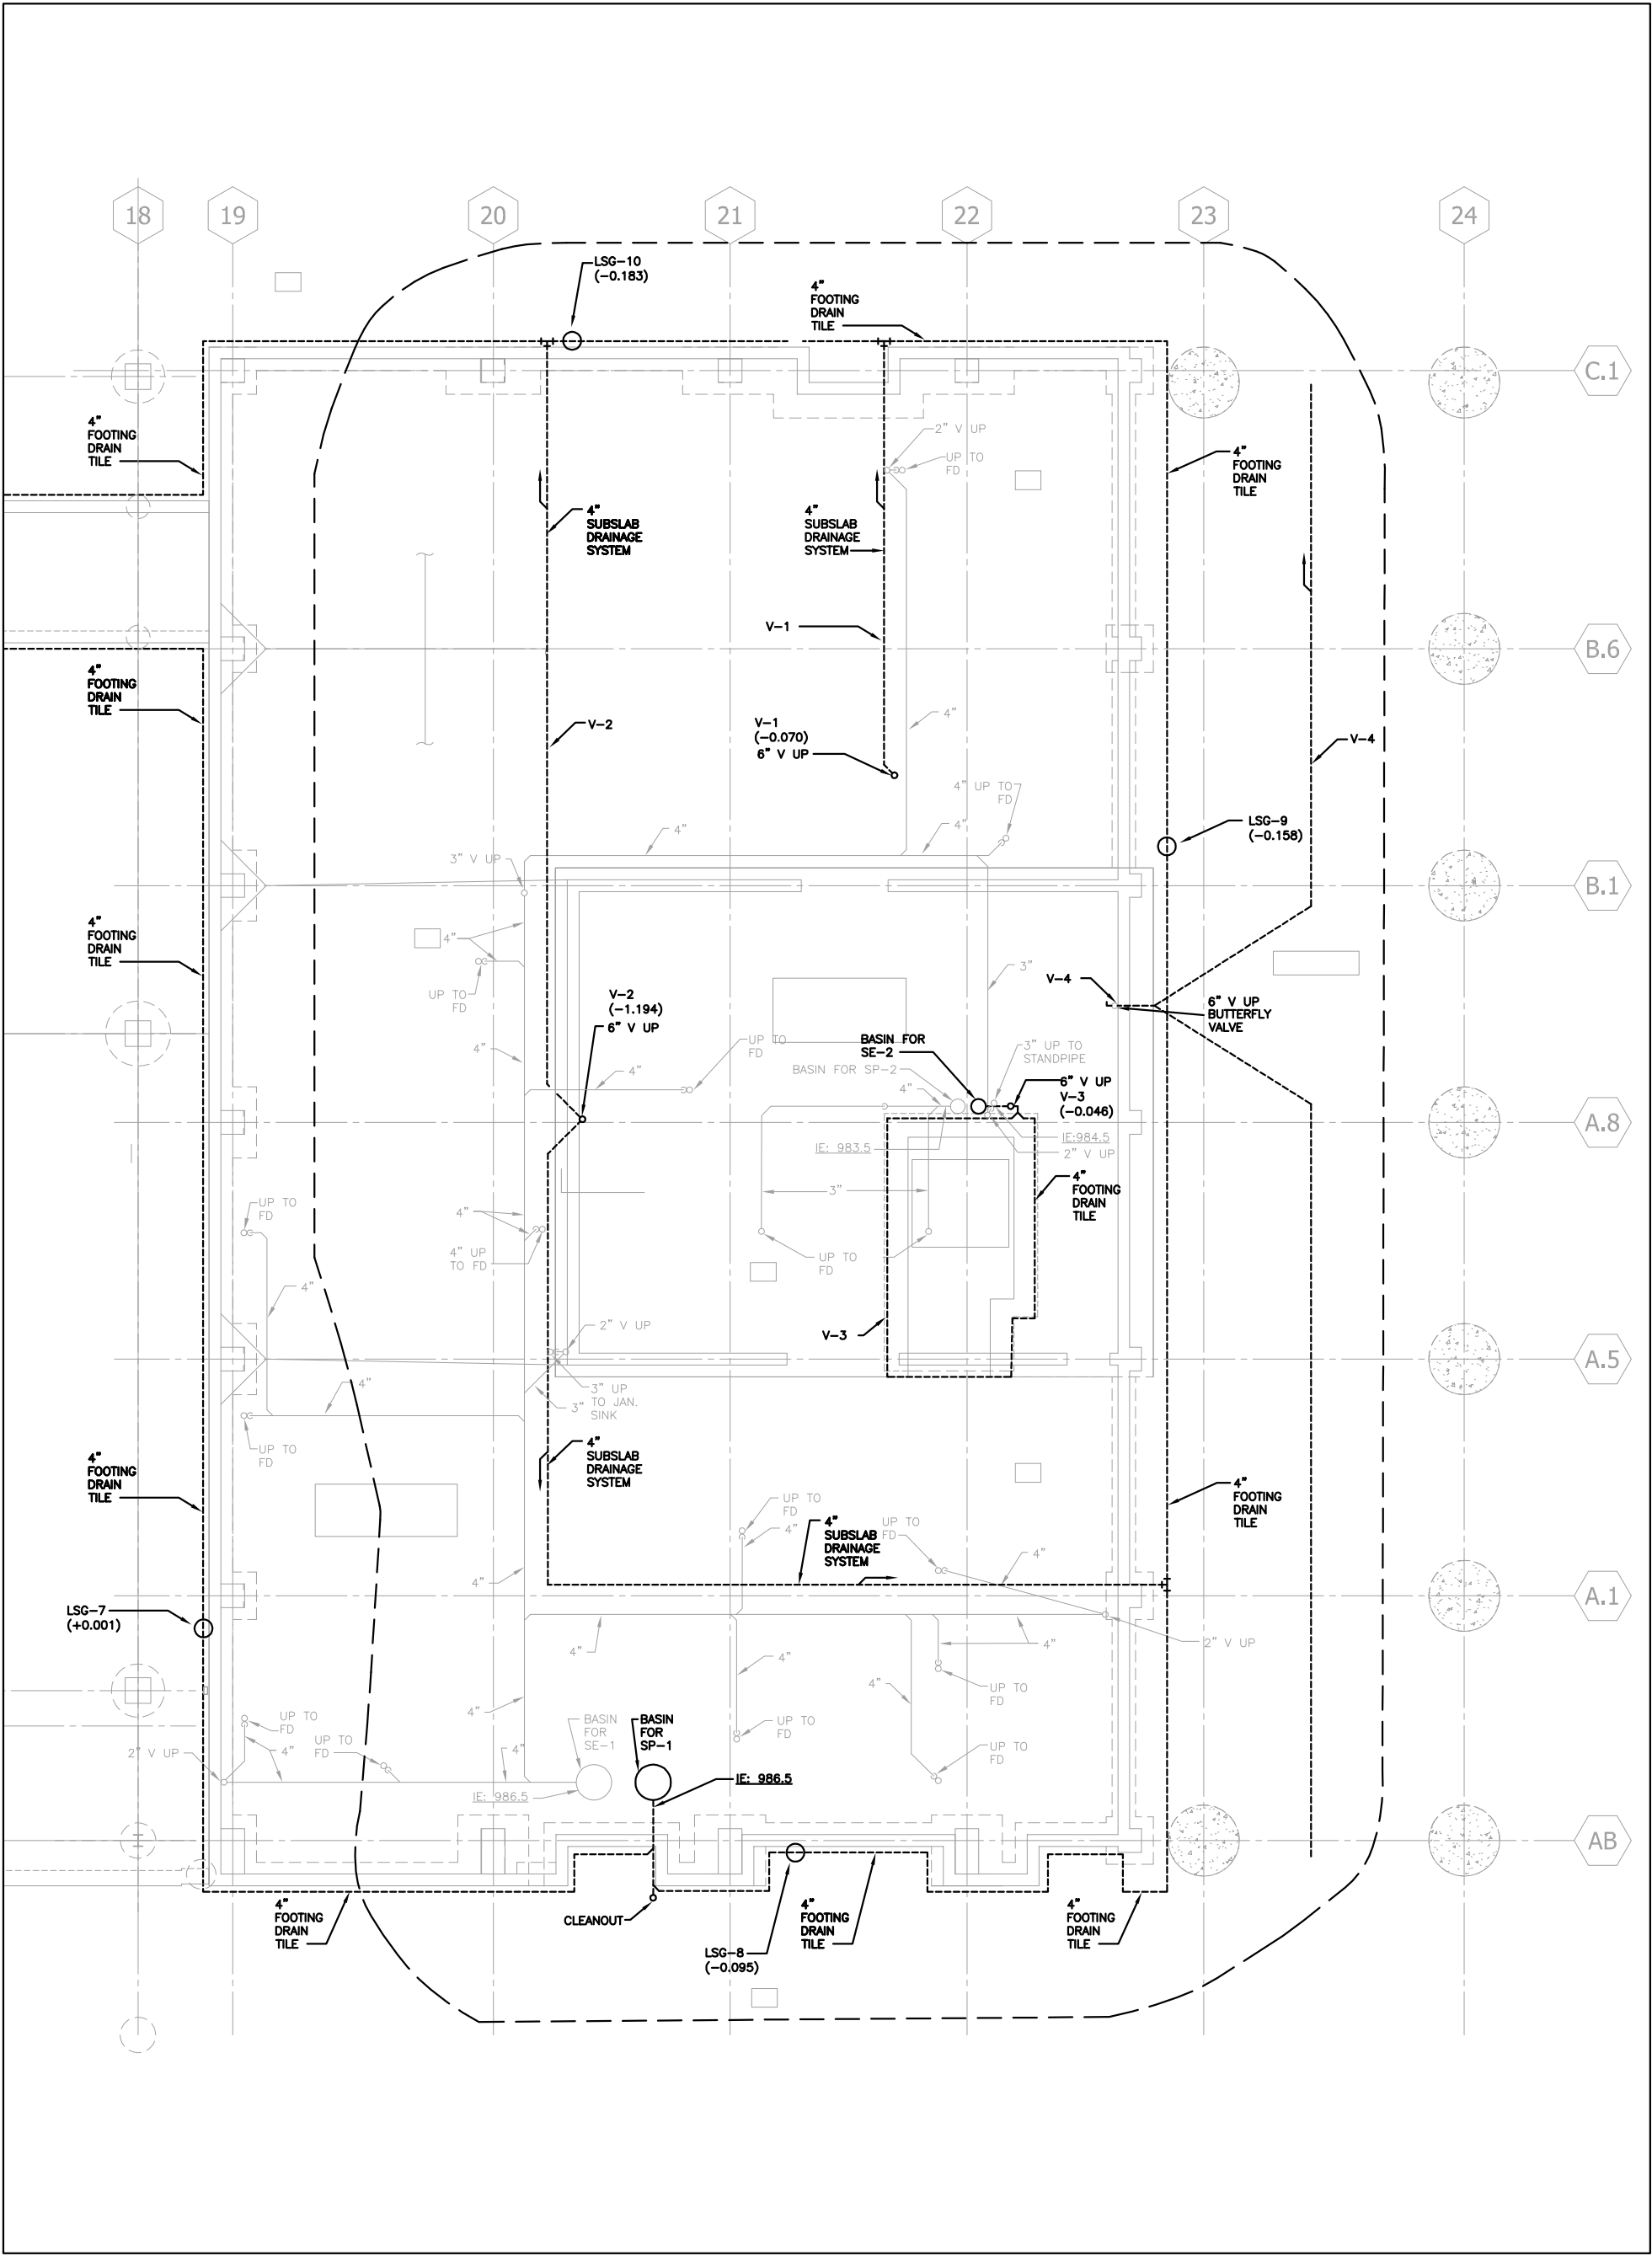
FIGURE 7
BASEMENT LEVEL ASBUILT DRAWING AND V-2
PRE-MITIGATION DIAGNOSTIC TESTING RESULTS
221 FIRST AVENUE S.W.
ROCHESTER, MINNESOTA

NOTE:
1) Drawing provided by HGA; however, the venting system was designed by Landmark Environmental LLC.
2) AMG Fury fan was used for pre-mitigation diagnostic testing for V-2.

Figure 7 shows the pressure field extension while testing the AMG Fury fan on the stack for venting system V-2. The fan pressure reading was -1.5 in. WC with a corresponding blower curve flow rate of 270 cfm. The riser pipe readings ranged from -0.046 to -1.194 in. WC and pressure field extension readings from LSG-7 through LSG-10 ranged from 0.001 to -0.183 in WC. The pre-mitigation diagnostic testing results are provided in **Table 1**.
