Re: Active Sub-Slab Venting System Modification Work Plan
MN Bio Business Center, Rochester, MN

On behalf of the City of Rochester and Landmark Environmental, LLC (Landmark) has prepared this Active Sub-Slab Venting System Modification Work Plan (Work Plan) for the above referenced property (Property). The Property location map is included as **Figure 1**. This Work Plan includes the results from pre-mitigation diagnostic testing conducted on the existing venting system on March 23, 2015. Based on the pre-mitigation diagnostic testing results, this Work Plan includes the proposed design modifications to convert the existing passive venting system to an active vapor mitigation system (VMS). This Work Plan is being submitted to the Minnesota Pollution Control Agency (MPCA) Voluntary Investigation and Cleanup (VIC) Program for review and approval.

Pre-Mitigation Diagnostic Testing Photos
MN Bio Business Center
Rochester, MN

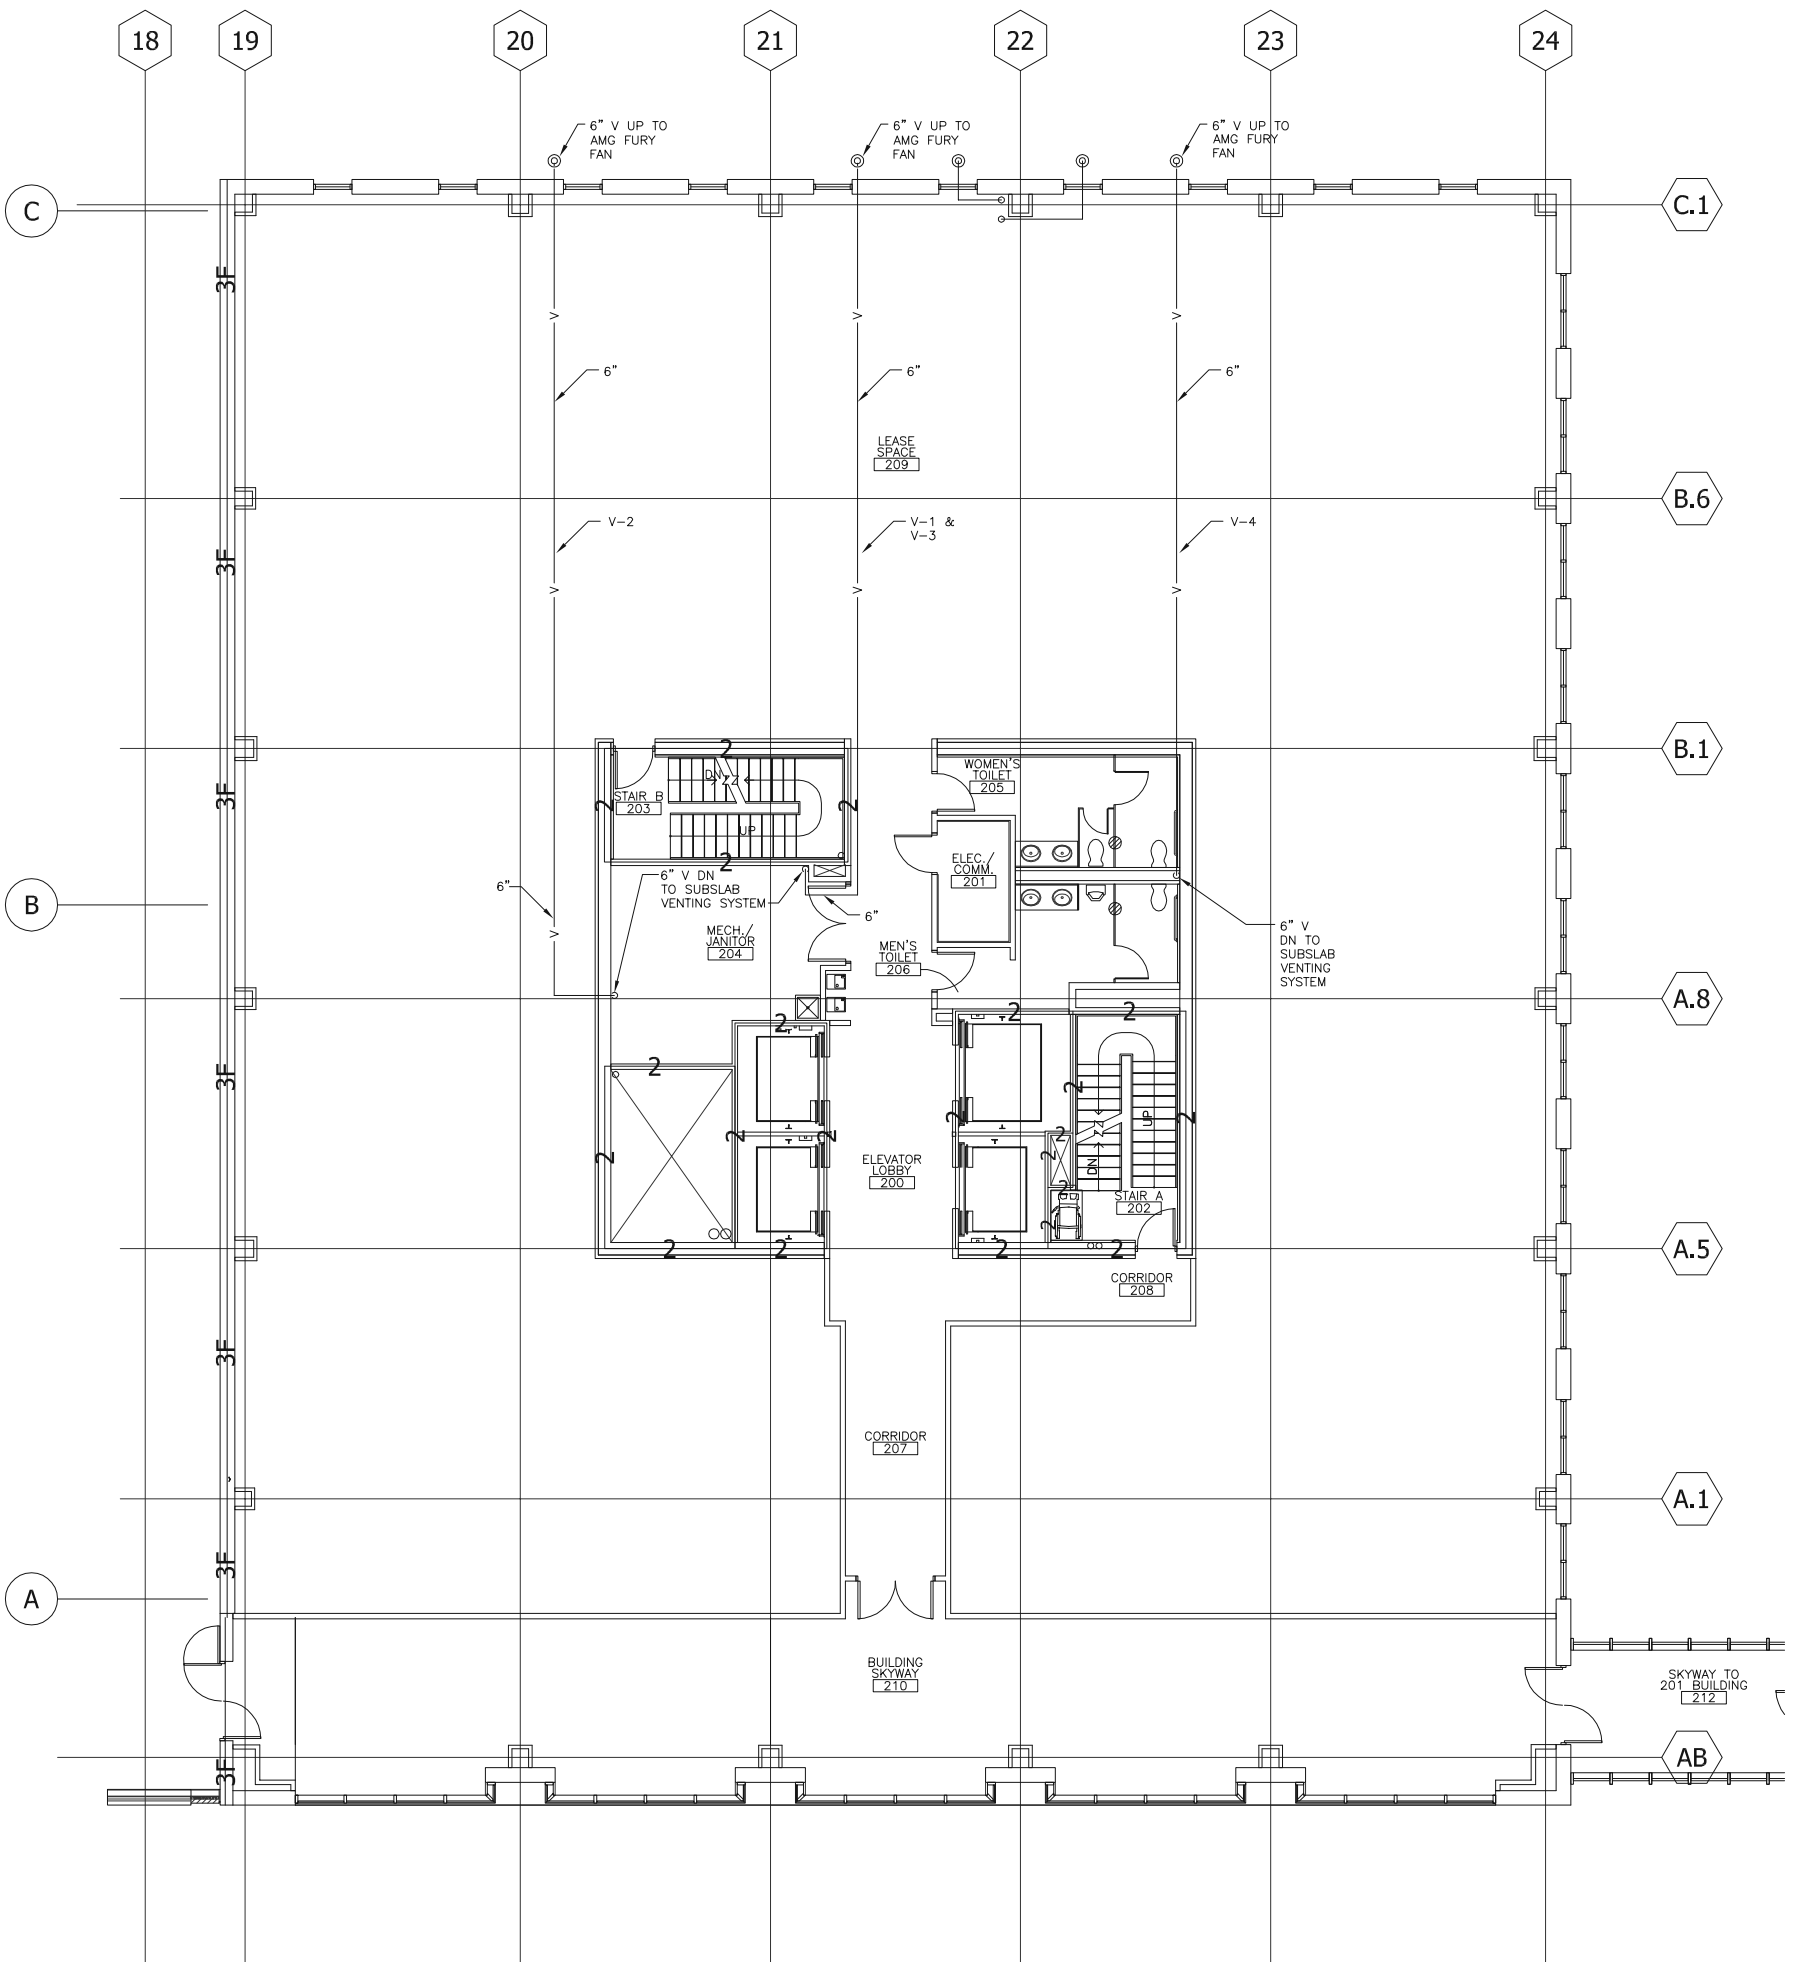
FIGURE 8
SECOND FLOOR - ACTIVE VENTING SYSTEM

NOTE: Drawing provided by HGA; however, the venting and DPE systems were designed by Landmark Environmental, LLC.

Based on the results of the pre-mitigation diagnostic tests, converting the existing passive venting systems to active VMS's was effective in creating a negative pressure field extension beneath the slab of the Property building. Therefore, the proposed VMS modifications include installing one AMG Fury fan on each of the three existing venting systems stacks located outside the building. There are a total of three 6-inch PVC venting system outlet pipes with turbine vents currently connected to the piping. These turbine vents will be removed and then replaced with AMG Fury fans. One AMG Fury fan will be connected to the stack for V-1 and V-3. One AMG Fury fan will be connected to the stack for V-2 and one AMG Fury fan will be connected to the stack for V-4. **Figure 8** shows the proposed active VMS layout. Pressure transducers will be installed on the inlet side of each fan so that fan pressure readings can be sent to a dedicated control panel with digital pressure reading displays.

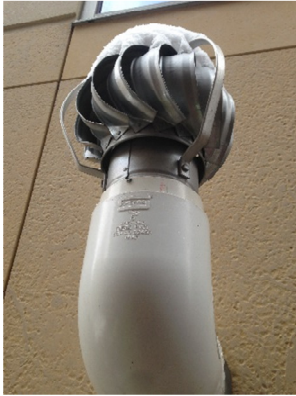
Close up existing rotary turbine ventilators connected to passive venting system.

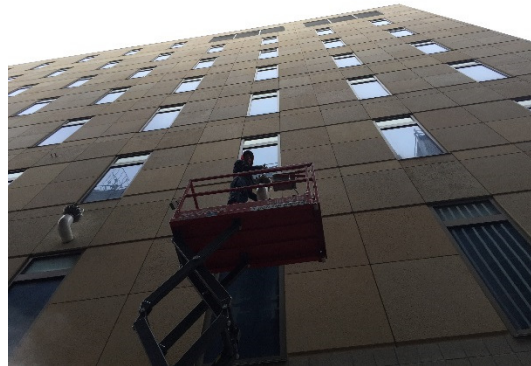
Scissor lift required to access stacks for pre-mitigation diagnostic testing.

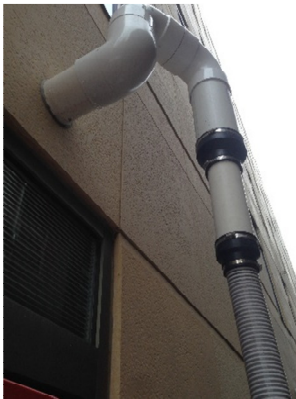
Pre-mitigation diagnostic testing pipe modifications.

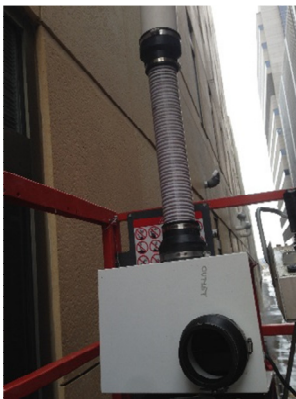
Pre-mitigation diagnostic testing pipe modifications with AMG Fury fan on top of scissor lift.
