Phase I Environmental Site Assessment

Kraus-Anderson Property
Montgomery Wards Automotive Service Center
Bloomington, Minnesota

Kraus-Anderson

Project Number CMXX-98-0716
September 24, 1998

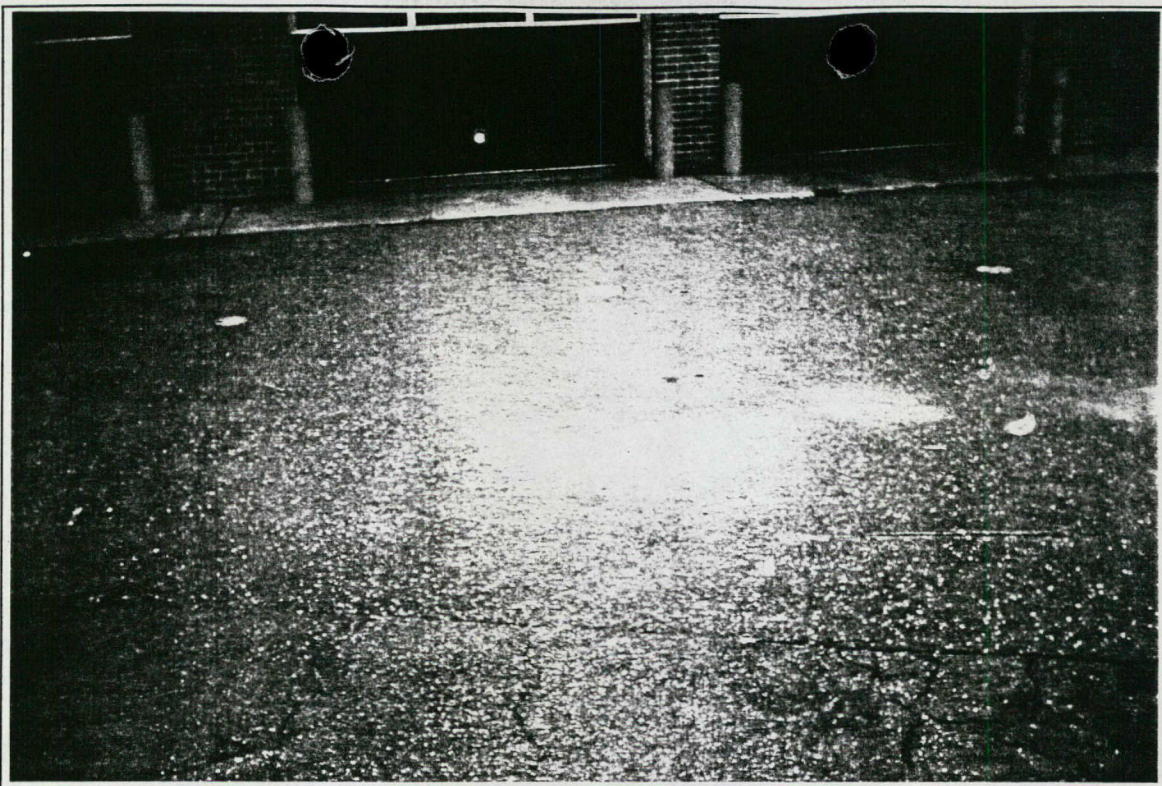
Two areas of asphalt patch were observed in the parking area adjacent to the south side of the automotive center. The eastern asphalt patch area contained five concrete patches consistent with soil borings. An abandoned flammable liquids sump was observed in the concrete sidewalk adjacent to the western asphalt patch area. A 4-inch-diameter steel pipe was noted protruding from the sidewalk near the abandoned flammable liquids sump.

Photograph #1
Date: September 21, 1998
Direction: Facing north
Subject: View of the eastern asphalt patch.

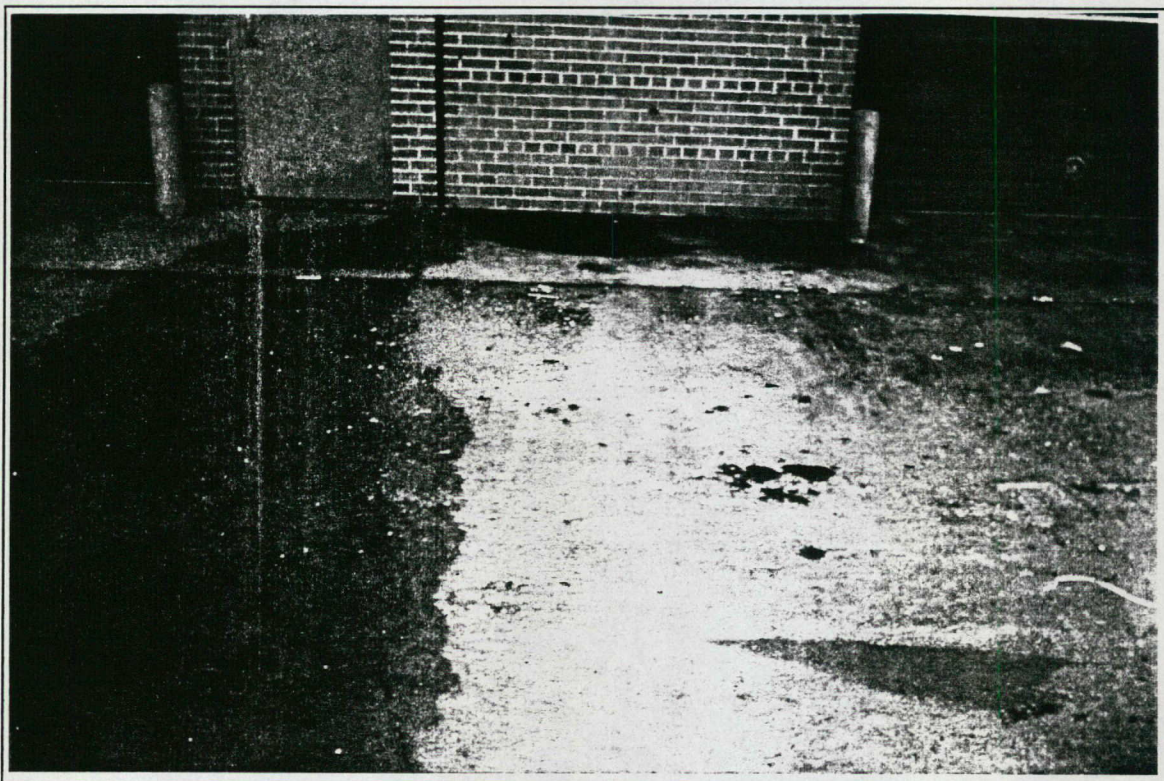
- An area of heavy petroleum staining approximately 25 feet long and 5 feet wide was observed on the north side of the automotive service center adjacent to the service bays. The staining suggests a long-term release of petroleum products. Based on the observed slope of the stained area back toward the automotive service center, this release appears to extend to soils adjacent to and under the existing automotive service center foundation and/or floor.

During the reconnaissance, the *Site* topography appeared relatively flat. The concrete sidewalk around the automotive service center had settled and appeared to slope from the parking lot toward the automotive service center in several areas including an area of heavily stained pavement on the north side of the building, adjacent to the service bays.

During the *Site* reconnaissance, heavy petroleum product staining was observed on the concrete floor in the automotive service center and on the concrete sidewalk on the north side of the automotive service center.

Photograph #2
Date: September 21, 1998
Direction: Facing south
Subject: View of the heavy petroleum staining adjacent to building.

Braun Intertec recommends performing a Phase II environmental site assessment (Phase II ESA) at the *Site* to evaluate whether soils and/or groundwater beneath the *Site* have been adversely impacted by the recognized environmental conditions described above. The recommended Phase II ESA work includes conducting soil borings both inside and outside of the automotive service center building to evaluate the recognized environmental conditions.

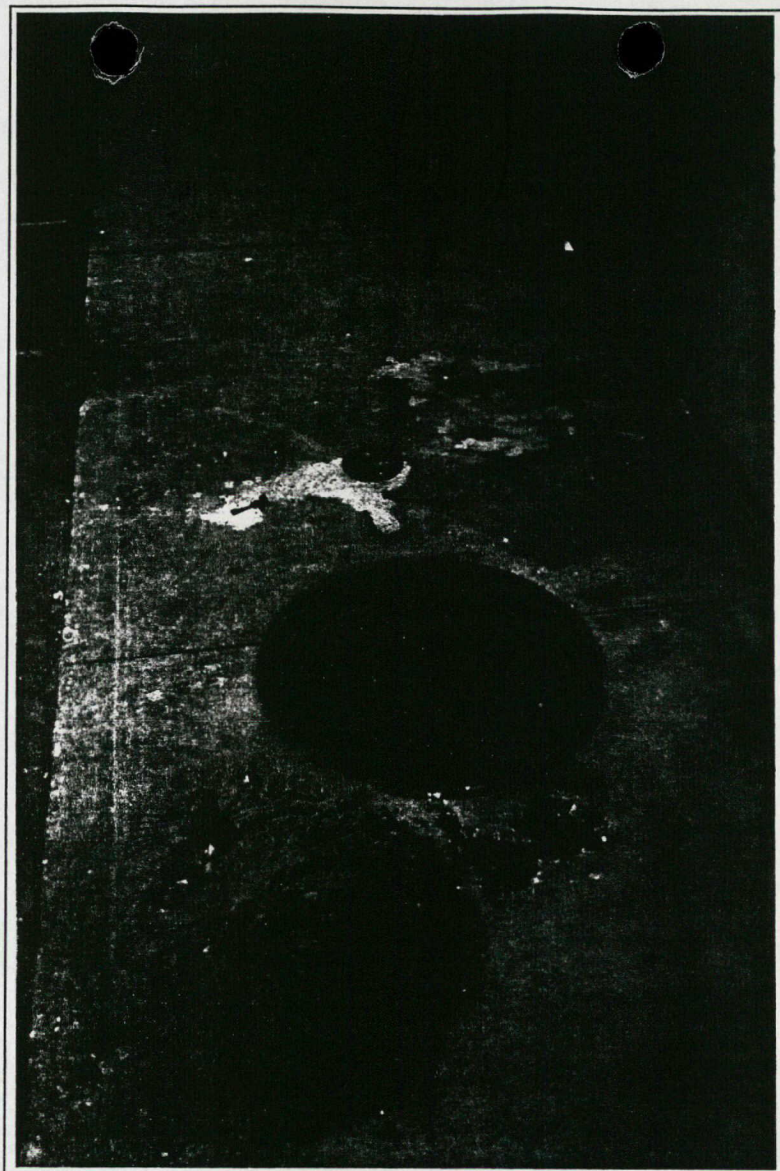
Photograph #3

- There is no documentation regarding an abandoned flammable liquids sump observed at the *Site*.
- There is no documentation regarding proper abandonment/closure of a used-oil UST, which was reportedly taken out of service by Montgomery Wards after years of use at the *Site*.

Subject: View of the abandoned flammable liquids sump on the south side of the building.
