*Re: LSI
Site: Wally McCarthy's Oldsmobile, 1900 West 78th Street, Richfield, MN 55423
Site ID#: LEAK00012876*

The purpose of this Phase I Environmental Site Assessment (ESA) was to assist Wally McCarthy's Oldsmobile and Aurora in identifying the presence of potentially hazardous materials at its automobile dealership and service center located at 1900 West 78th Street, Richfield, Minnesota (Figure 1).

EXCAVATION REPORT WORKSHEET FOR PETROLEUM RELEASE SITES

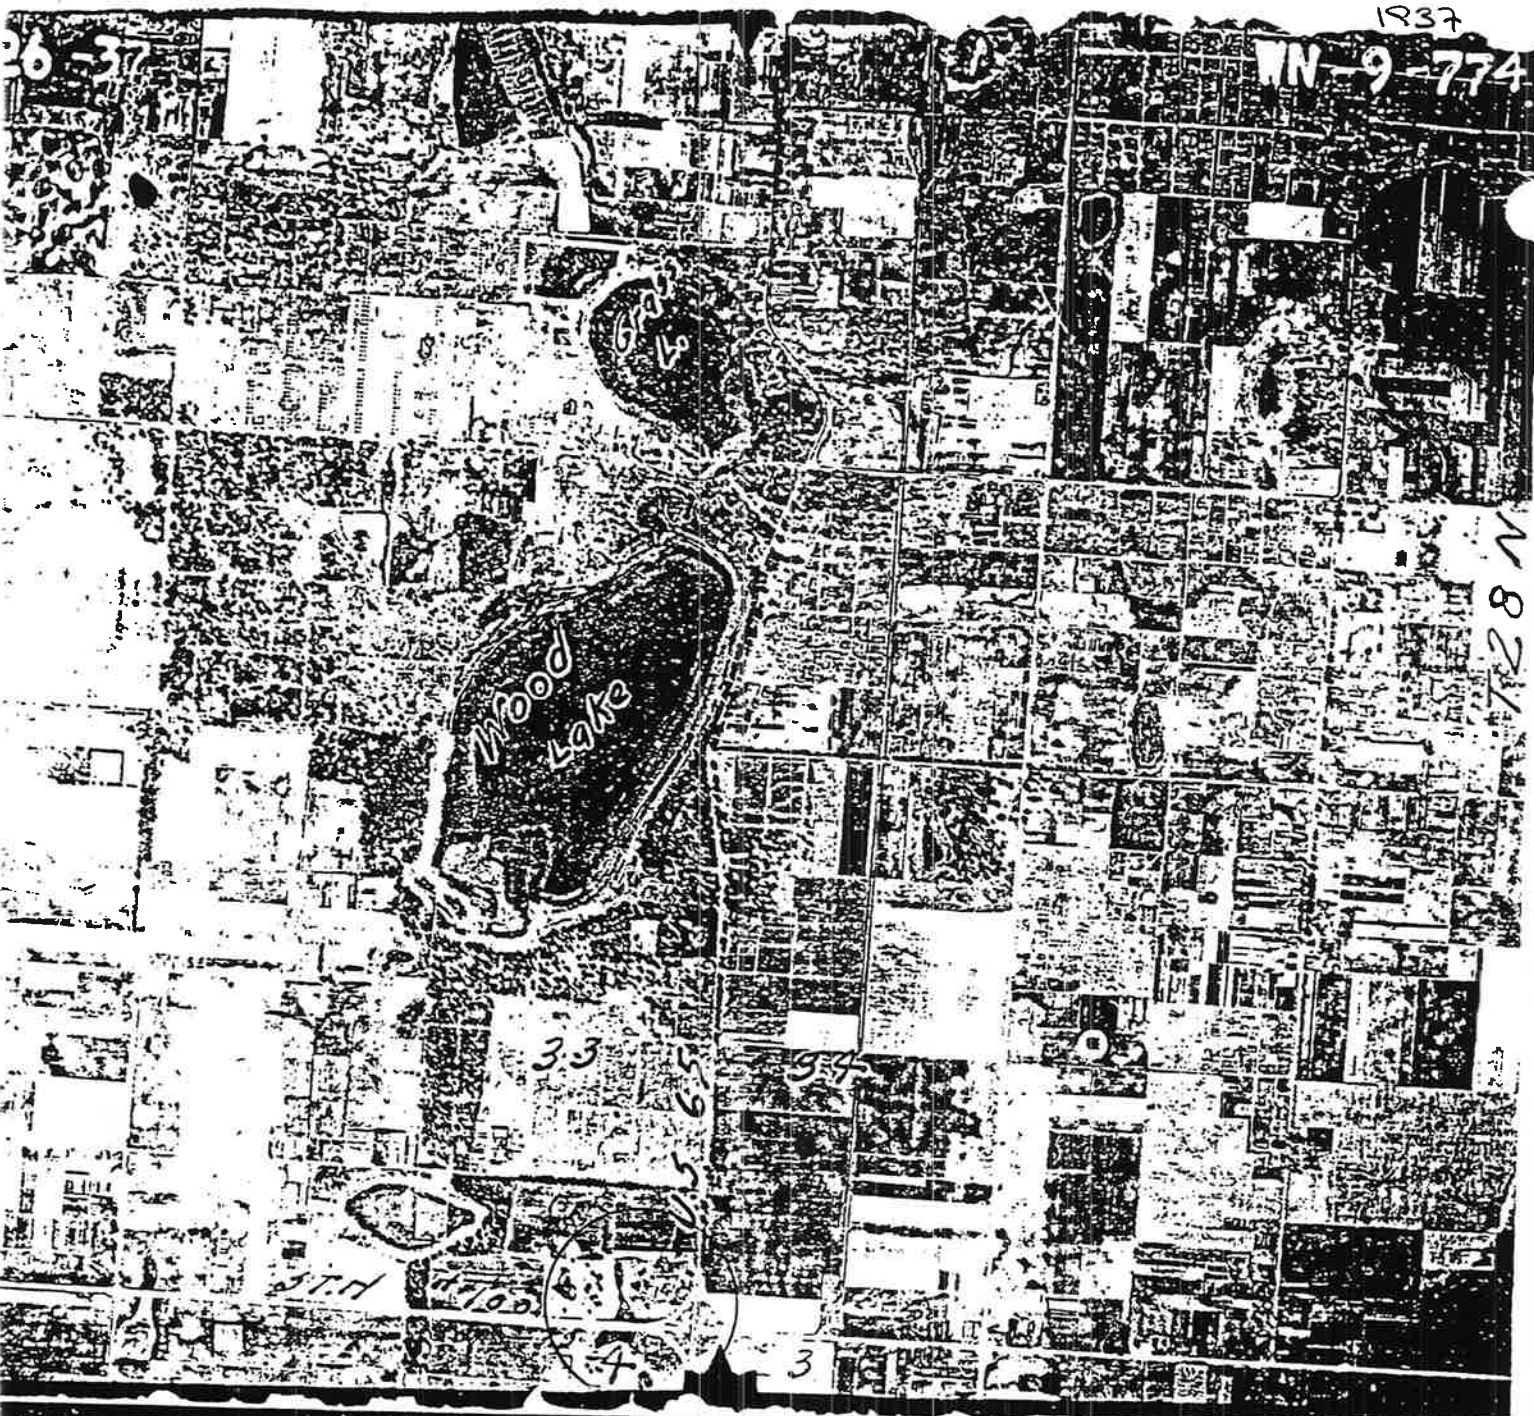
Aerial photographs were reviewed to identify historical land development and historical uses which may have potentially generated hazardous materials or impacted the site. Aerial photographs from 1937 to 1997 were viewed in the imagery room of the University of Minnesota Library. The reference section of this report lists the aerial photographs reviewed. Reproductions of aerial photographs taken in 1937, 1945, 1956, 1966, 1978, 1987, and 1997 are supplied in Appendix A.

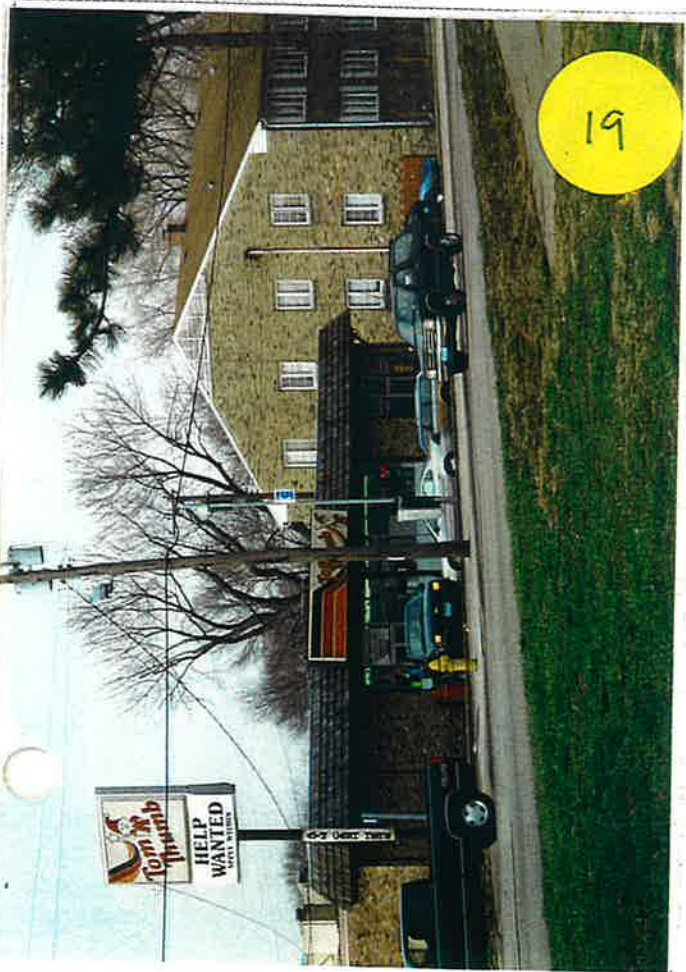
Photo #	Comments
1-3	Adjacent property to the north and northwest (two churches and residential homes); picture 3 is facing east, along W. 76 th Street.
4	Citgo gas station west/southwest adjacent to the Property
5	Fountainhead apartments east/northeast adjacent to the Property
6-9	Residential homes along Oliver, Newton, Morgan, and Logan Avenues, respectively.
10-11	The Diplomat and South Court apartments, respectively
12	Facing north/northeast, businesses along Logan Avenue S.
13	Approximately 6-7 55-gallon drums on pallets southwest of building at 7629-7635 Logan Avenue S.
14	Facing south/southeast, businesses along Logan Avenue S.
15	Facing west/southwest, businesses bordering W. 77 th St. between Morgan and Logan Avenues
16	Facing south/southeast, businesses along the east side of Morgan Avenue S.
17-18	Facing north/northwest, businesses along Knox Avenue S.
19	7600 Knox Avenue S.
20	Lift station at the southwest corner of W. 77 th Street and Knox Avenue S.

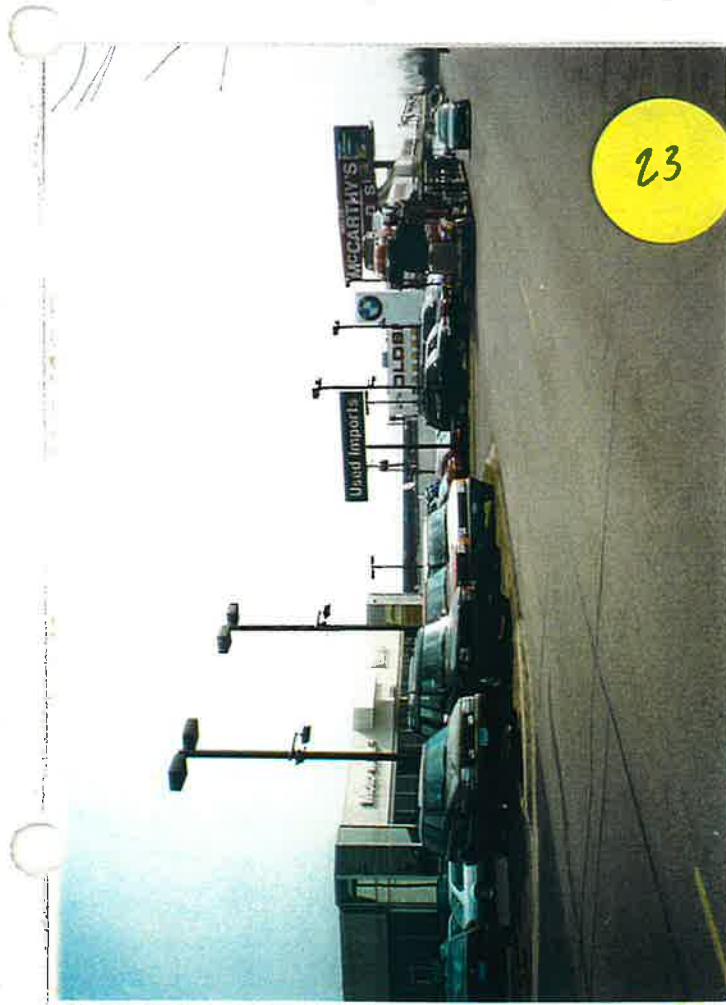
22

21	The corner of W. 77 th St. and Penn, facing south/southeast. Walser used cars, and further south, Walser Truck Center.
22-24	South edge of 2100, 2000/1920, 1920/1900 W. 78 th St., respectively.
