**NON-AQUEOUS PHASE LIQUID (NAPL)  
DELINEATION REPORT  
FORMER UNION 76  
329 EAST FIRST AVENUE SOUTH  
CAMBRIDGE, MINNESOTA  
MPCA SITE ID: LEAK8001**

Liesch Companies

**NOVEMBER 16, 2011  
PROJECT NUMBER: 65677.00**

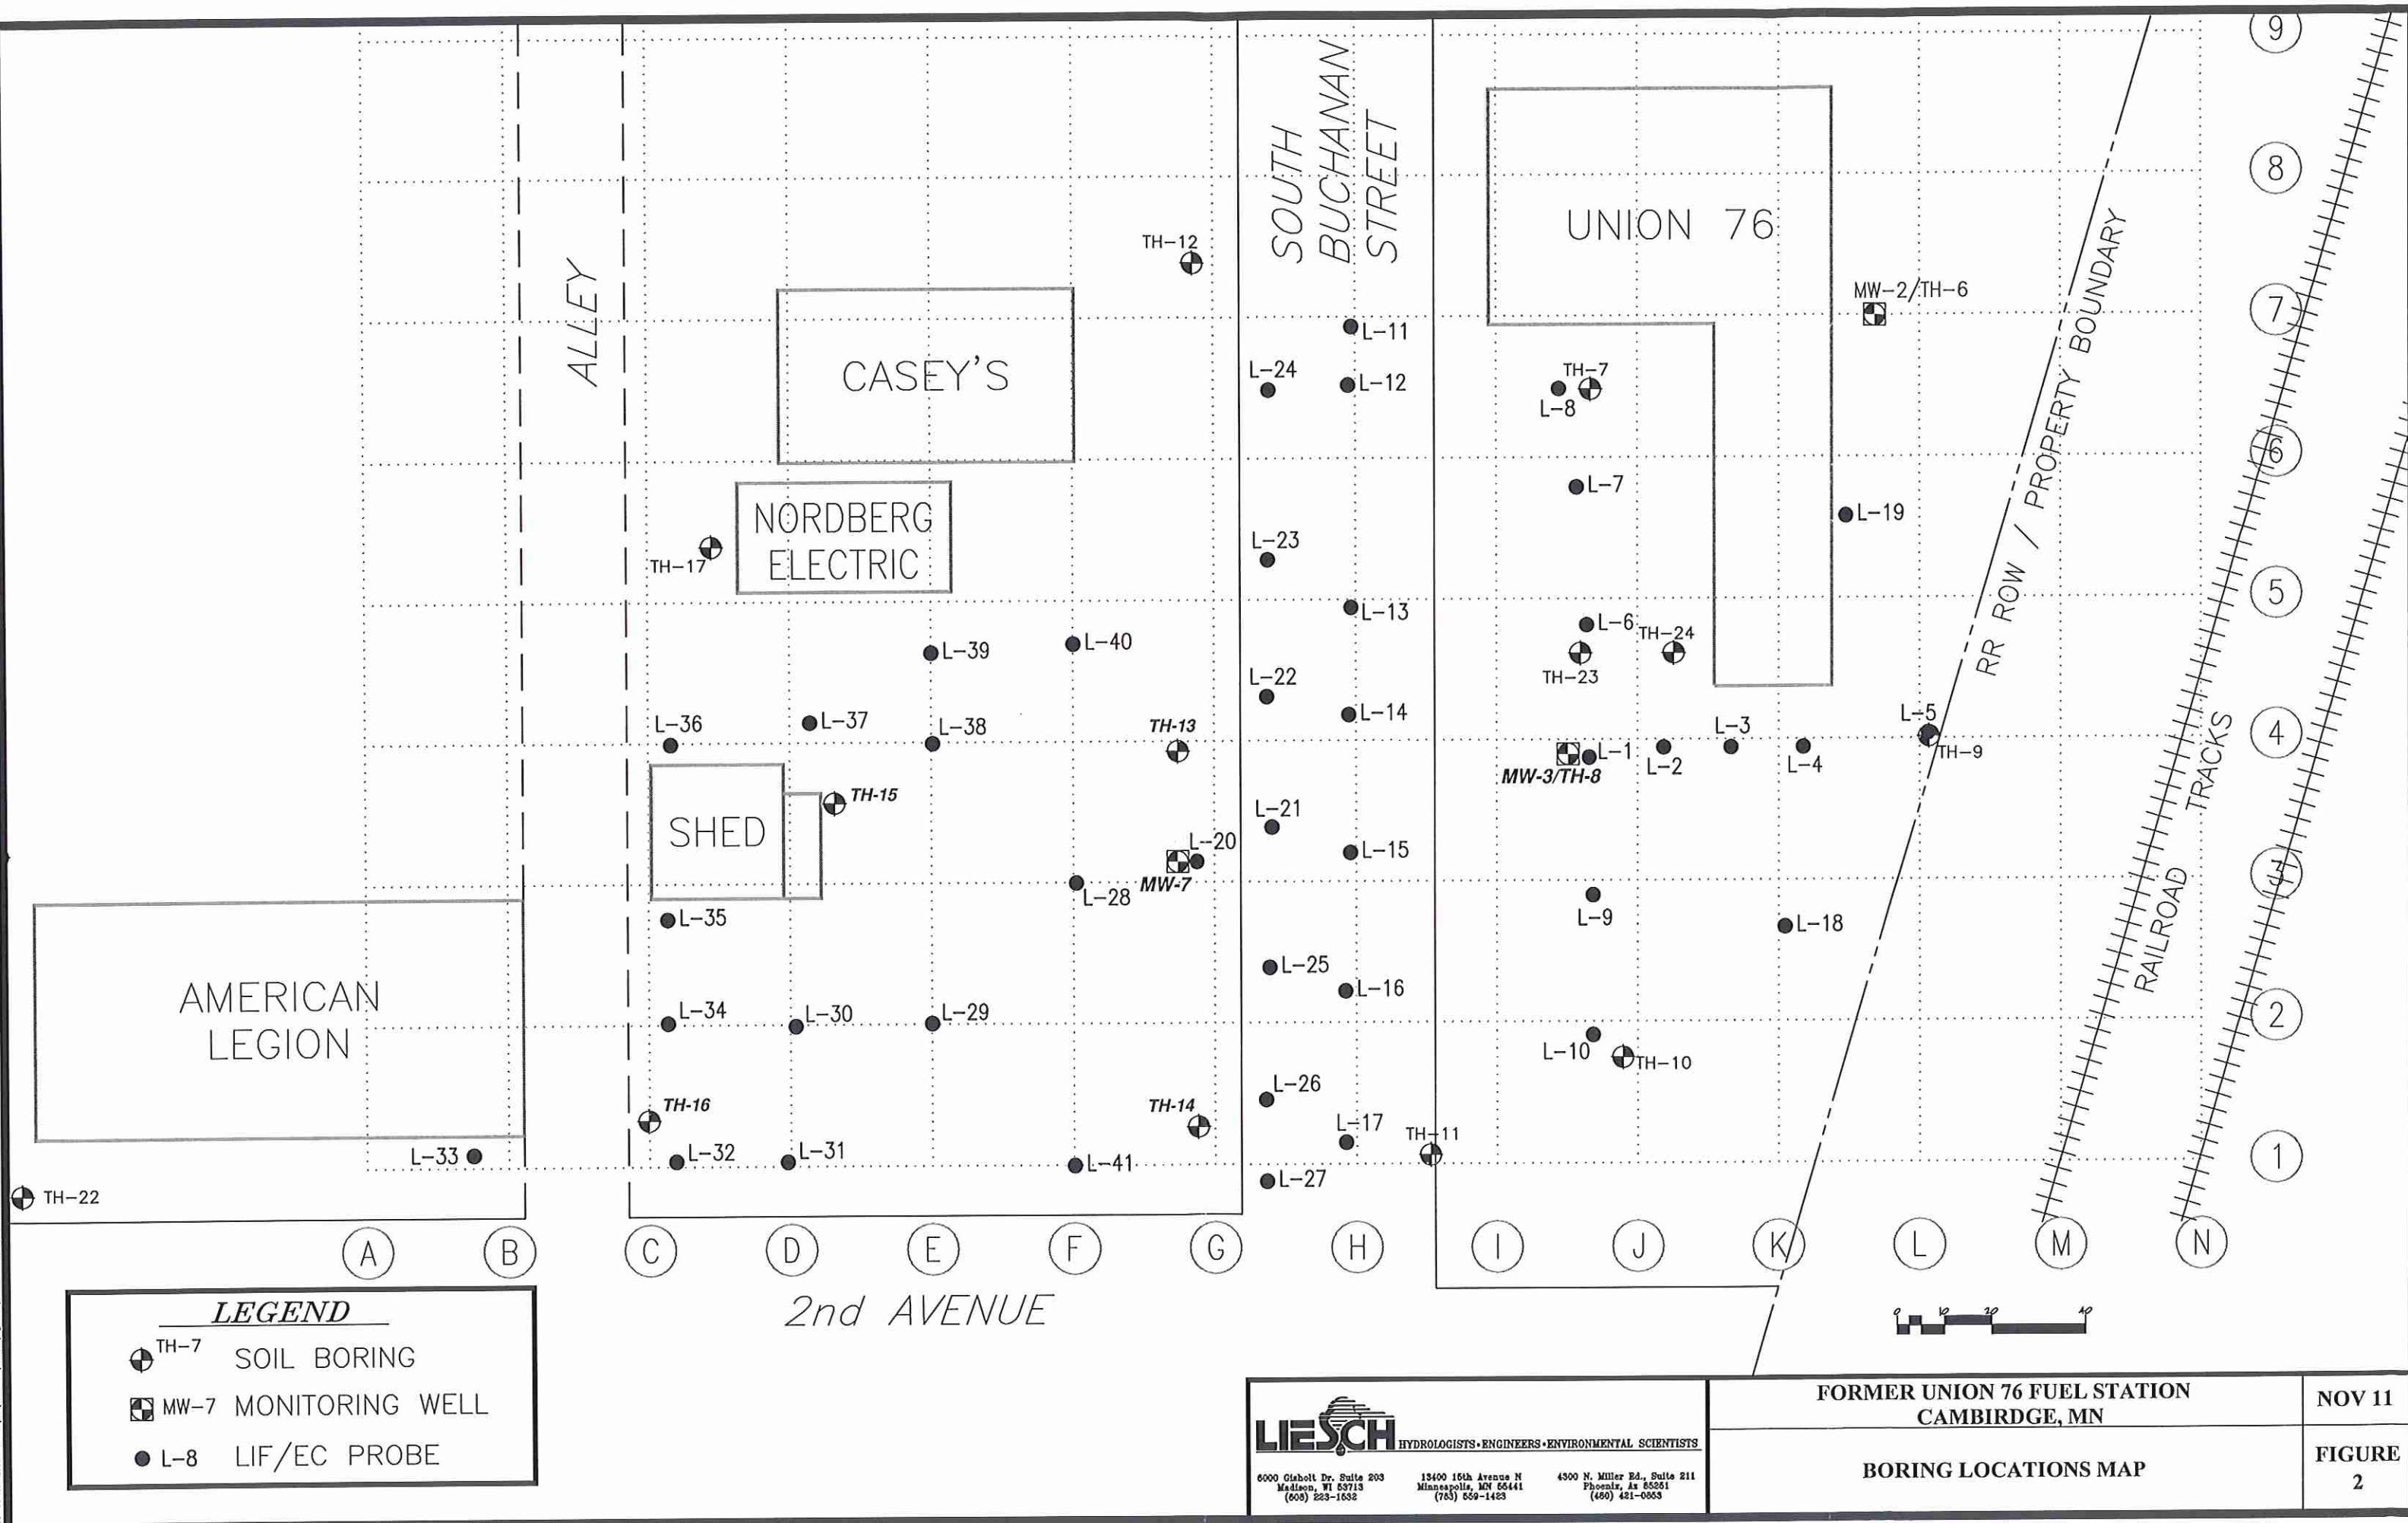
Liesch retained Matrix Technologies, Inc. (Matrix) to assist with the delineation investigation using a UVOST LIF screening tool pushed by a truck-mounted 6610DT Geoprobe® rig. Forty-one (41) probes designated as L-1 through L-41 were completed on the Property on March 21 through March 25, 2011. The probe locations are shown on **Figure 2** in **Appendix A**.

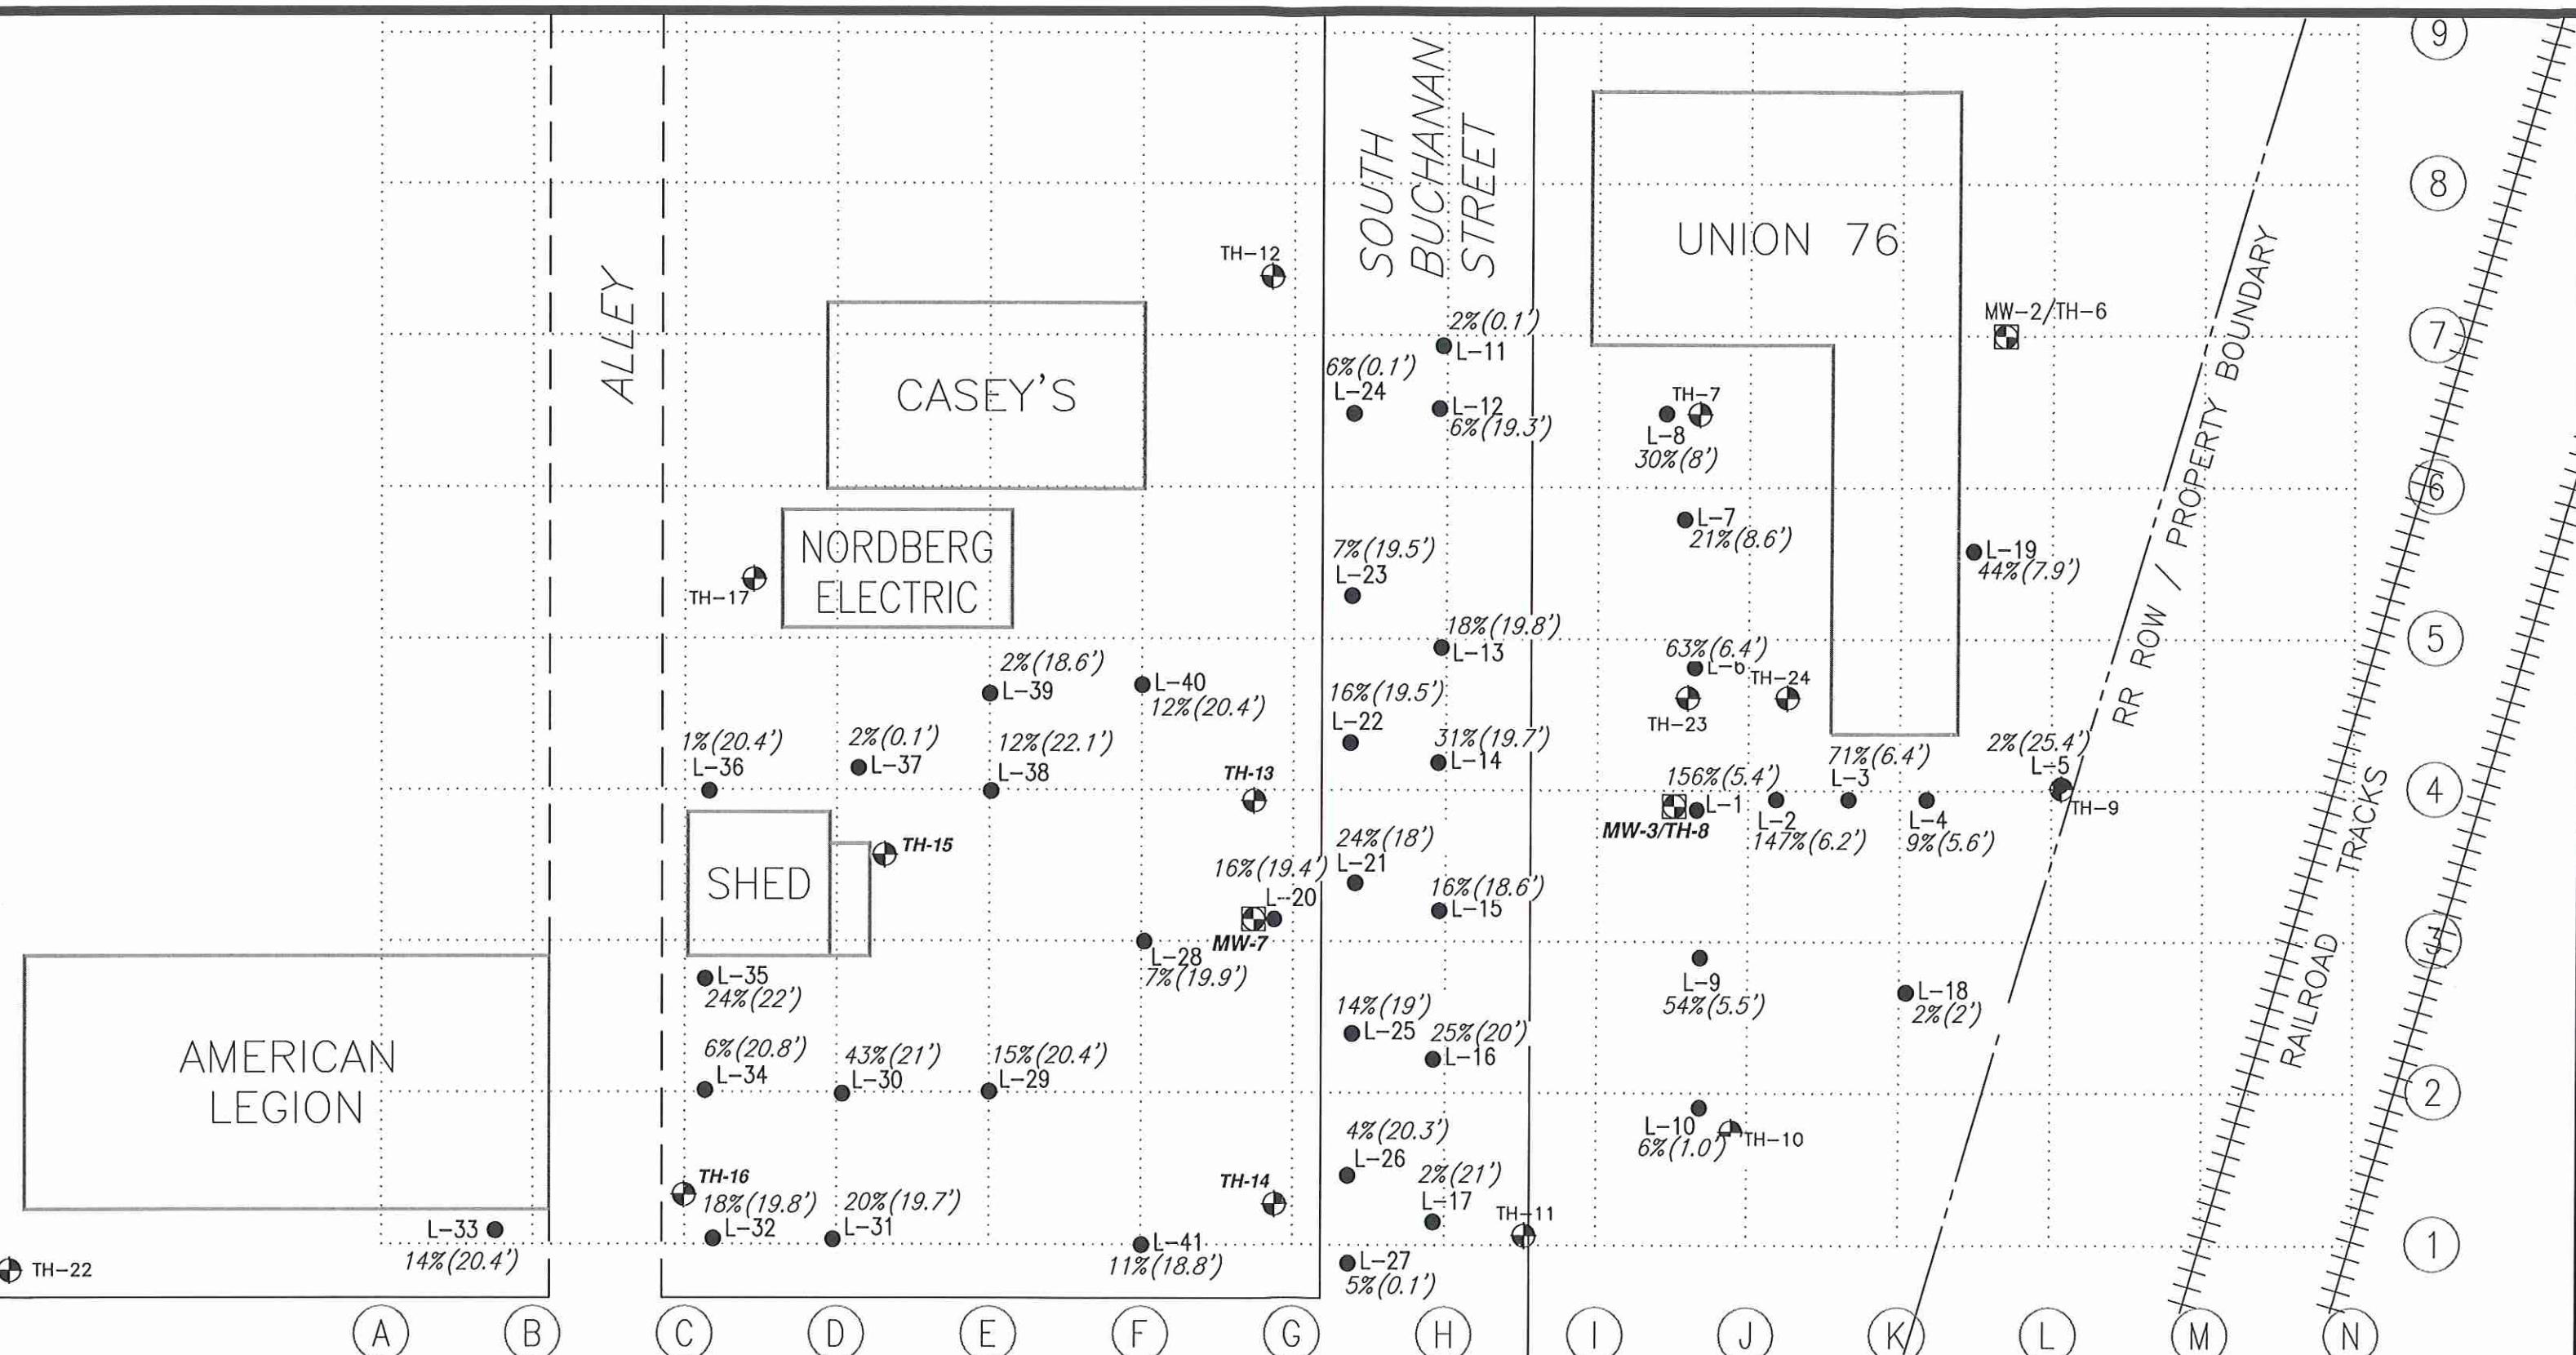
**Figure 3 in Appendix A** identifies the maximum signal at each probe location and the depth of that signal. **Figure 4 in Appendix A.** is a Isocontour map of the maximum signals. The

maximum signal results for probes L-10, L-11, L-18, L-24, L-27, and L-37 were modified from the maximum signal, which occurred in the upper two feet, to the maximum signal at the water table. As previously mentioned, these shallow signals are not considered to be indicative of the gasoline NAPL signals found near the source area or at the water table across the site. The map view locations of two cross-sectional views (North-South and West-East) are depicted on **Figure 5** in **Appendix A**. The Cross-sectional views for North-South and West-East are included in the Matrix Direct Sensing Report included as **Appendix B**.

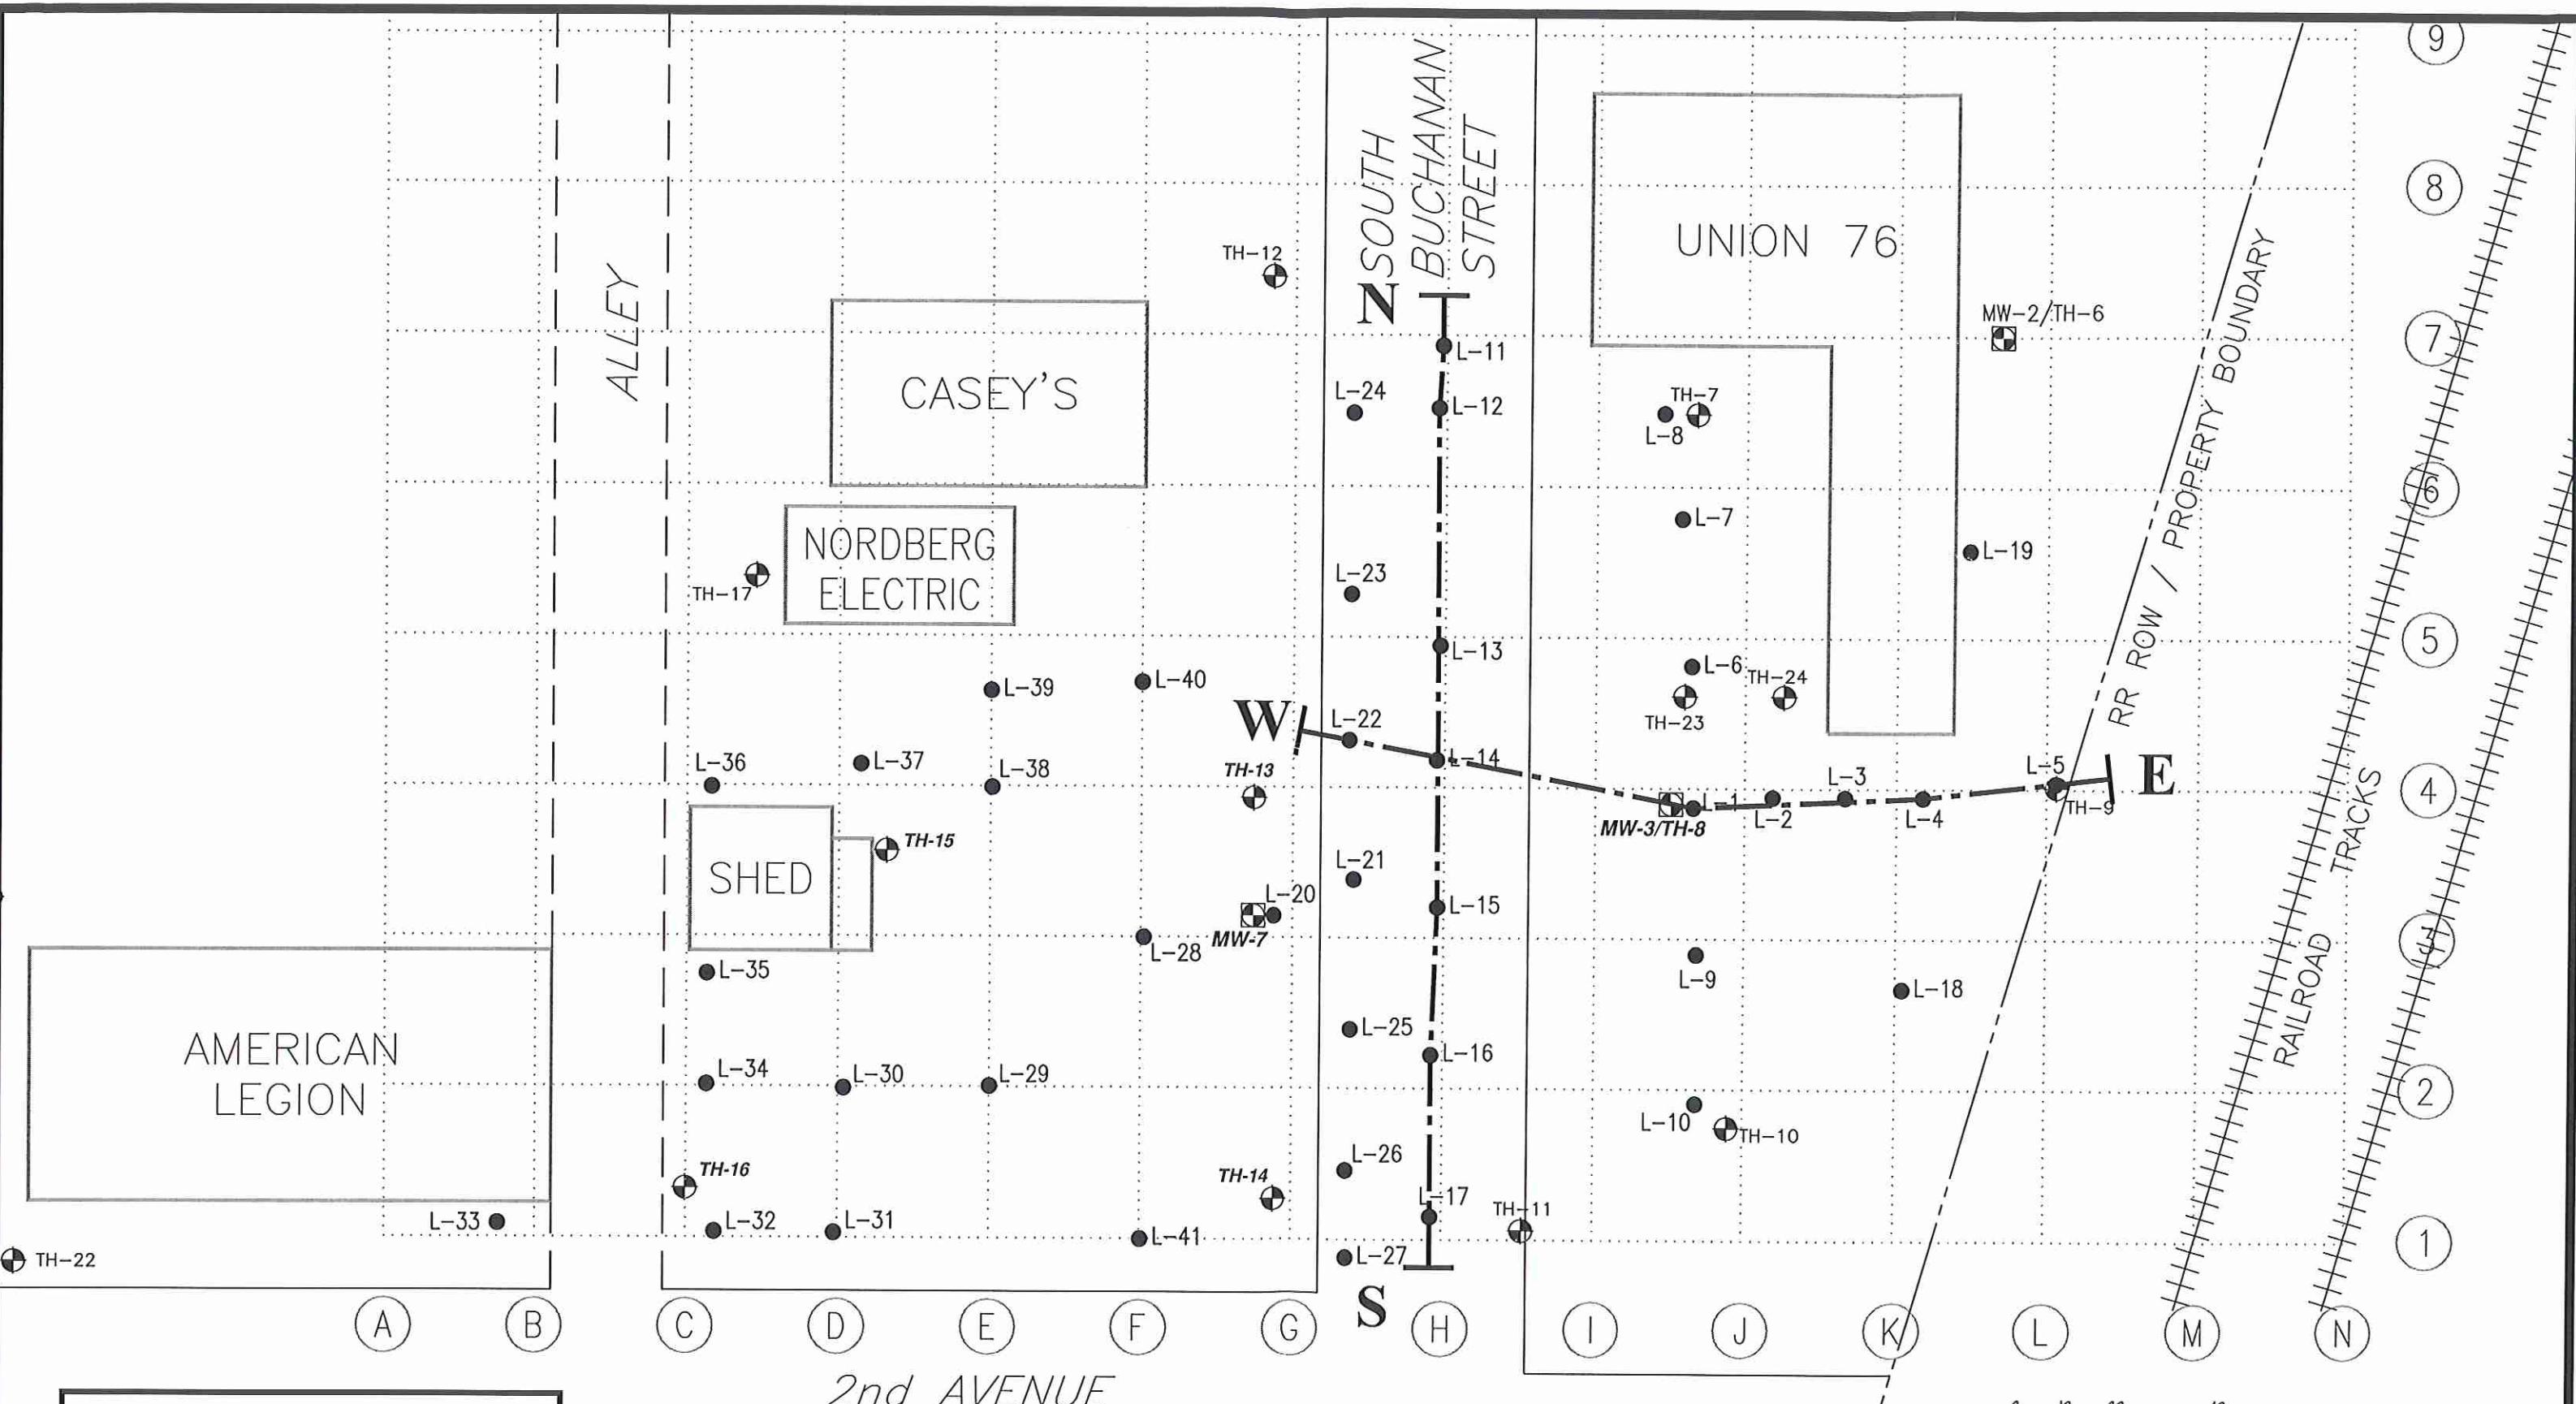
## FIGURE 5

## CROSS SECTION LOCATIONS

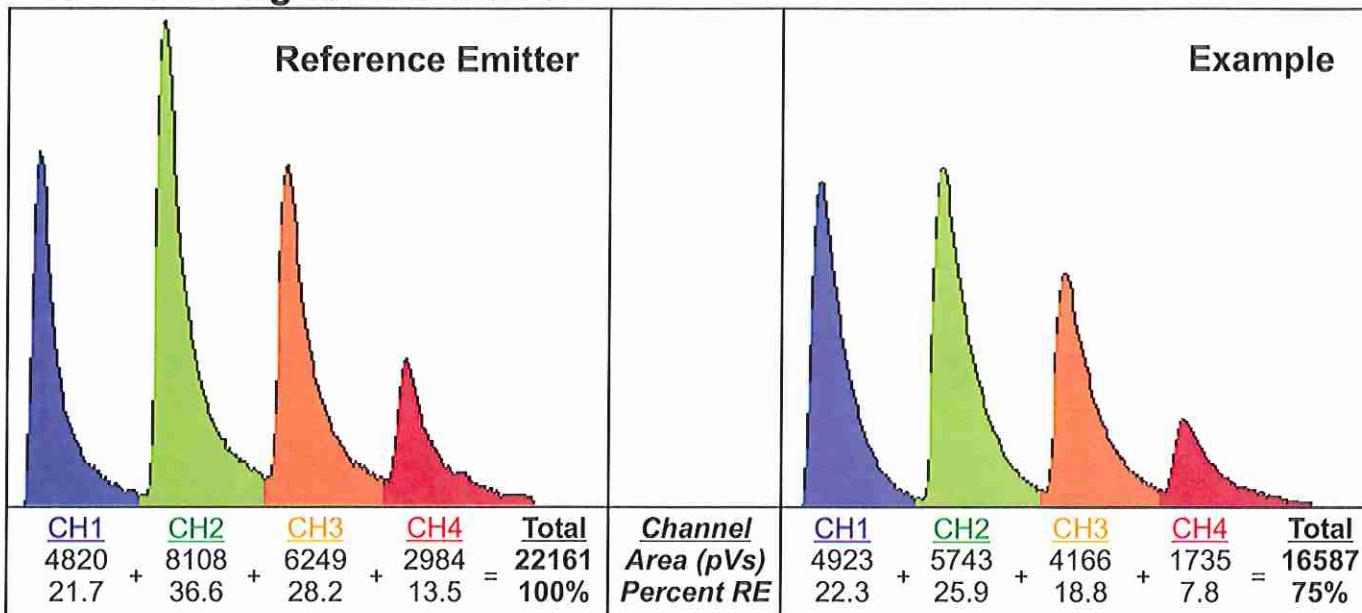
## Waveform Signal Calculation

Signal (total fluorescence) versus depth where signal is relative to the Reference Emitter (RE). The total area of the waveform is divided by the total area of the Reference Emitter yielding the %RE. This %RE scales with the NAPL fluorescence. The fill color is based on relative contribution of each channel's area to the total waveform area (see callout waveform). The channel-to-color relationship and corresponding wavelengths are given in the upper right corner of the main plot.
