## Memorandum

**To:** Pam Anderson, MPCA  
**From:** John Hanson  
**Subject:** VBWD WRAPS, Eagle Point Lake – Shallow Lake vs. Wetland Classification  
**Date:** 6/17/2013  
**Project:** 23/82-1061  
**c:** Chris Klucas, MPCA; Jen Koehler, Barr Engineering

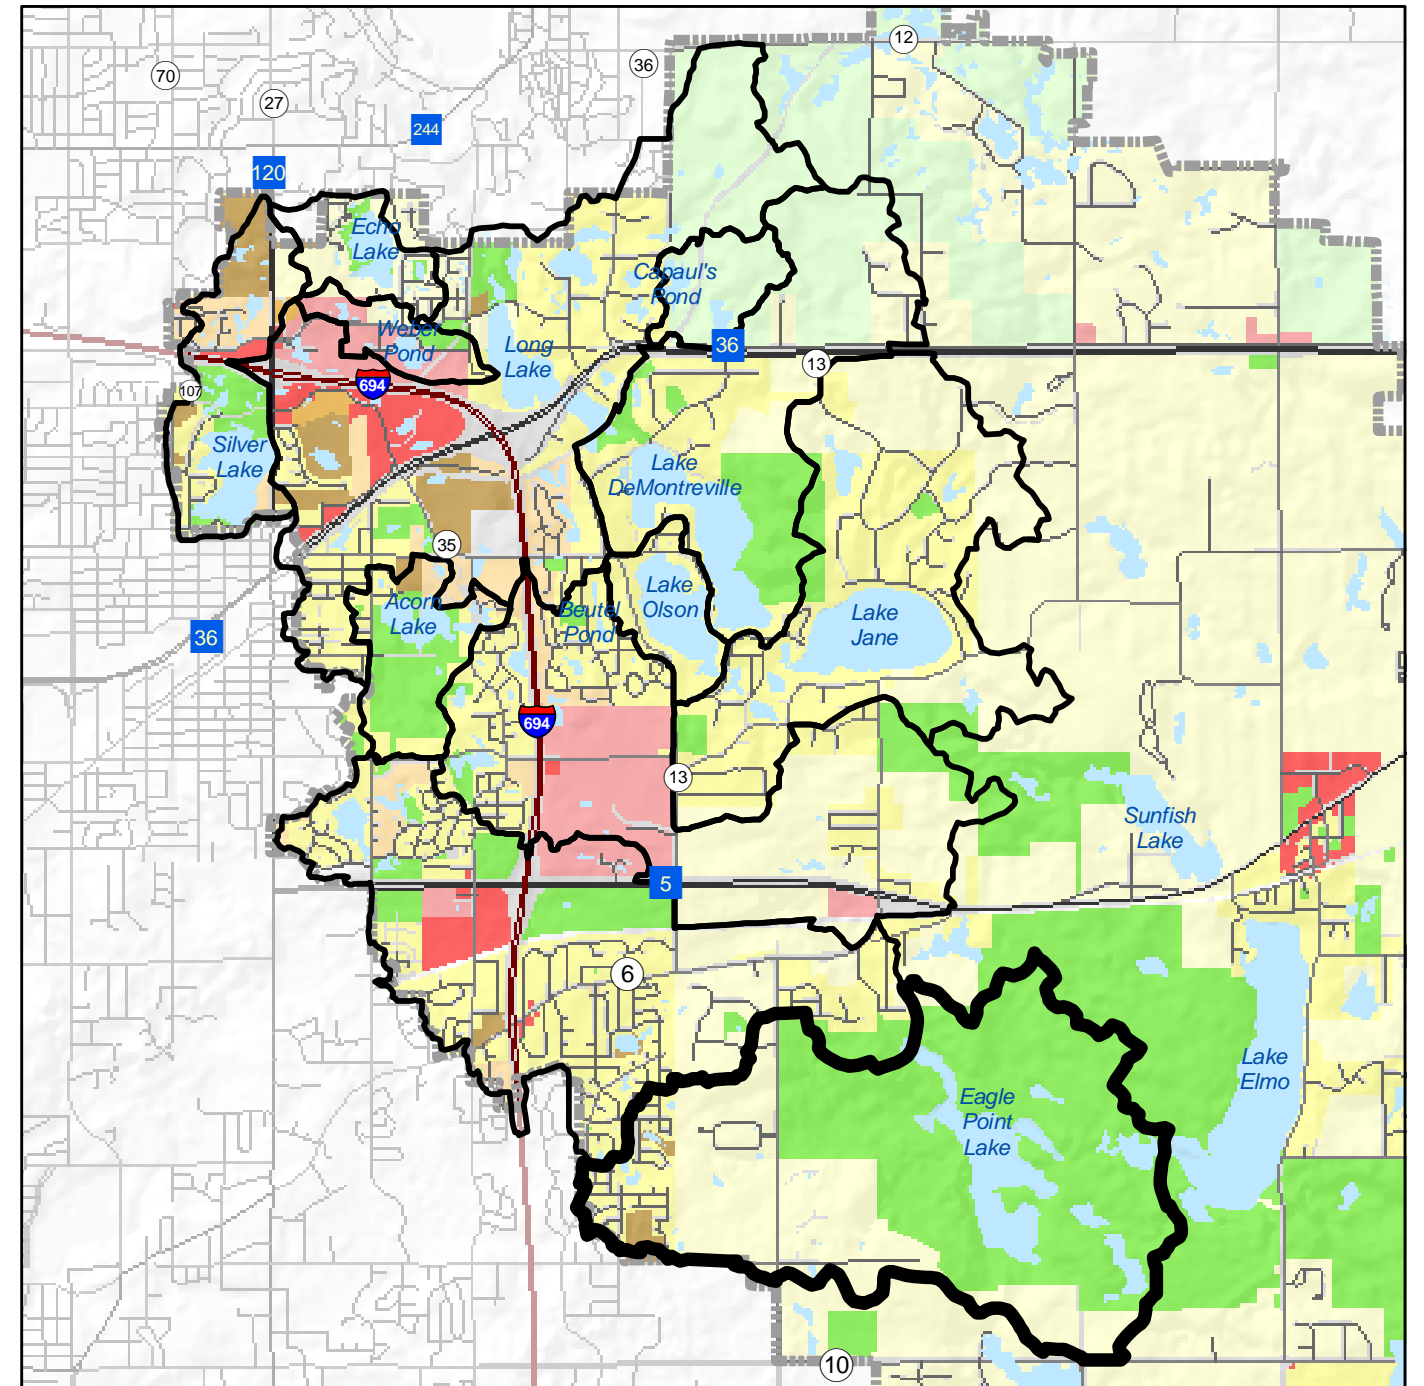
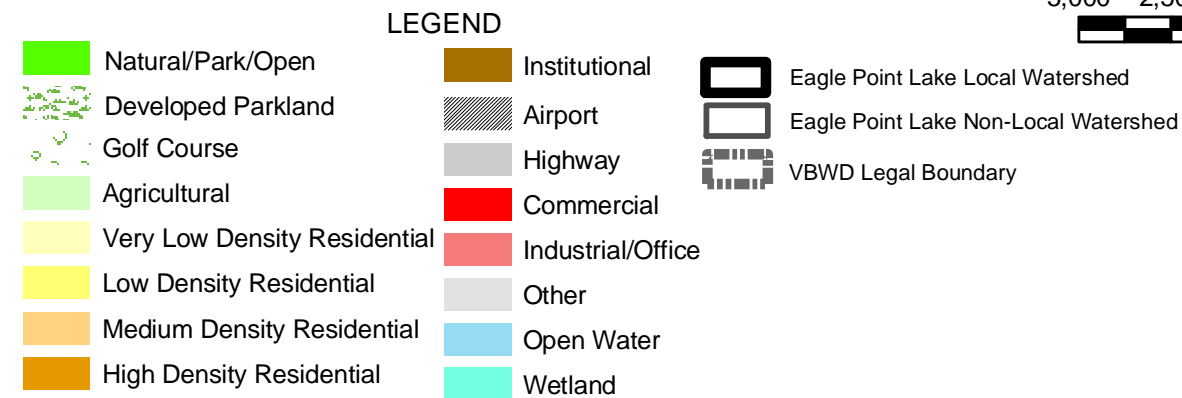
Figure 5.12-2

CURRENT AND FUTURE LAND USE  
EAGLE POINT LAKE LOCAL AND NON-LOCAL WATERSHEDS  
Valley Branch Watershed District

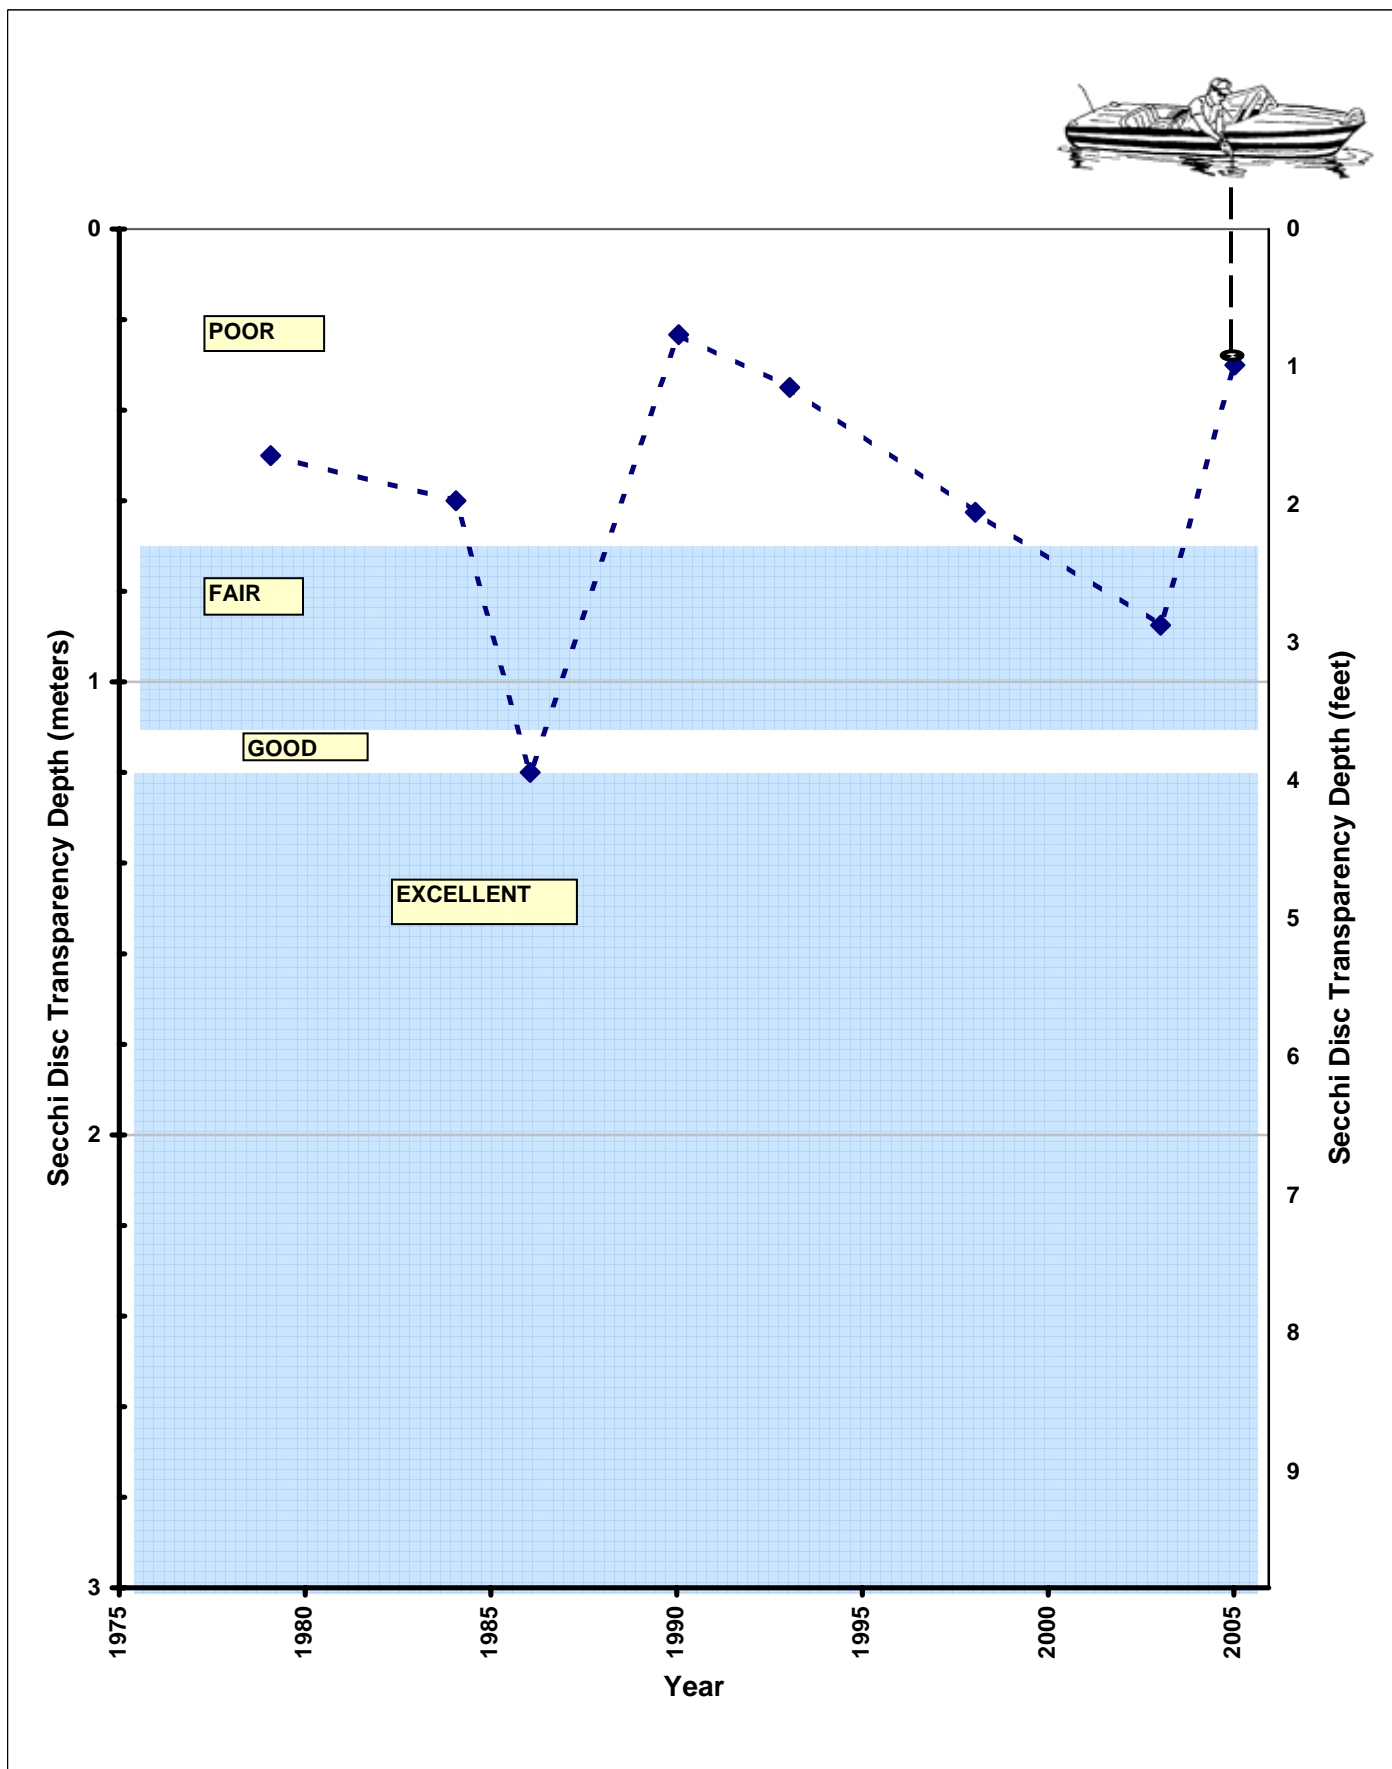
Figure 5.12-3

EAGLE POINT LAKE  
SUMMER AVERAGE WATER CLARITY  
Valley Branch Watershed District

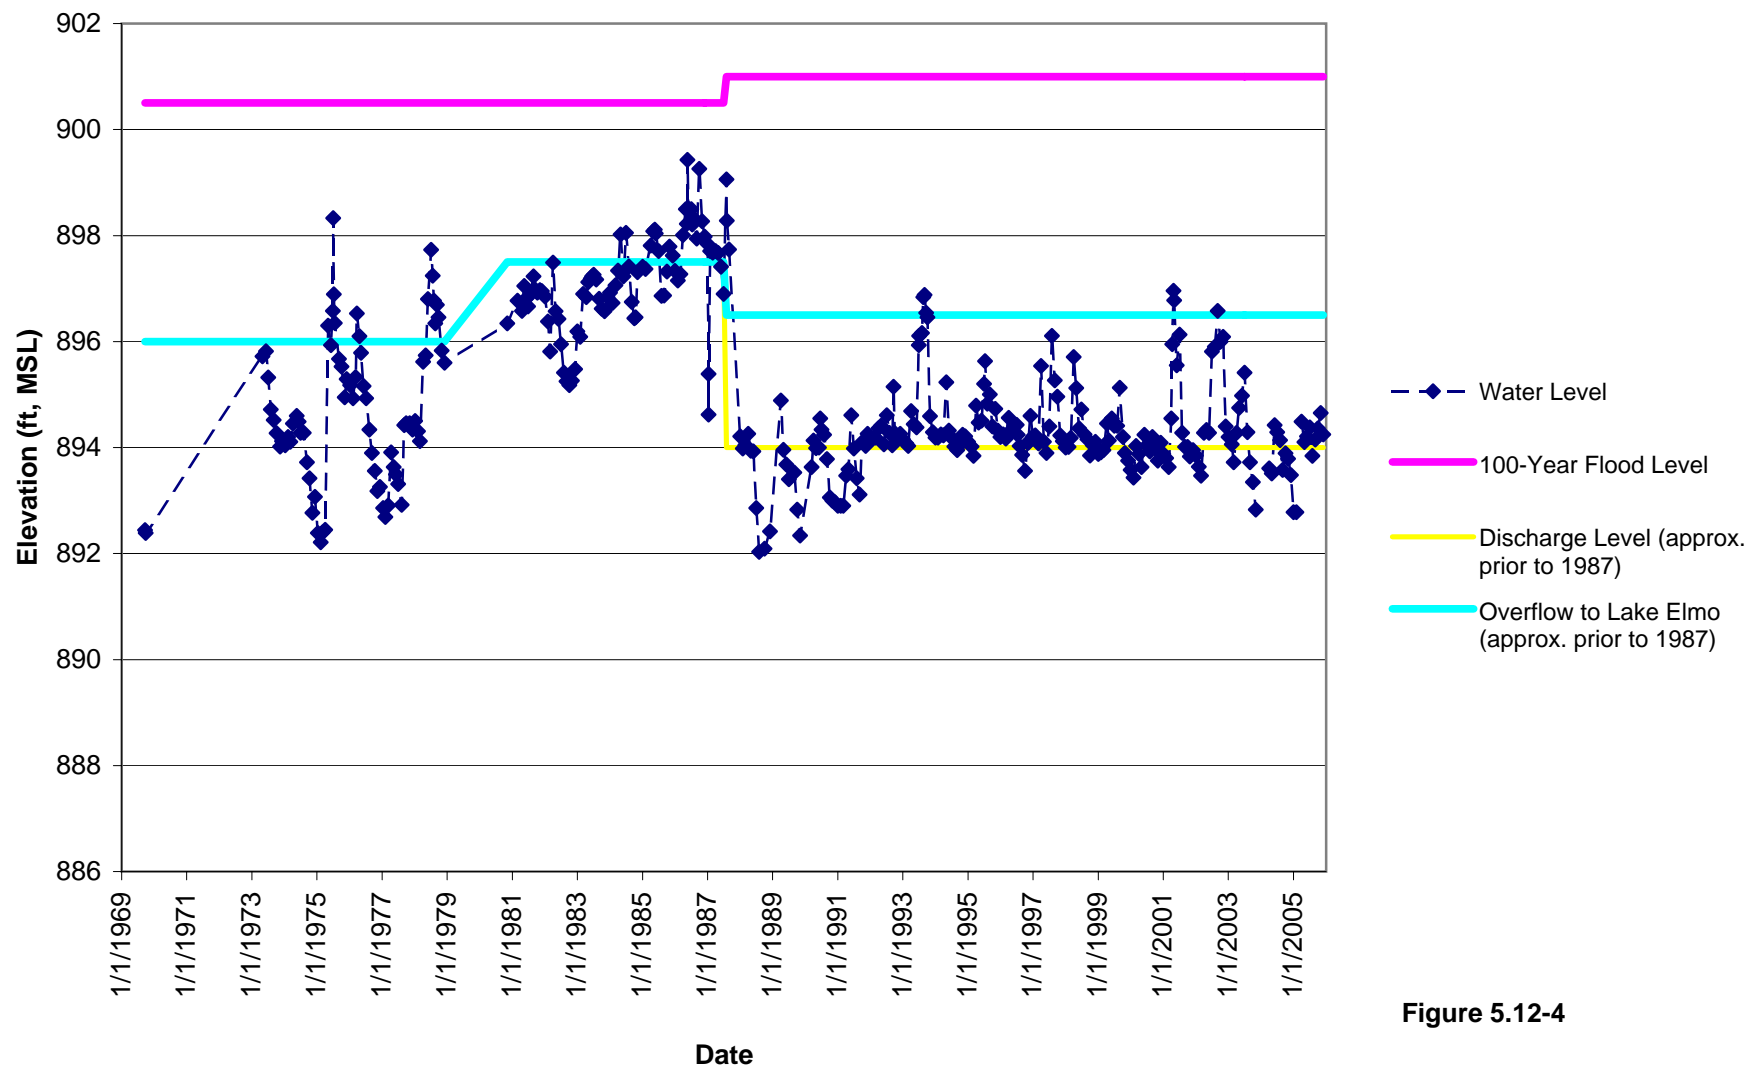
Figure 5.12-4

**EAGLE POINT LAKE WATER LEVELS**  
**Valley Branch Watershed District**

The highest water level in the lake was reported on June 30, 1976, when a major storm caused the lake to rise to Elevation 901. In May of 1986, the water level reached Elevation 899.4. Since the shoreline of the lake is undeveloped, the lake has historically been used as a water storage area. In 1980, an earthen dam was placed across the outlet stream, which raised the lake as high as Elevation 898 on a temporary basis. As part of VBWD's Project 1007, a dam was constructed in 1986 across the outlet stream from Eagle Point Lake, just upstream from Lake Elmo. The temporary dam was subsequently removed. Two control structures and outlet pipes were installed as part of the Project 1007 dam construction. One structure contains a stop-log weir which controls the Eagle Point Lake water level at Elevation 894.0; above this elevation, water flows over the weir and into a 22-inch diameter pipe which carries water from Eagle Point Lake along the bottom of Lake Elmo (bypass pipe). This structure is shown in Figure 5.12-5. The second structure is an overflow structure with a 20-foot long weir at Elevation 896.5. When the water level in Eagle Point Lake rises above Elevation 896.5, water flows into the overflow structure and into a 42-inch diameter pipe, which discharges directly to Lake Elmo. Figure 5.12-6 shows this overflow structure. Ninety percent of the water from Eagle Point Lake is designed to be diverted through the bypass pipe. Since completion of Project 1007, water flowed into the overflow structure four times: (1) in July 1987, following a large rainfall event, (2) in August until October of 1993, following a period of above-average precipitation, (3) in the spring of 2001, following a spring melt and rainstorms, and (4) in early September 2002 after a period of above-average precipitation.

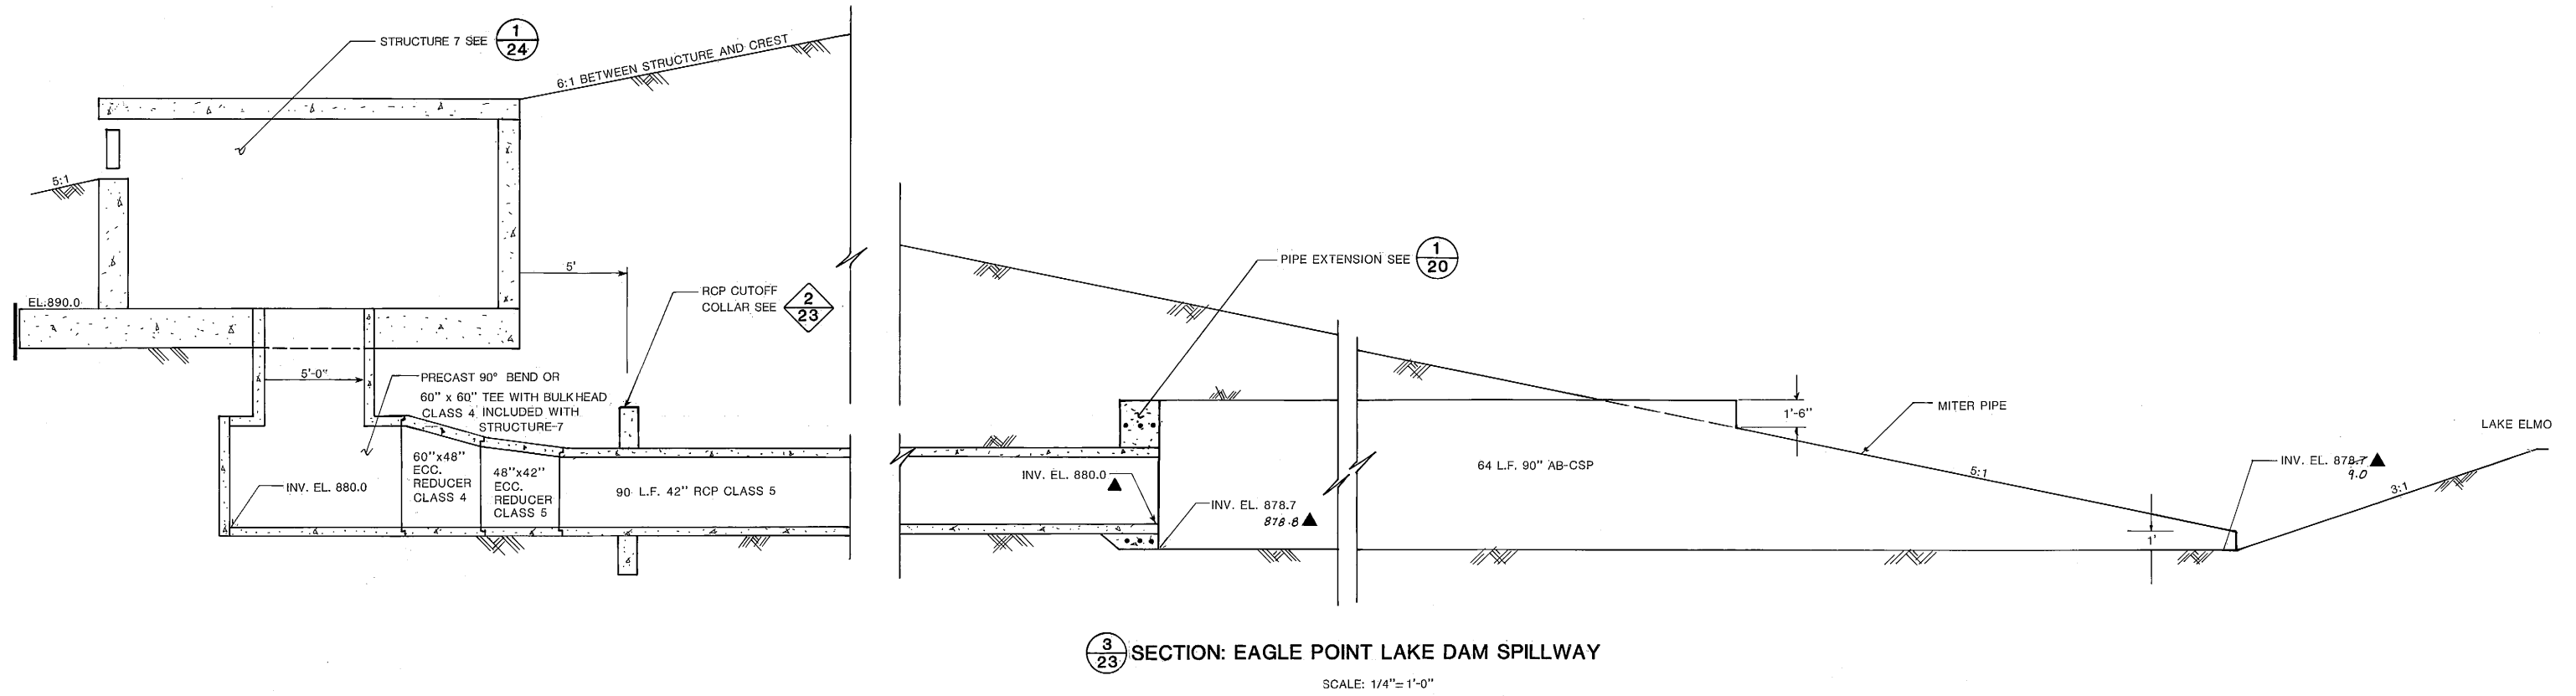
Figure 5.12-6

EAGLE POINT LAKE OVERFLOW  
Valley Branch Watershed District

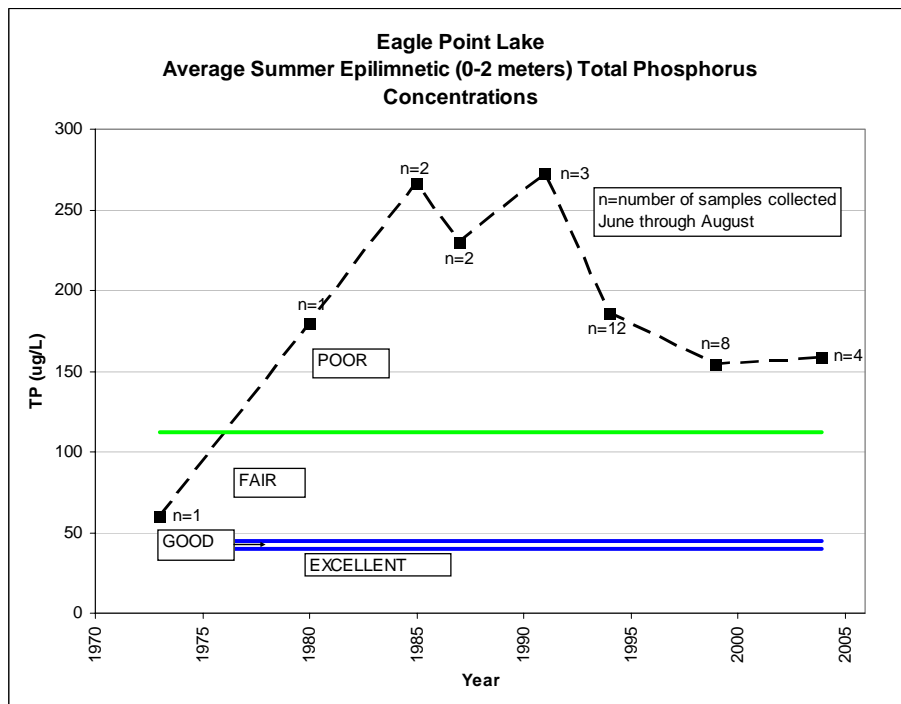
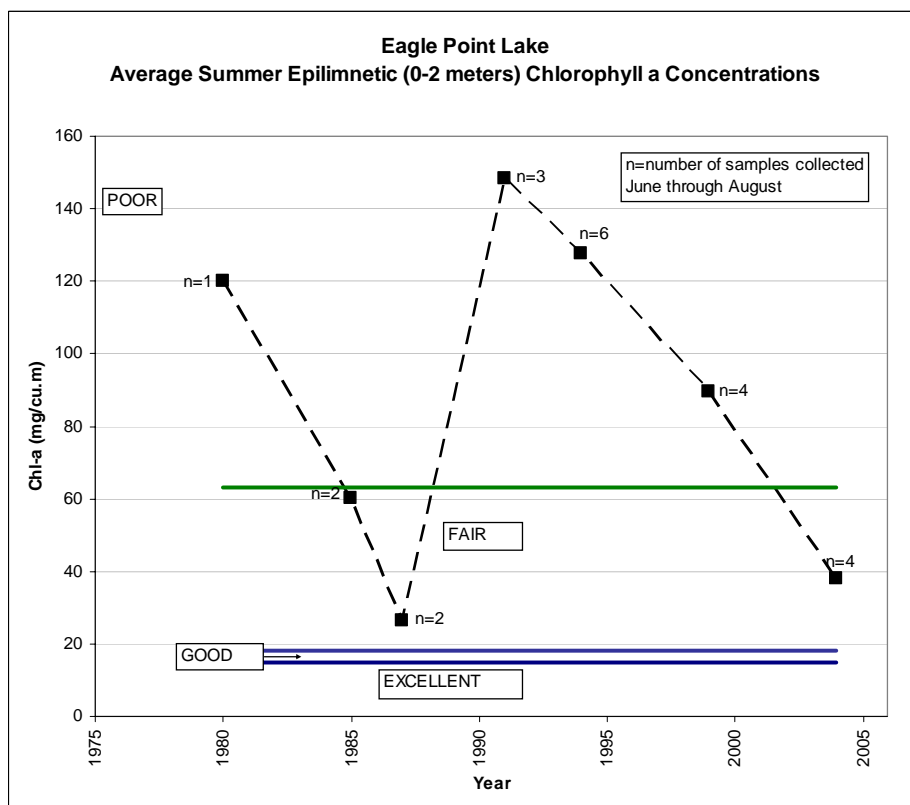
**Appendix A-5.12**  
**Figure 1**

**EAGLE POINT LAKE**  
**HISTORIC WATER QUALITY DATA**  
**Valley Branch Watershed District**

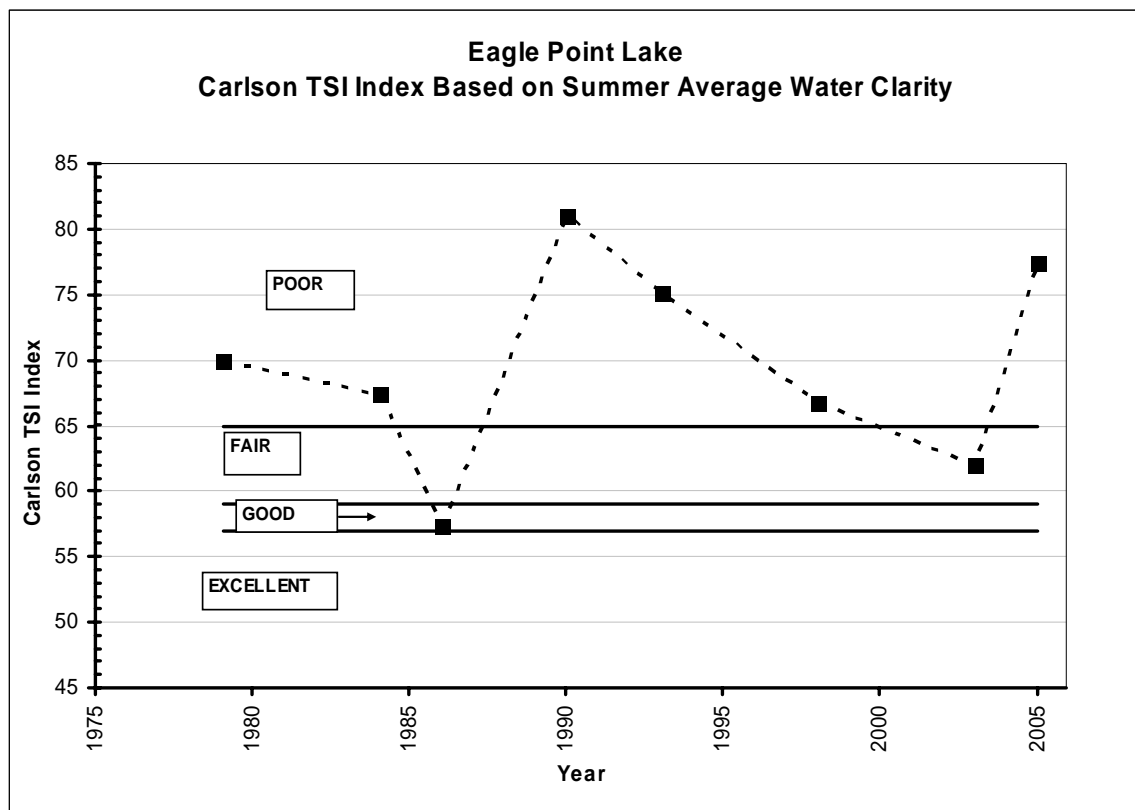
**Appendix A-5.12**  
**Figure 2**

**EAGLE POINT LAKE**  
**HISTORIC WATER QUALITY DATA**  
**Valley Branch Watershed District**

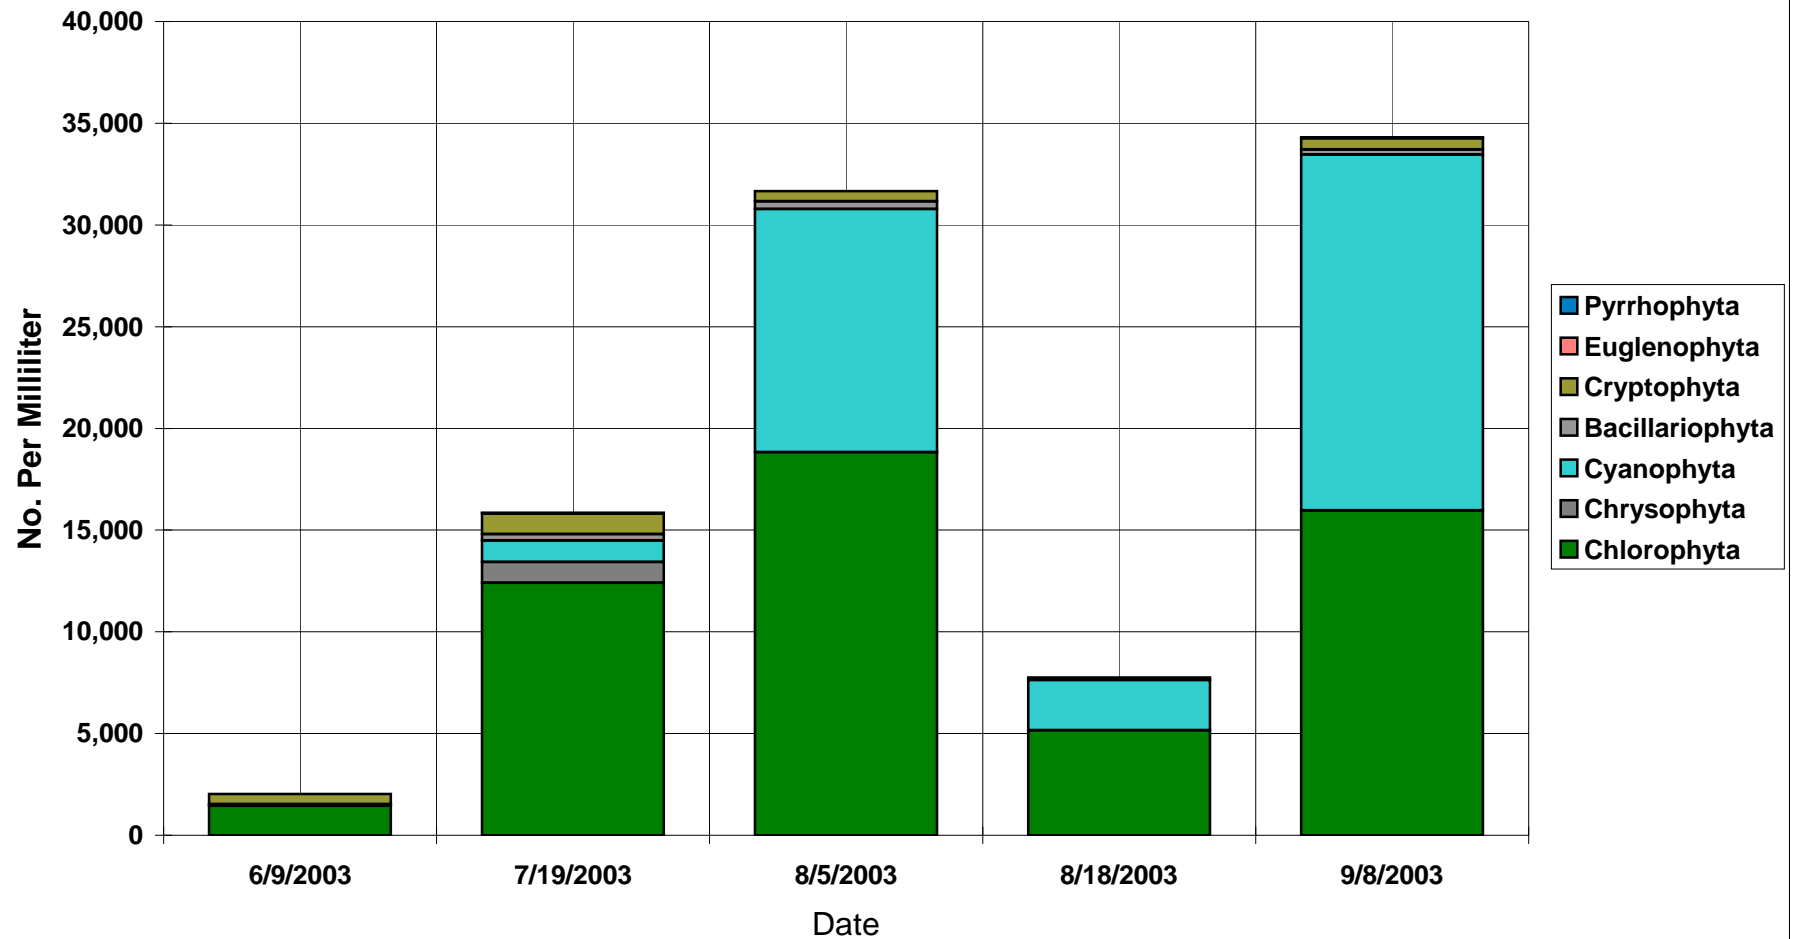
# 2003 Eagle Point Lake Phytoplankton Data Summary

Although nutrient levels in Eagle Point Lake were similar during 1998 and 2003, reduced algal growth was observed during 2003. The maximum number of algae observed in 1998 and 2003 were 77,611 units per milliliter and 34,312 units per milliliter, respectively. The decrease in algal numbers corresponds to the reduction in average summer chlorophyll concentration observed during 2003. The average summer chlorophyll concentrations during 1998 and 2003 were 90 µg/L and 38 µg/L,

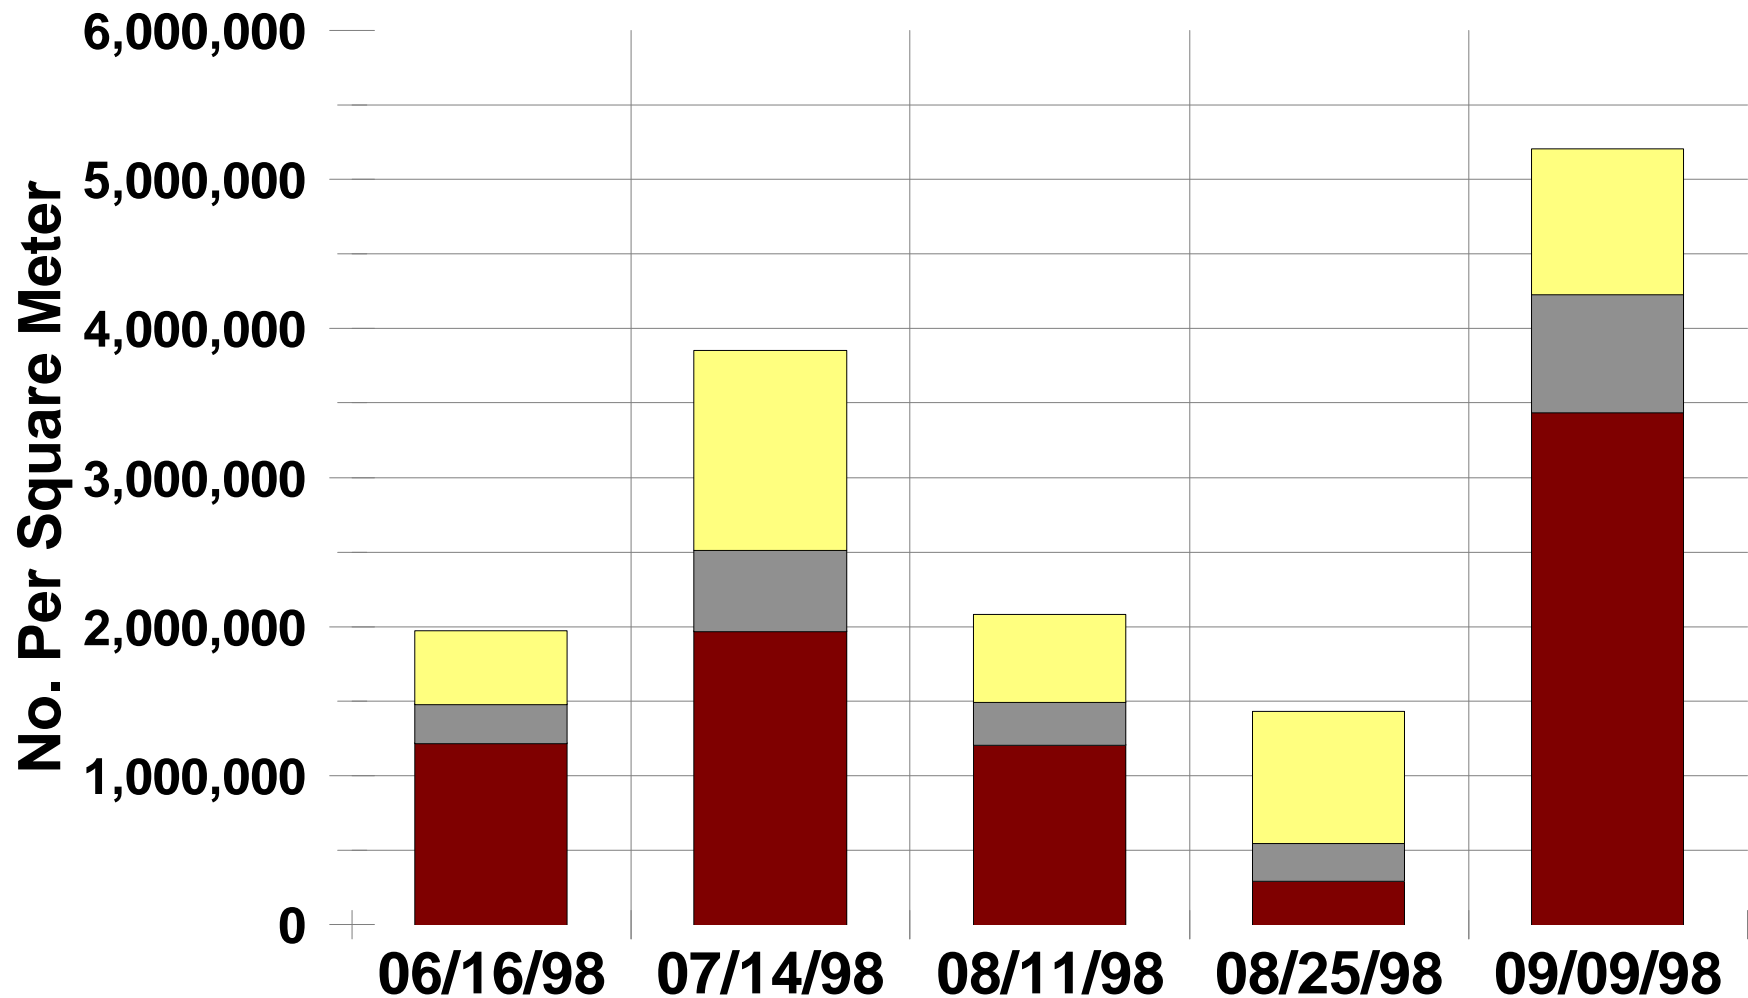
# 1998 Eagle Point Lake Zooplankton Data Summary

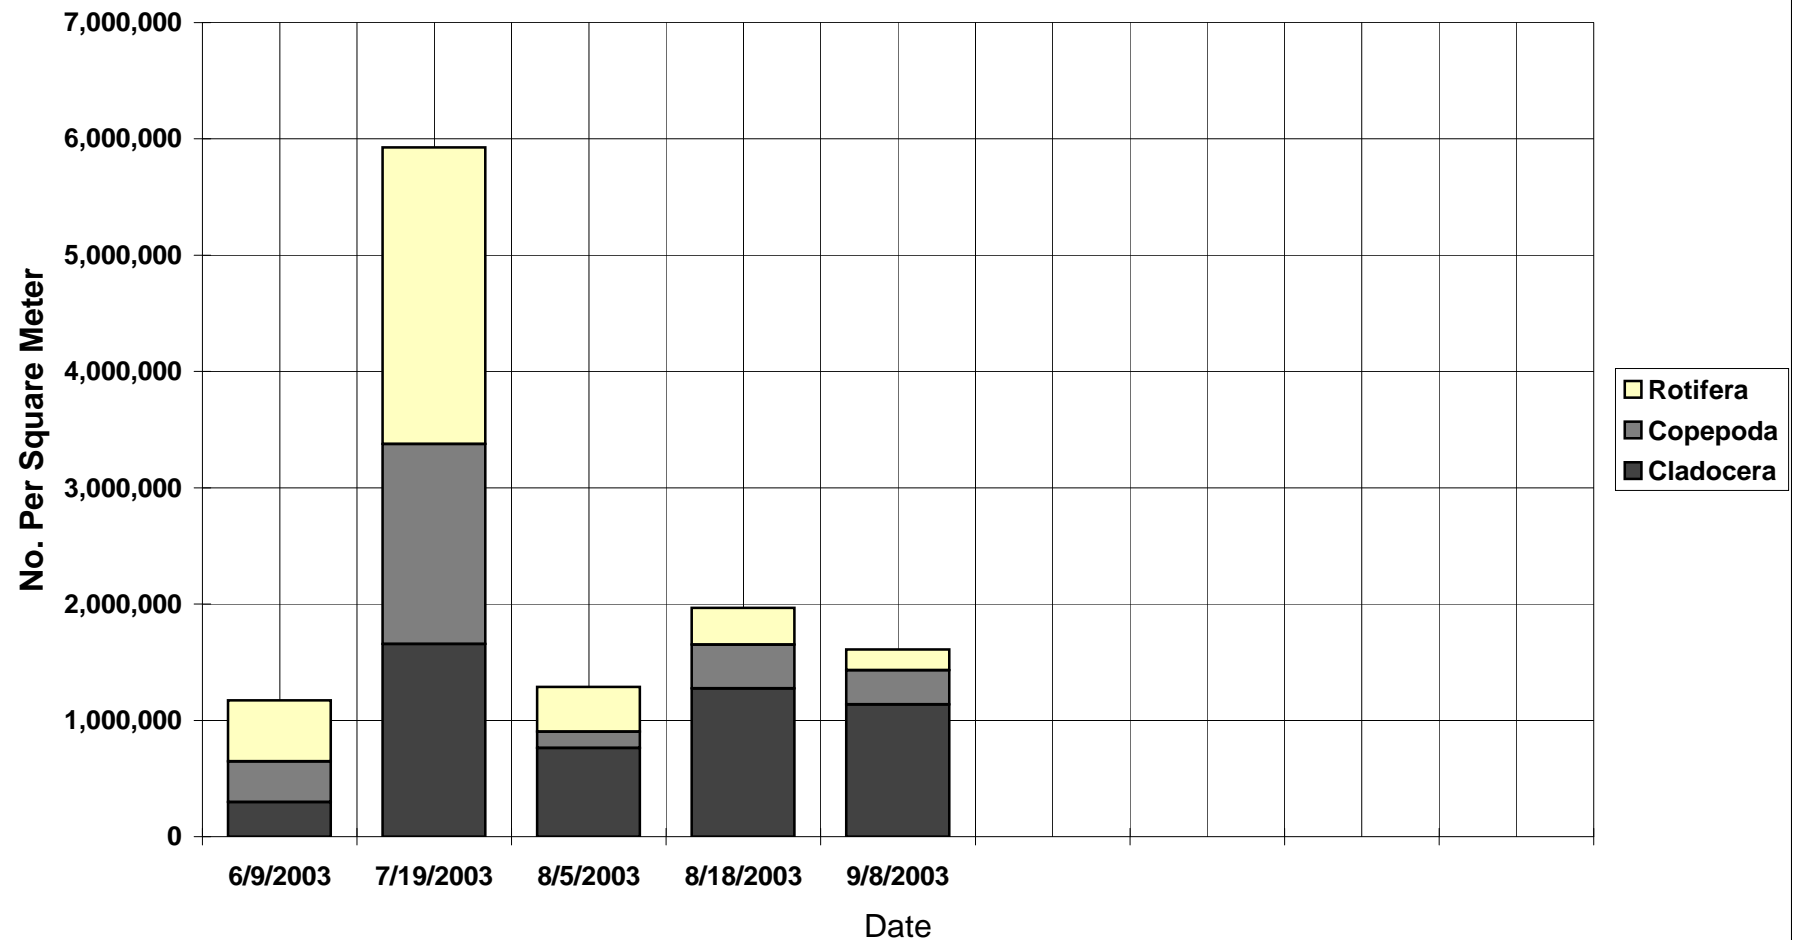
# 2003 Eagle Point Lake Zooplankton Data Summary

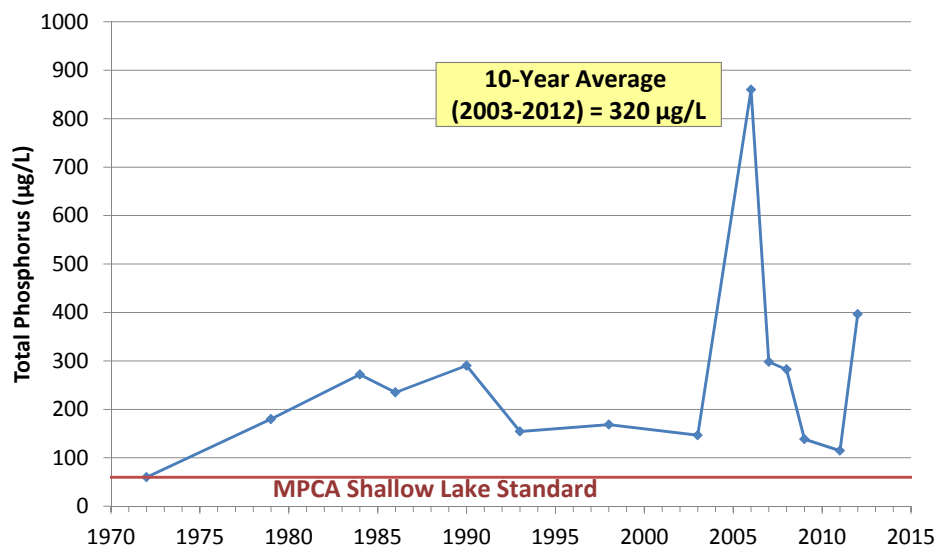
## Eagle Point Lake Historic Water Quality Total Phosphorus Growing Season Averages
