St. Louis River Watershed Stressor Identification Report

Minnesota Pollution Control Agency

May 2015

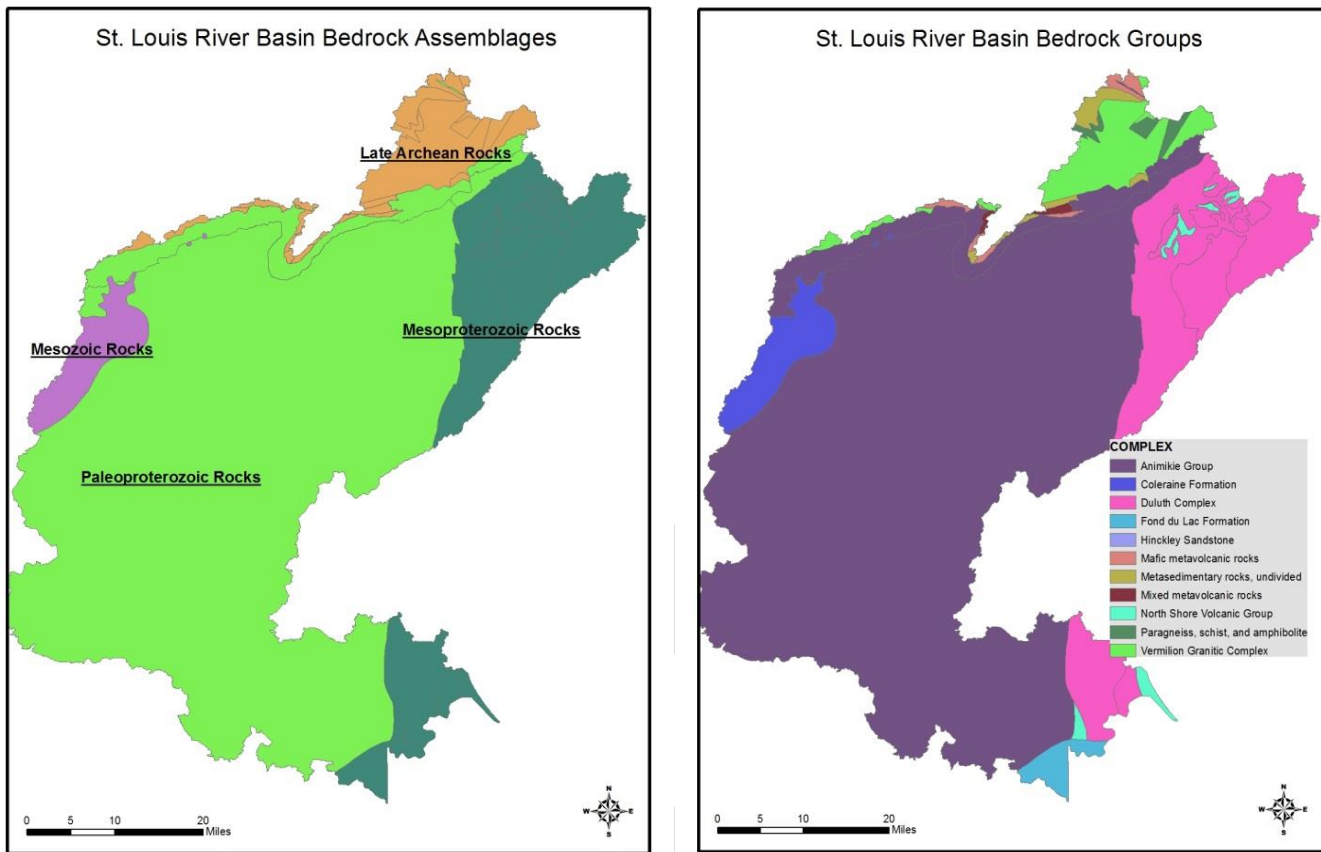
Figure 3: Major bedrock assemblages of the St. Louis River watershed (left) and bedrock groups of the St. Louis River watershed (right)

The bedrock geology of the St. Louis River basin is ancient and complex. There are four main assemblages representing four very different geologic conditions in Minnesota's past (Figure's X and X). The oldest rocks are found in the northernmost regions of the watershed - north of the Mesabi and Cuyuna iron ranges. These rocks date from the Archean period of geologic history and are between 2.5 and 3.0 billion years old. Igneous and metamorphic rock types are dominant and were formed when present-day Minnesota was at the margin of an expanding North American continent.

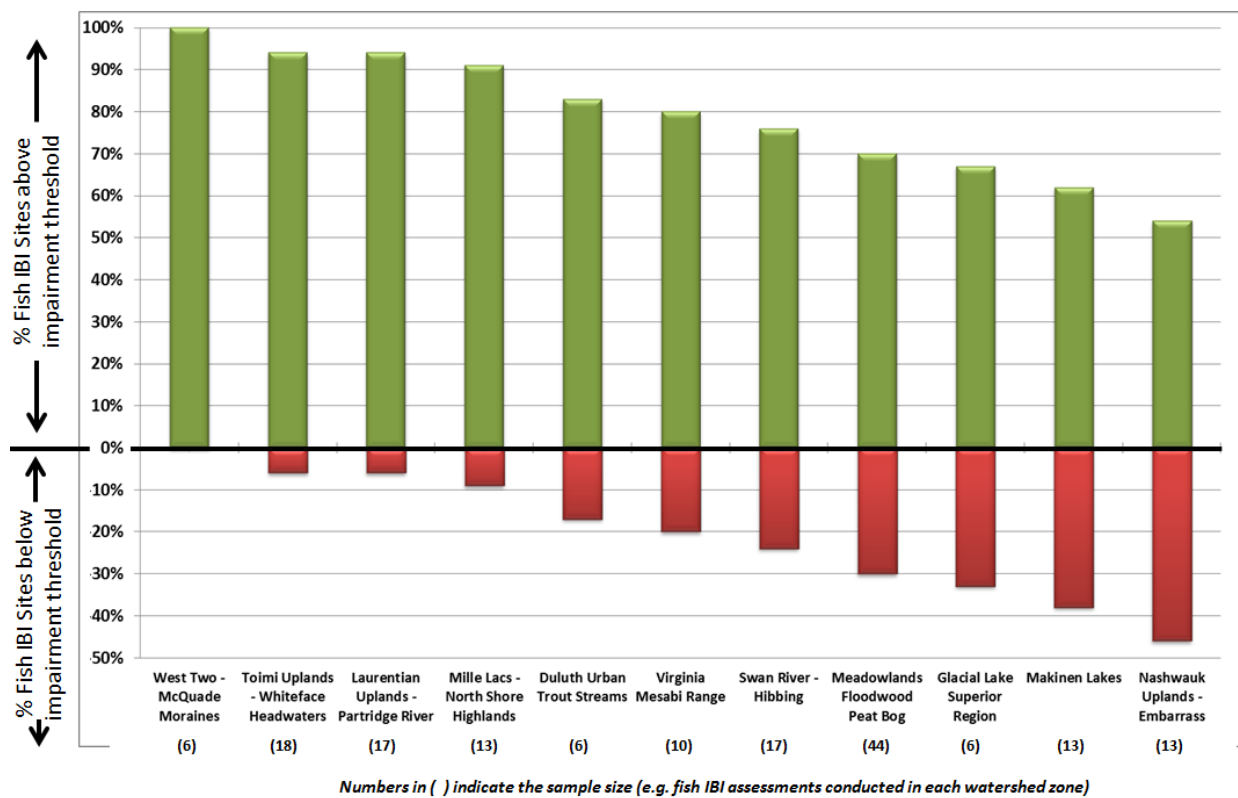
Figure 11: Percentage of monitoring stations above and below fish IBI impairment threshold.

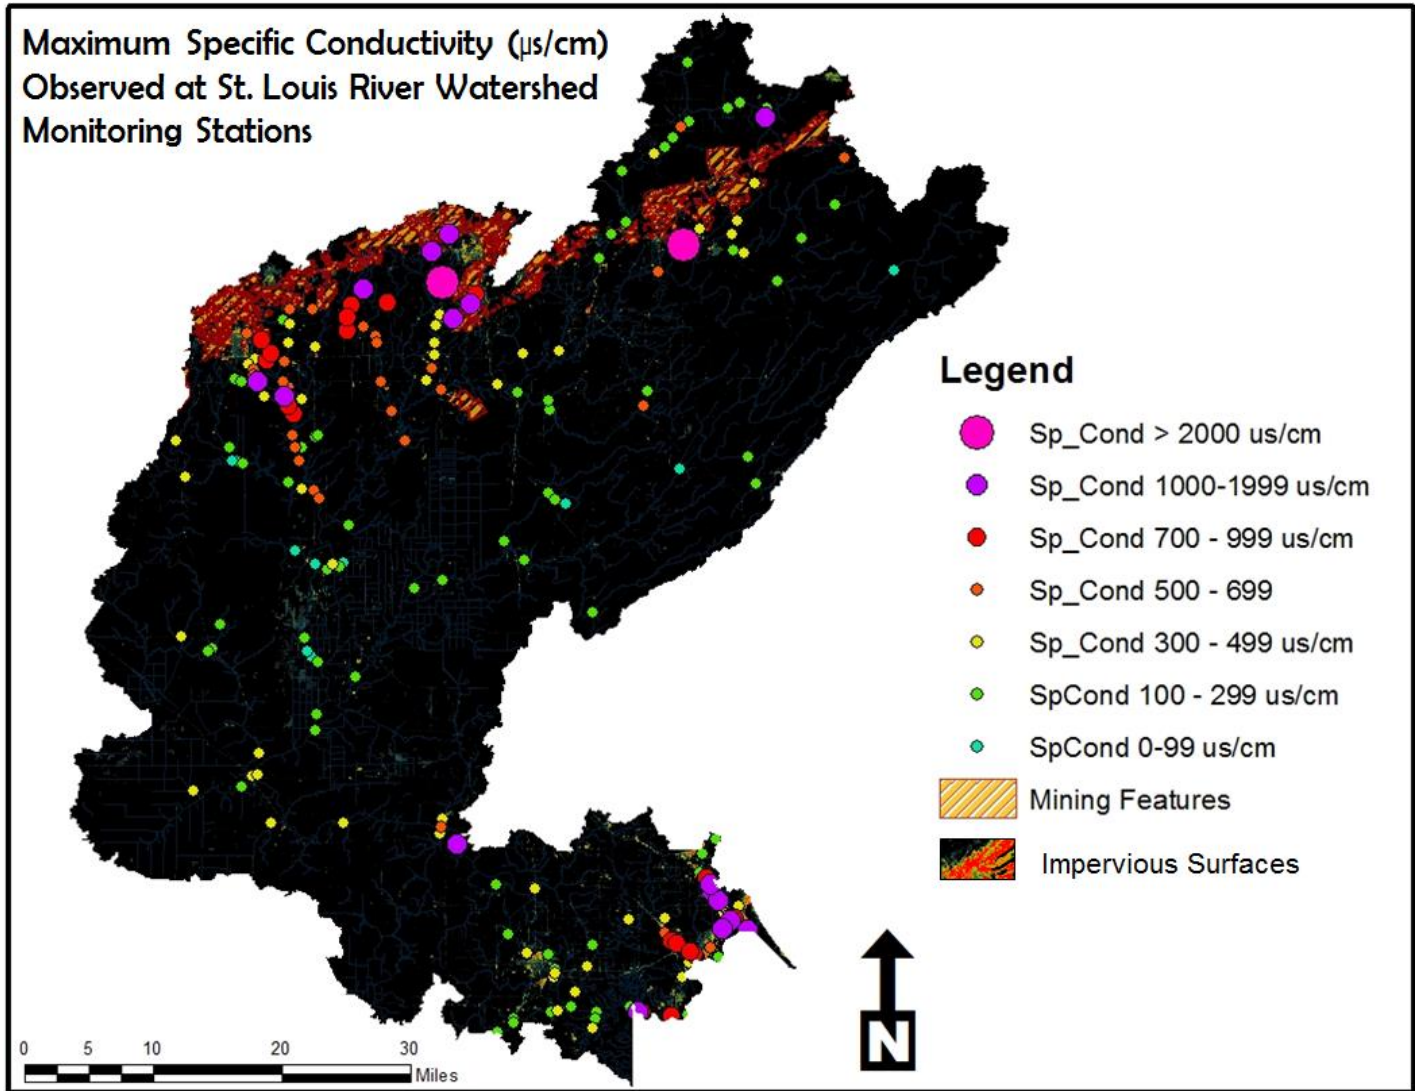
Figure 15: Maximum specific conductivity levels observed at stations across the St. Louis River 8 HUC watershed

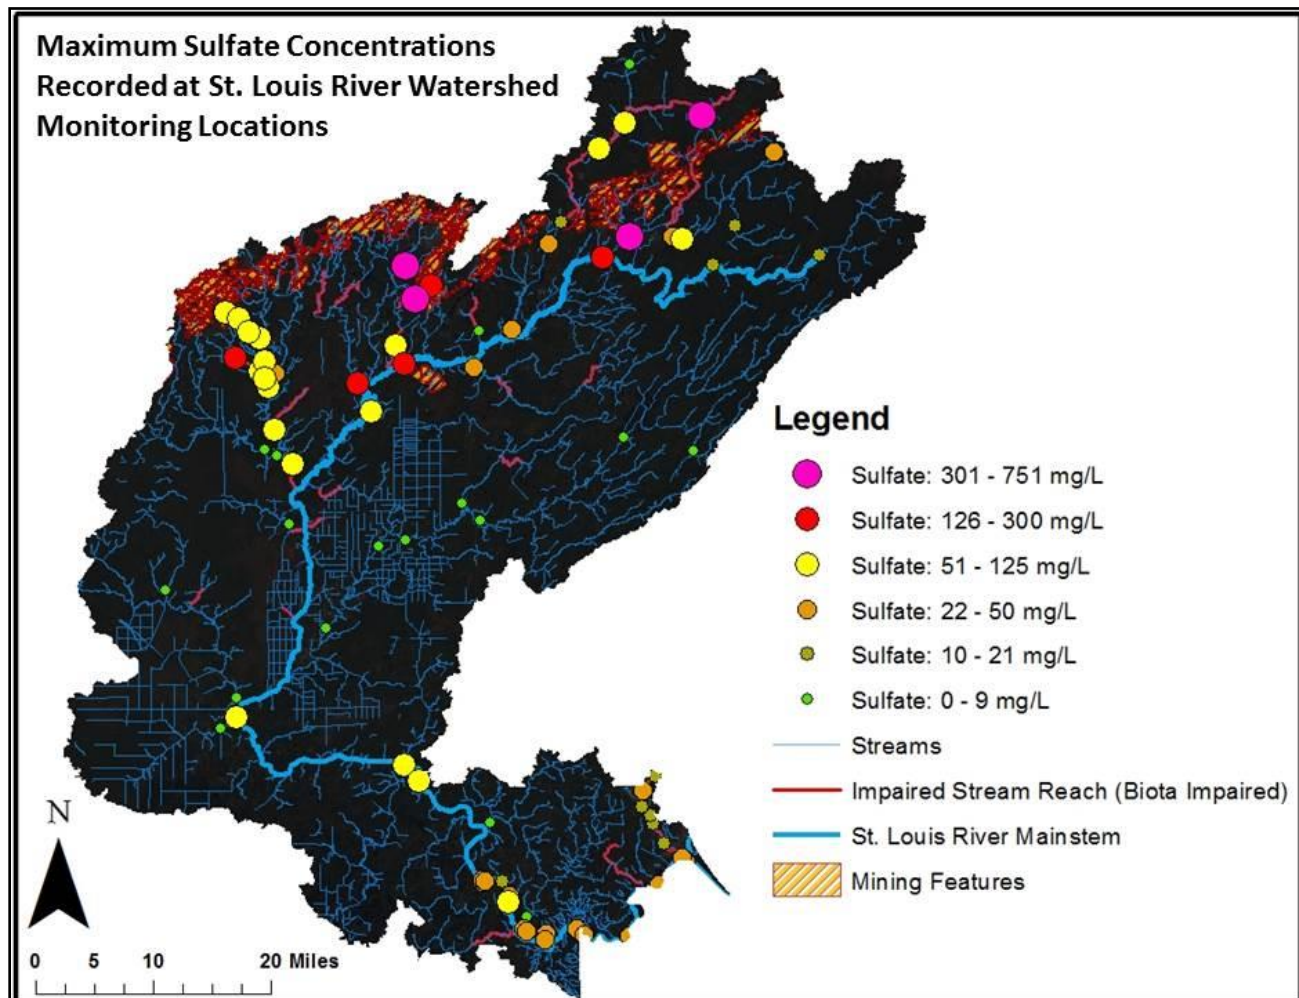
Figure 16: Maximum sulfate concentrations observed in streams across the St. Louis River 8 HUC watershed

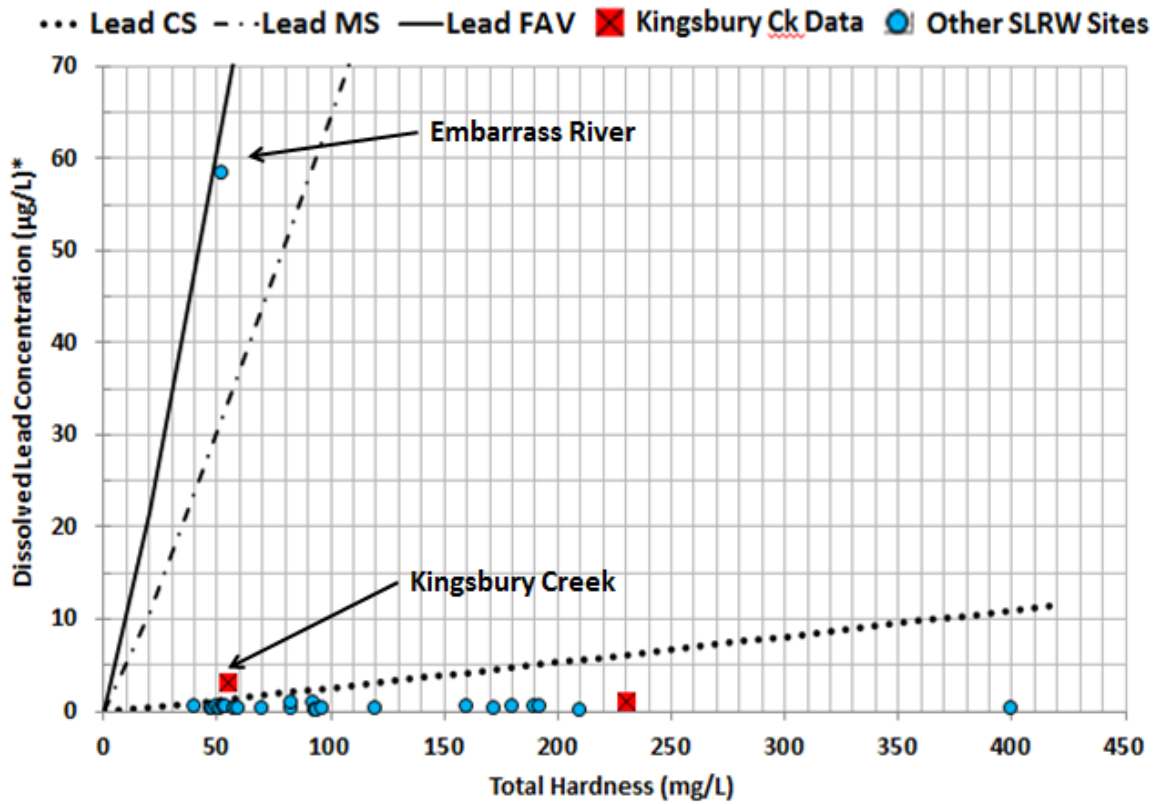
Figure 18: Dissolved lead results for SLRW streams with biological impairments

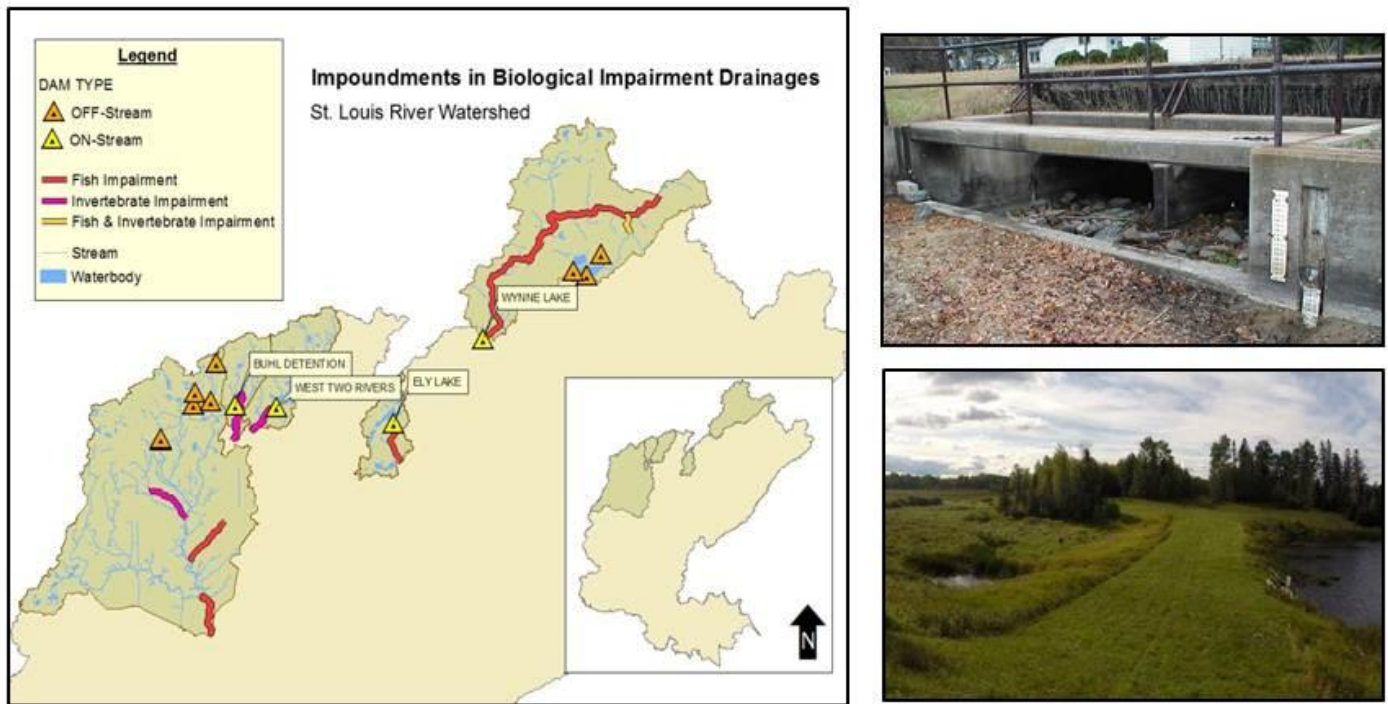
Figure 24: (Left) Impoundments within watershed boundaries of biologically impaired reach pour-points. (Upper Right) Ely Lake outlet and water level gage during late summer dry period in 2006, with no observed outflow to Ely Creek and the water level gage out of water. (Bottom Right) Buhl Detention with reservoir on right and stable downstream channel through wetlands on left

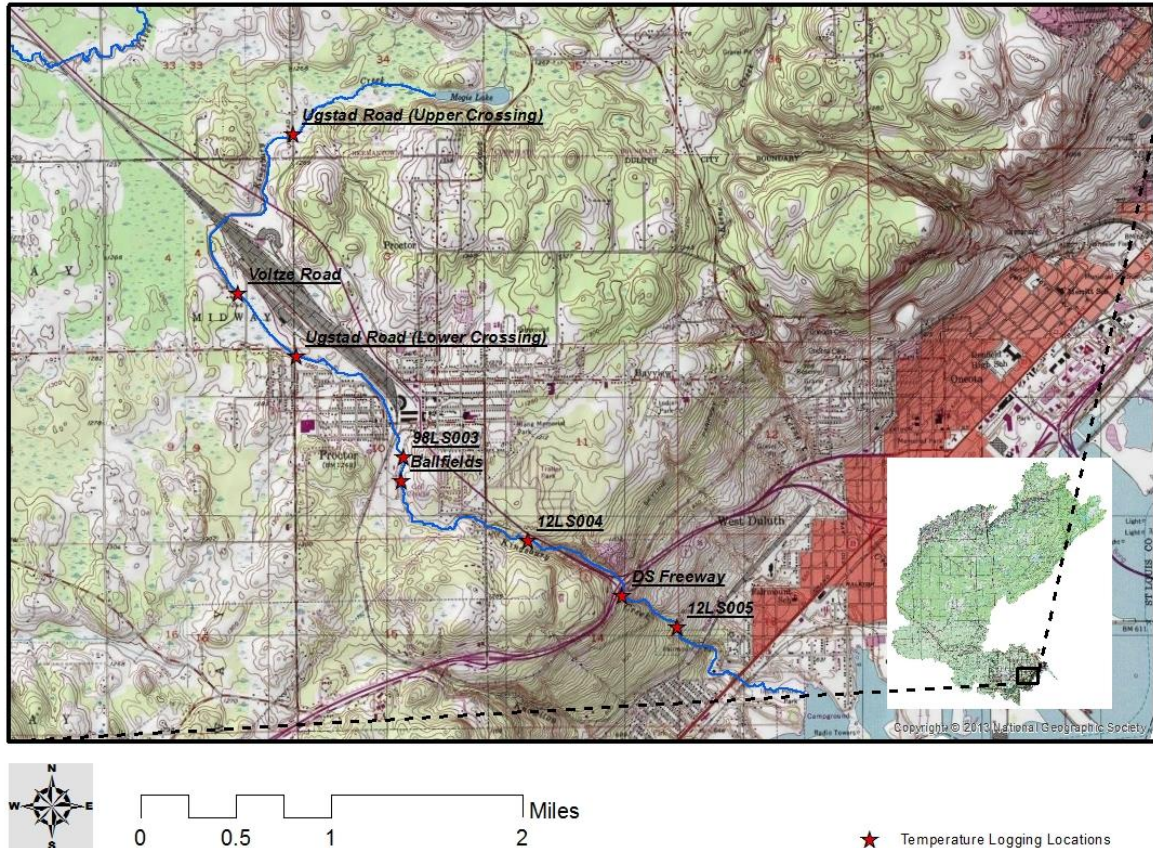
Figure 32: Temperature monitoring locations on Kingsbury Creek

Continuous temperature data were collected at three MPCA biological monitoring stations on Kingsbury Creek, (1) 98LS003 upstream of the Proctor High School ball fields, (2) 12LS004 upstream of Highway 2, and (3) 12LS005 upstream of the Lake Superior Zoo (figure 32). The logger at 12LS005 was swept away during the June 2012 flood and had to be replaced. Therefore, only August 2012 data are available from that site. Additionally, data was used from MN DNR loggers at five sites between 1998 and 2002. Only data between June 1 and August 31 were analyzed (when stream temperatures are most likely to exceed the stress threshold for coldwater obligate species).

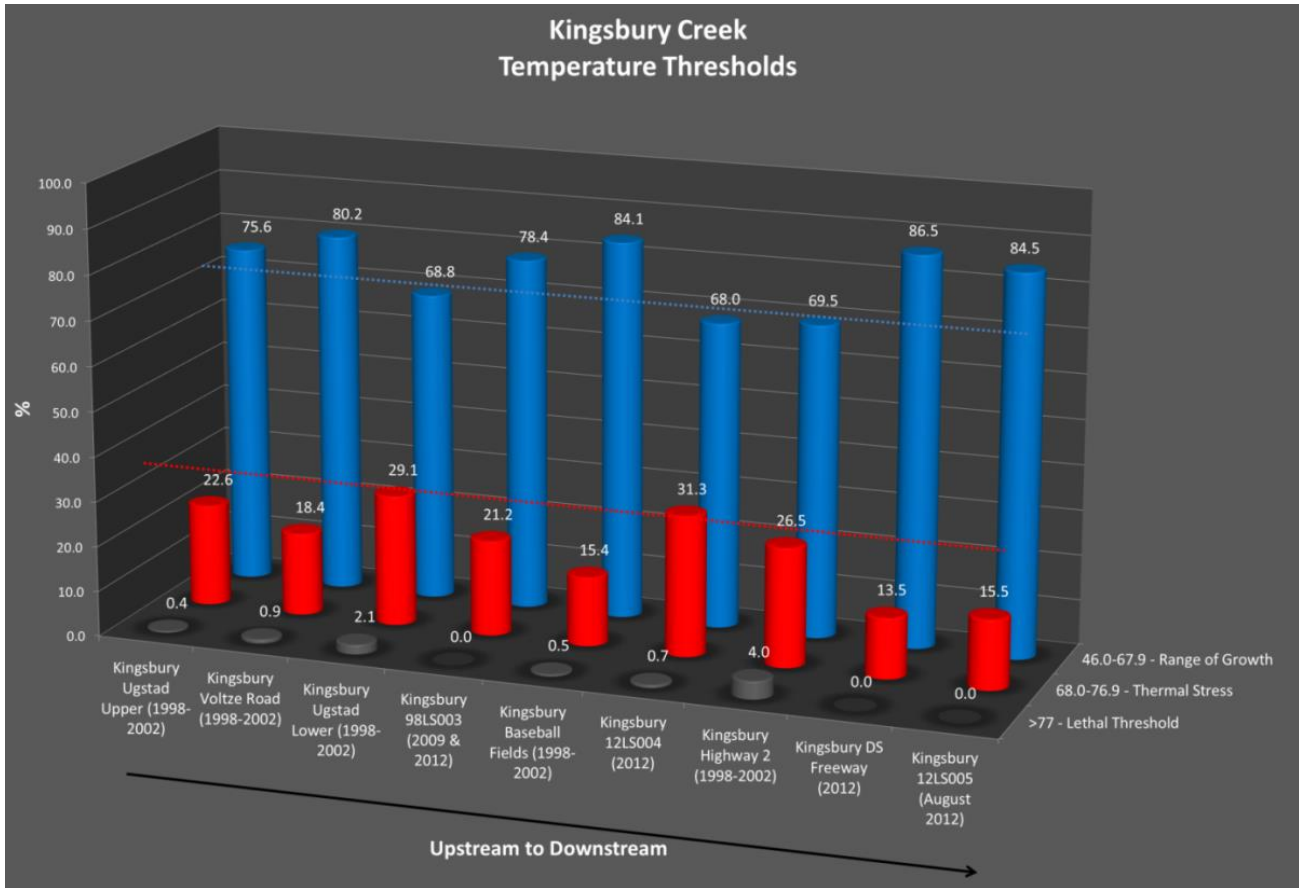
Figure 33: Percentage of time spent in BKT growth, stress and lethal ranges

Late June to the middle of August seems to be the critical time in Kingsbury Creek for coldwater sensitive species such as brook trout. **Figure X** shows the spatial breakdown of the temperature data, which was evaluated using at least 70% of the time in growth temperature (46.0-67.9° F) as the indicator of whether or not BKT should be present based on water temperature alone (**add source?**). At the majority of the Kingsbury Creek sites, the water temperature was adequate for most coldwater species, and was in the brook trout growth range at least 70% of the time. Three sites fell below 70% growth – Ugstad Road (Lower Crossing), 12LS004, and the DNR Highway 2 site (which is very close to 12LS004). The Ugstad Road and Highway 2 sites also significantly exceeded the lethal range (>77° F) for trout. At times, water temperatures at these stations were above the lethal threshold for 12 straight hours.

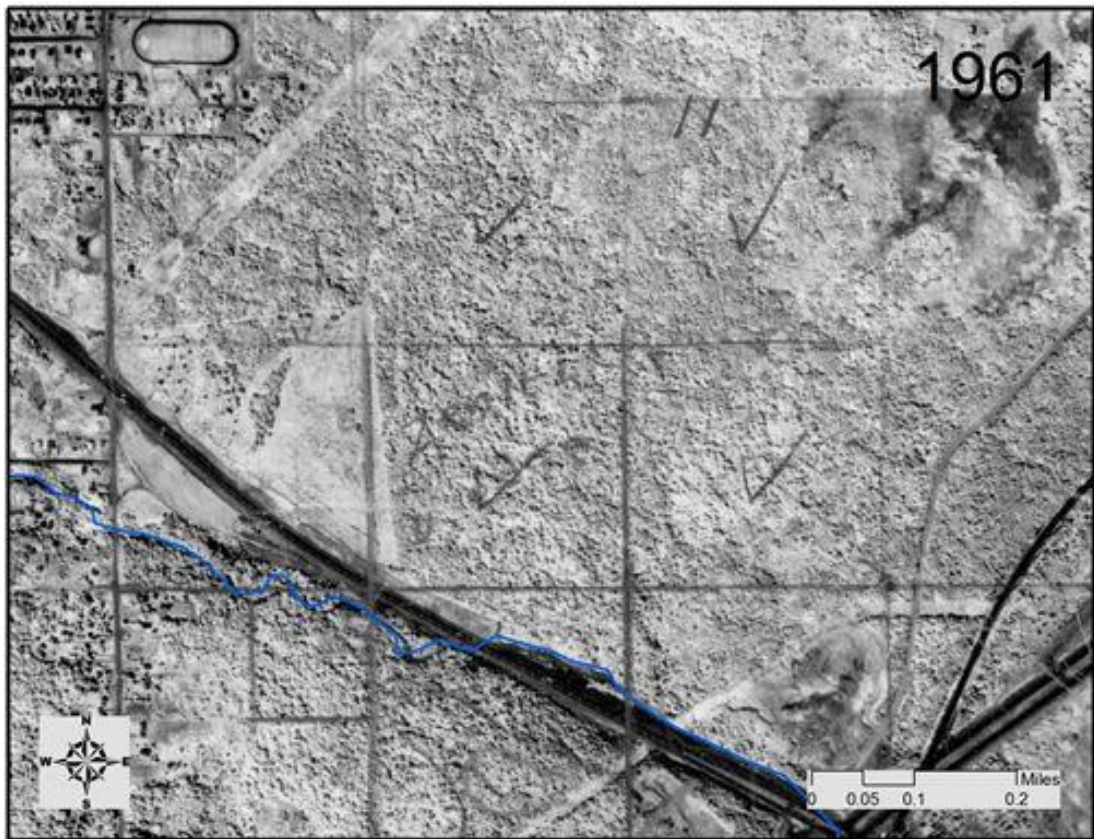
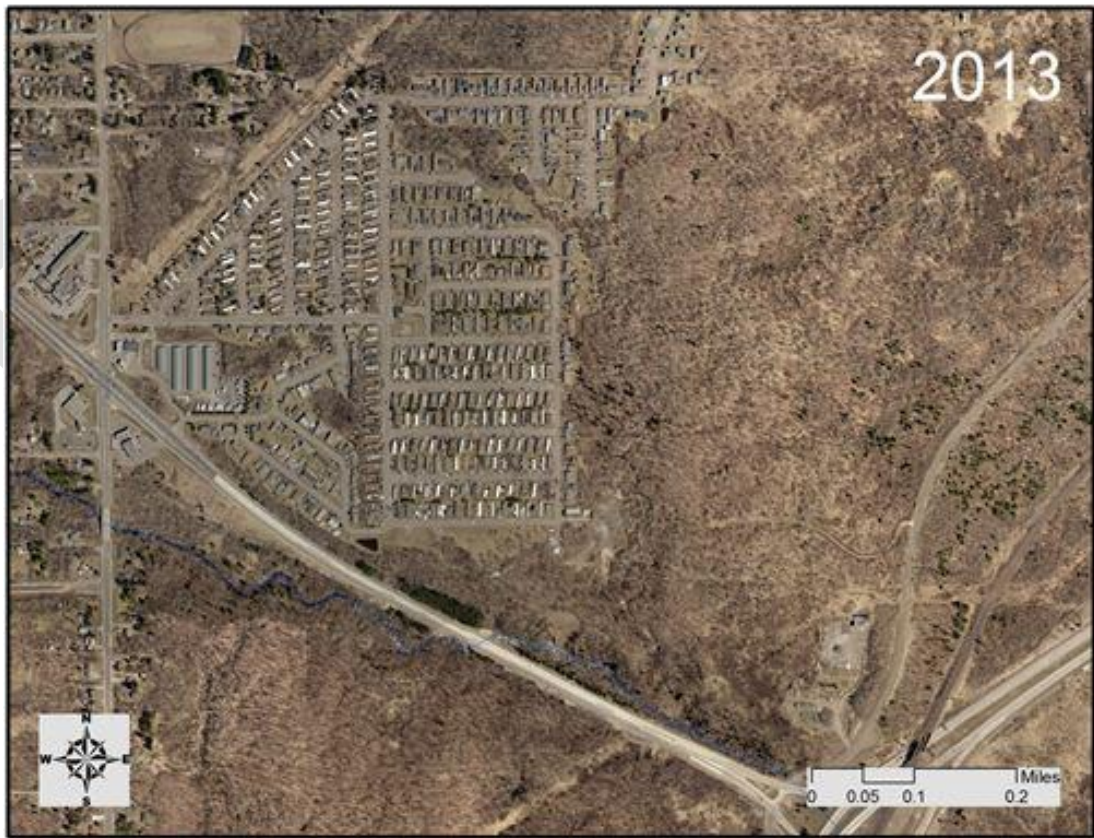
Figure 45: A dramatic example of development in the Kingsbury Creek watershed

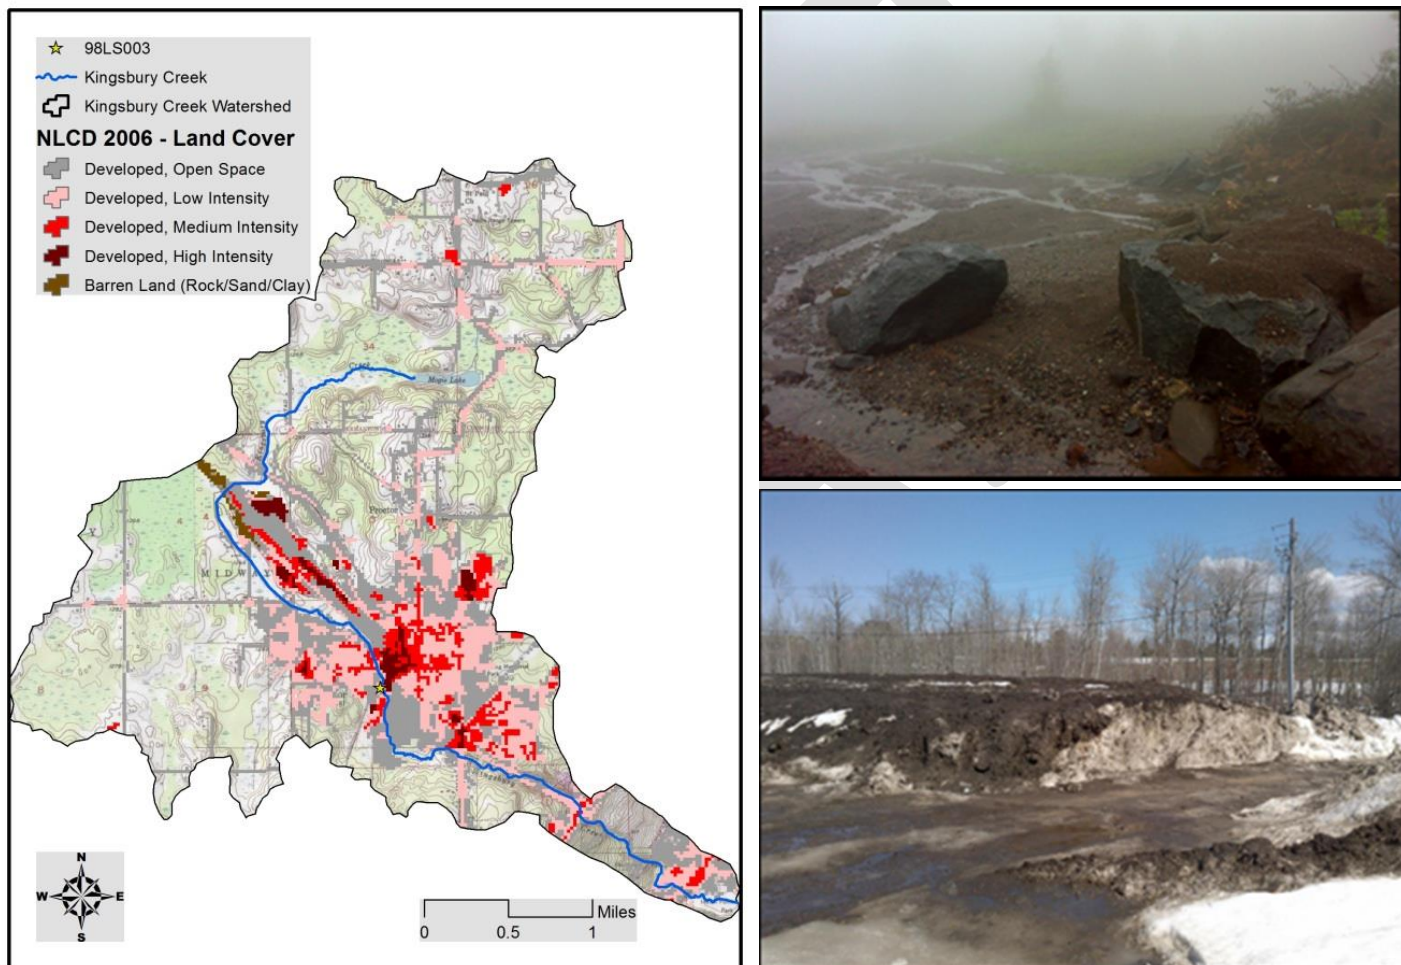
Figure 47: Developed and barren land in the Kingsbury Creek watershed (left); After snowmelt, road sand and other detritus is ready to be washed into nearby Kingsbury Creek (right)

Urban, residential, and industrial development in and around the city of Proctor has increased the amount of impervious surfaces in the Kingsbury Creek watershed, causing precipitation to flow over the land instead of infiltrating into the ground. This quickly flowing runoff can transport sediment and other particulates into streams. During snowmelt, road sand, litter, and other detritus piled into snowbanks over the course of the winter season (Figure X) are flushed into stormwater pipes and streams in a relatively short period of time. Soils exposed by construction and industrial activities are susceptible to erosion during rain events. The Kingsbury Creek watershed has a great deal of developed and barren land (see Figure X), especially in close proximity to the stream channel, thus it is likely that urban runoff is a pathway for suspended solids in Kingsbury Creek.

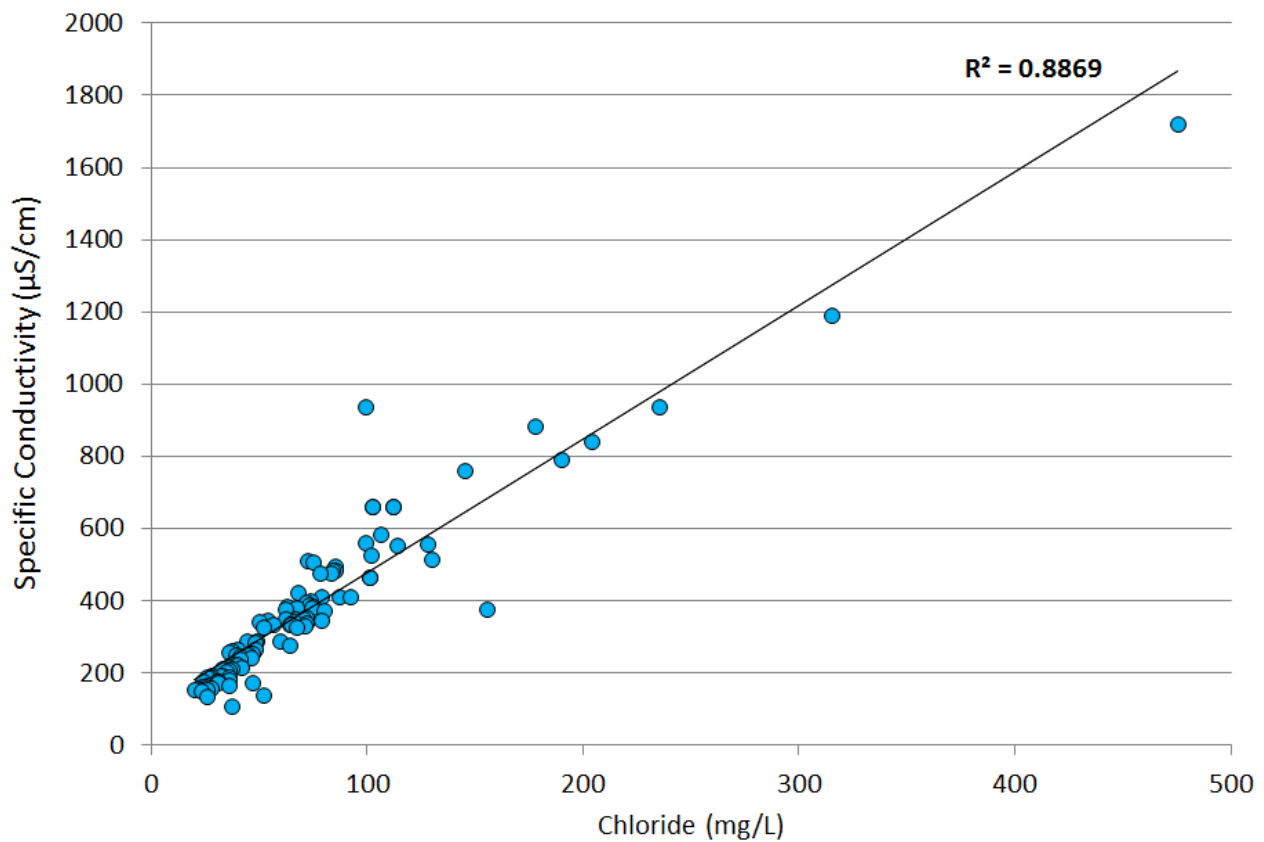
Figure 60: Scatter-plot regression of paired chloride and specific conductivity measurements from Kingsbury Creek

The regression equations in figures BLANK and BLANK developed using data from Kingsbury Creek can be used to derive estimated chloride concentrations based on specific conductivity readings. In addition, NRRI developed an equation to determine chloride concentrations via conductivity readings by adding city road salt to water from three streams in the Duluth metropolitan area (DuluthStreams.org; figure BLANK). The two equations derived from these data sets were applied to specific conductivity readings collected during continuous monitoring efforts by NRRI at the Kingsbury Creek monitoring station just upstream of the Lake Superior Zoo. Elevated specific conductivity readings (>1500 µS/cm) were selected from the continuous data spanning the years 2002-2013 to estimate chloride concentrations. The results, shown in Table BLANK, clearly show that chloride concentrations (estimated) in Kingsbury Creek exceed the acute water quality standard of 860 mg/L fairly frequently, and in some instances, by a wide margin. If these estimations prove to be accurate after additional sampling, chloride toxicity can be considered a significant threat to sensitive aquatic life in Kingsbury Creek. Winter grab samples during the Duluth Urban WRAPS project (link) are recommended to verify these estimated chloride concentrations.

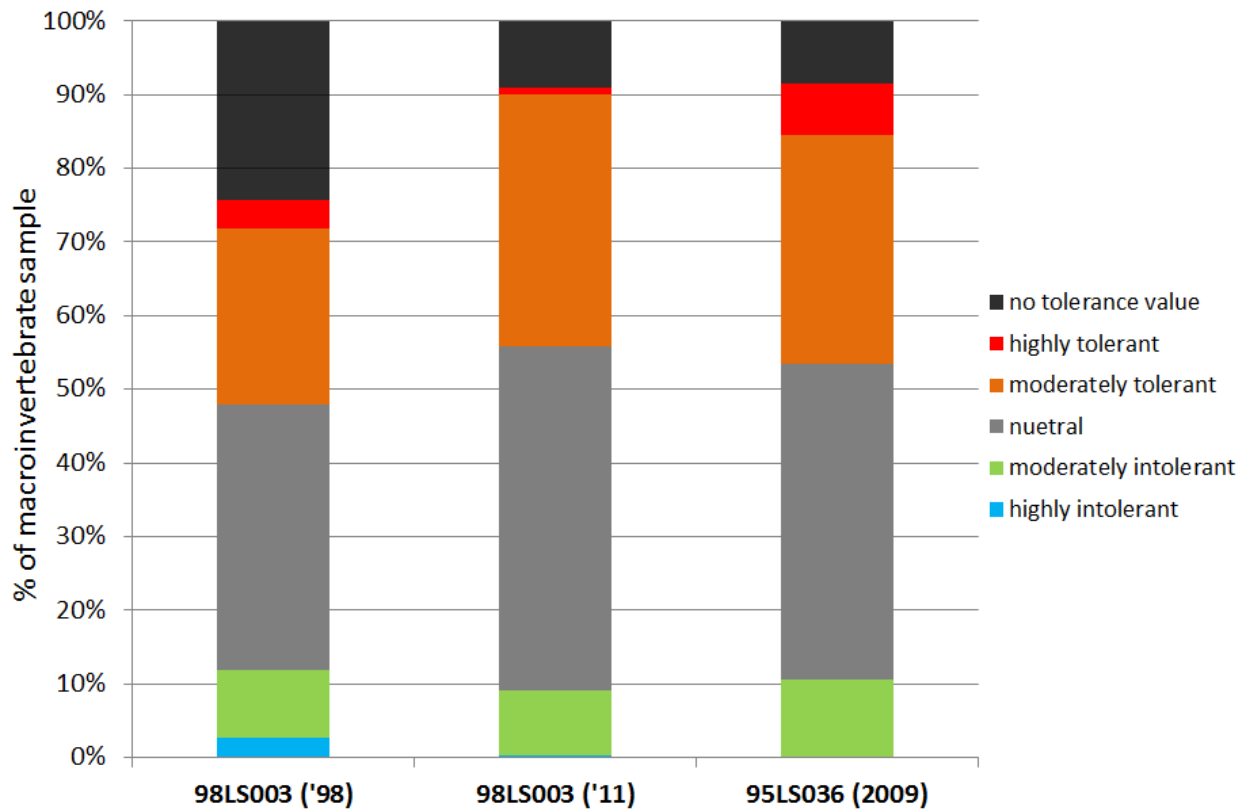
Figure 61: Macroinvertebrate community tolerance to specific conductivity in Kingsbury Creek, based on taxon specific TIV values

Overall, a very small percentage of the macroinvertebrate population observed in Kingsbury Creek can be considered “highly tolerant” of elevated specific conductivity (figure BLANK). However, several sites had large numbers of *Oligochaeta* and *Hirudinea*, which are listed as “no tolerance value” in figure BLANK because MPCA has yet to develop a tolerance value for these taxa. Most members of *Oligochaeta* and *Hirudinea* are tolerant of many forms of pollution and habitat degradation, so it can be assumed that the macroinvertebrate community of Kingsbury Creek is more tolerant of elevated specific conductivity than figure BLANK depicts. A very low percentage of the macroinvertebrate community of Kingsbury Creek can be considered highly or moderately intolerant of elevated specific conductivity levels (figure BLANK).

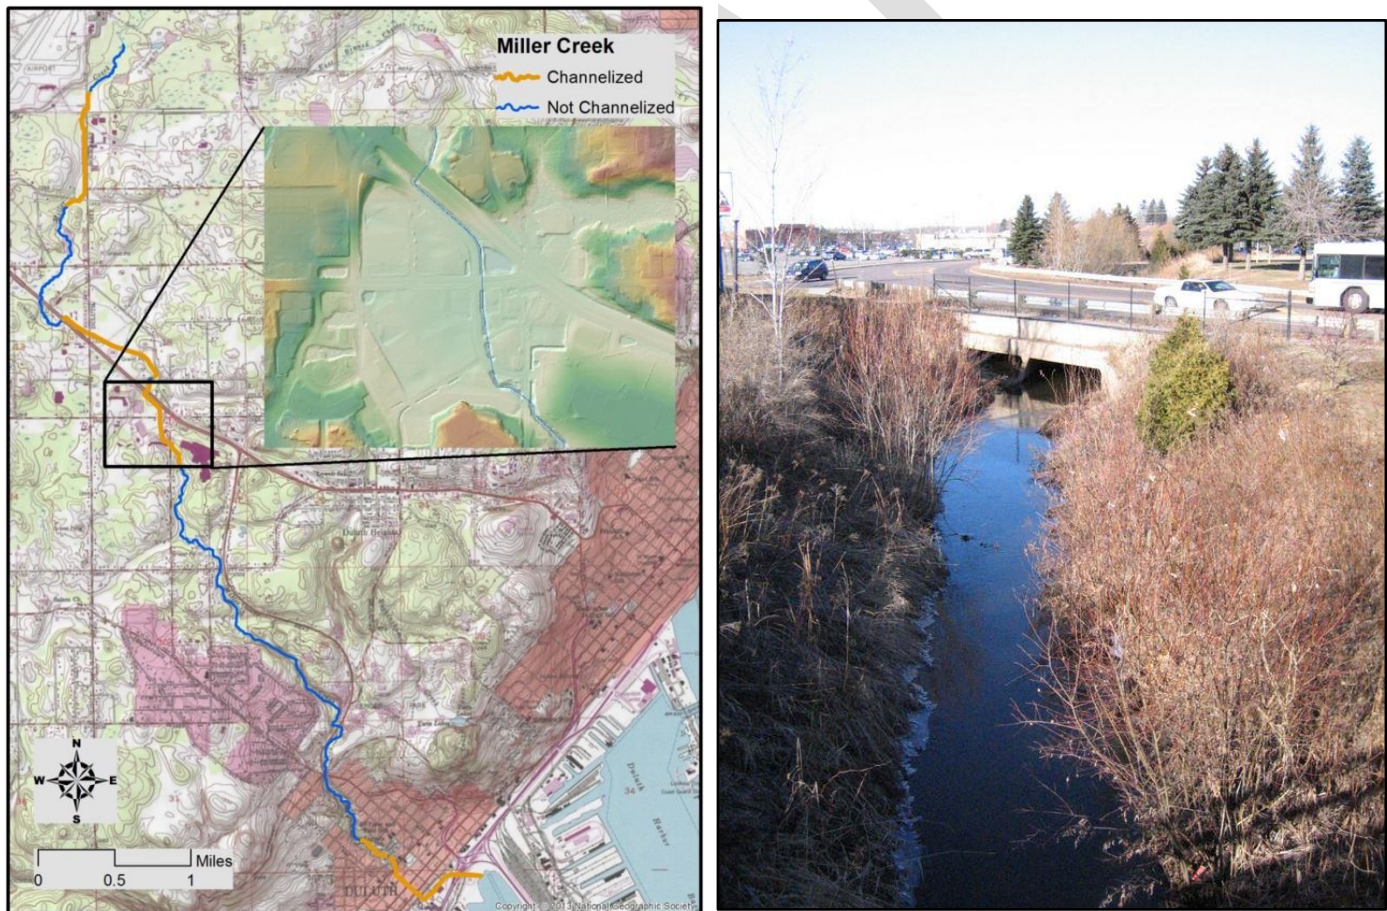
Figure 71: Map showing the channelized and straightened reaches of Miller Creek

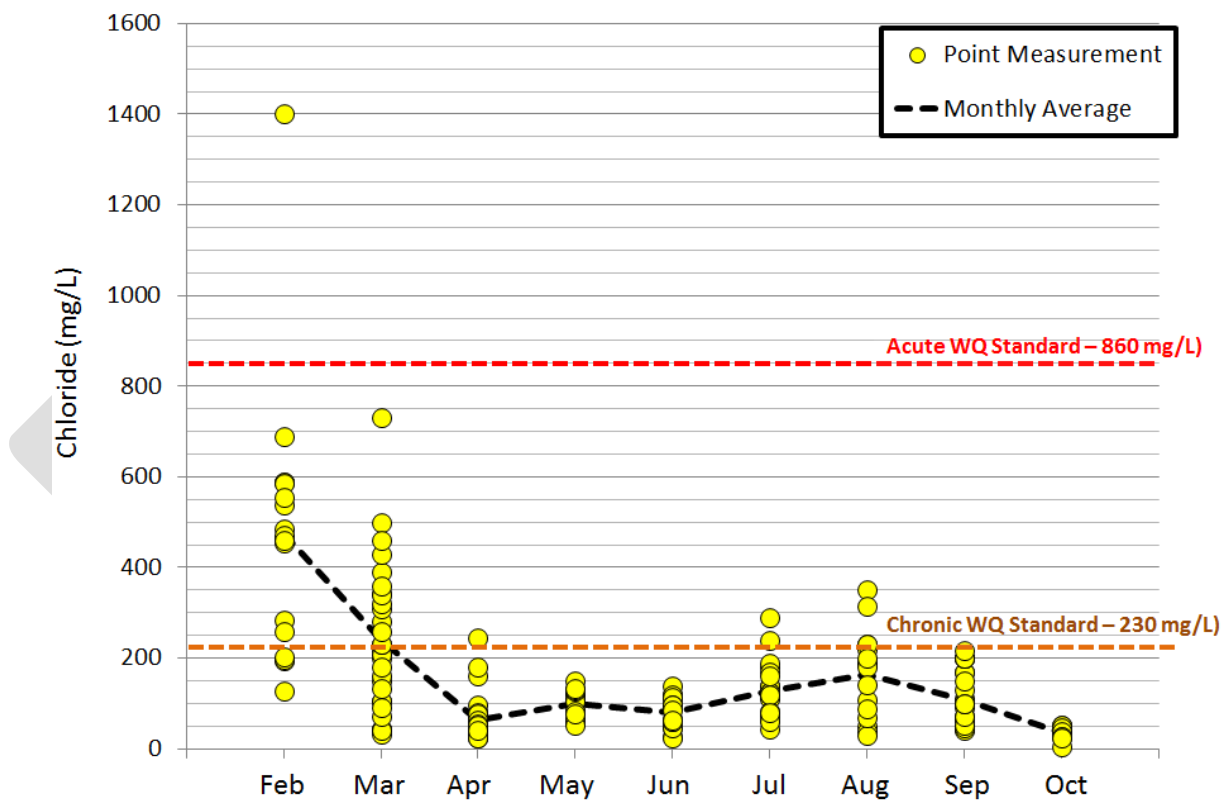
Figure 76: Available chloride data for Miller Creek obtained by grab sampling, arranged by calendar month.

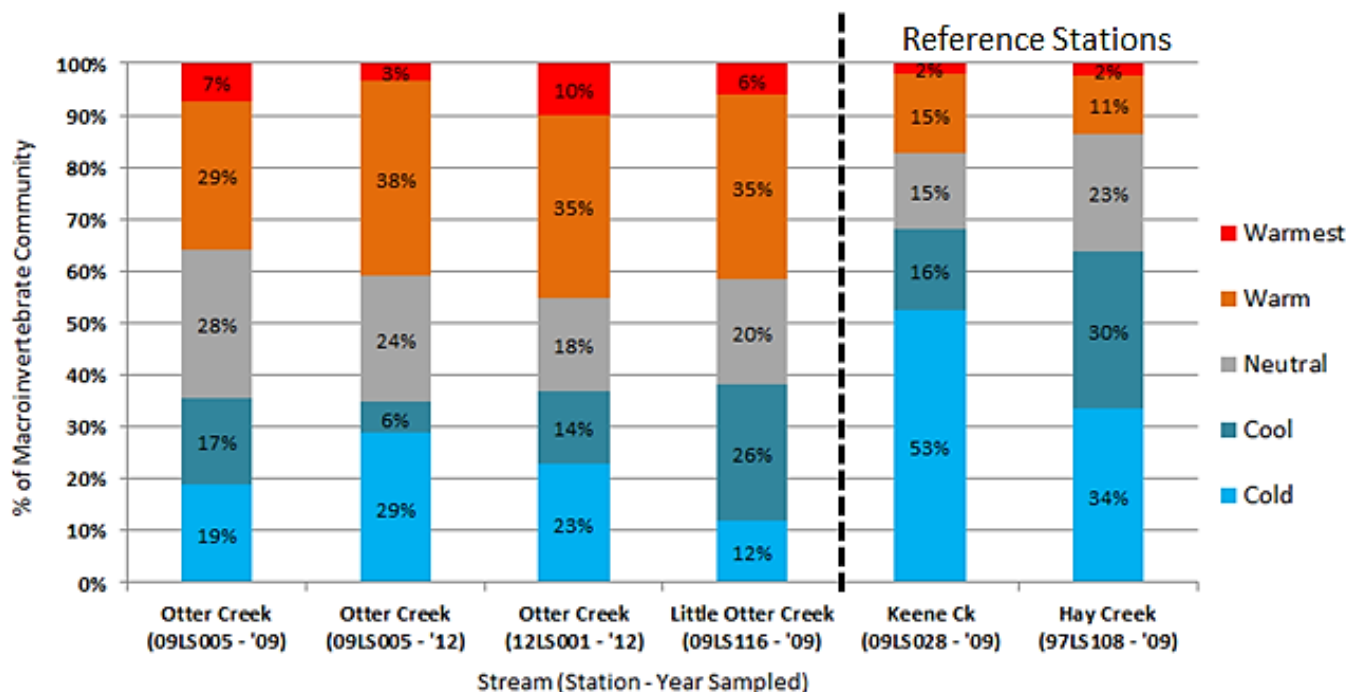
Figure BLANK: Percentage of macroinvertebrate community associated with cold, cool or warm stream temperatures observed in Otter Creek compared to reference stations

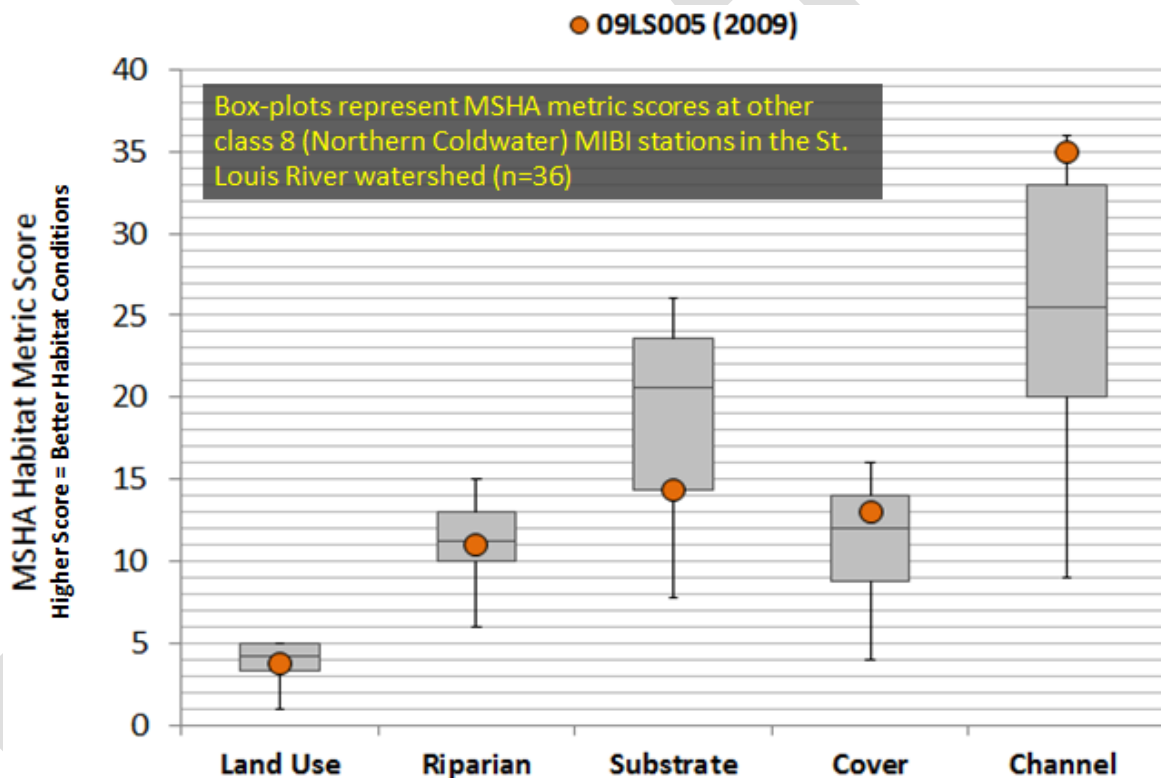
Figure BLANK: Minnesota Stream Habitat Assessment (MSHA) metric scores for Otter Creek station 09LS005 compared to the box plot distribution of results from all other class 8 (Northern Coldwater) stations in the St. Louis River Watershed.

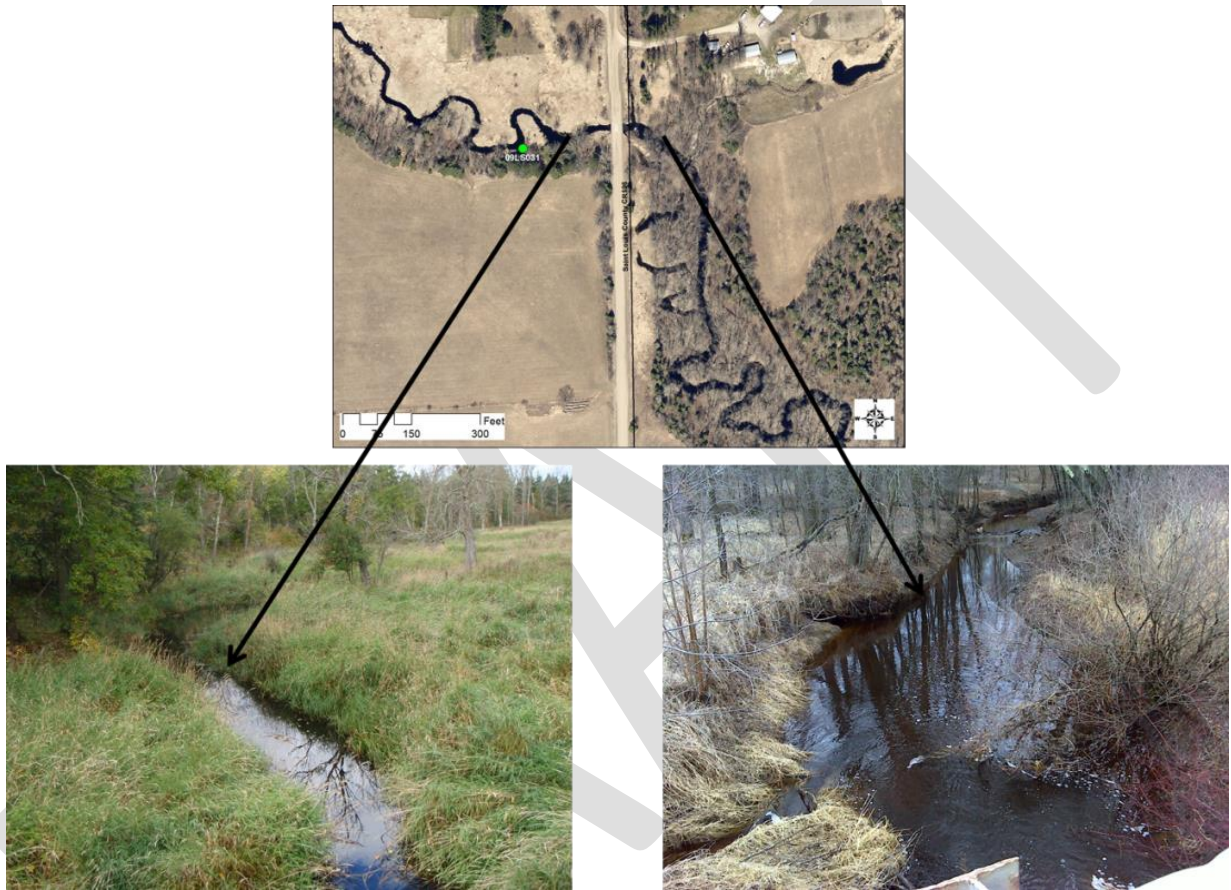
Figure BLANK: Aerial photo of Skunk Creek 09LS031 and CR 196 crossing (top). Upstream of the crossing, the stream is stable (bottom left). Downstream, the stream is widened and eroding (bottom right)

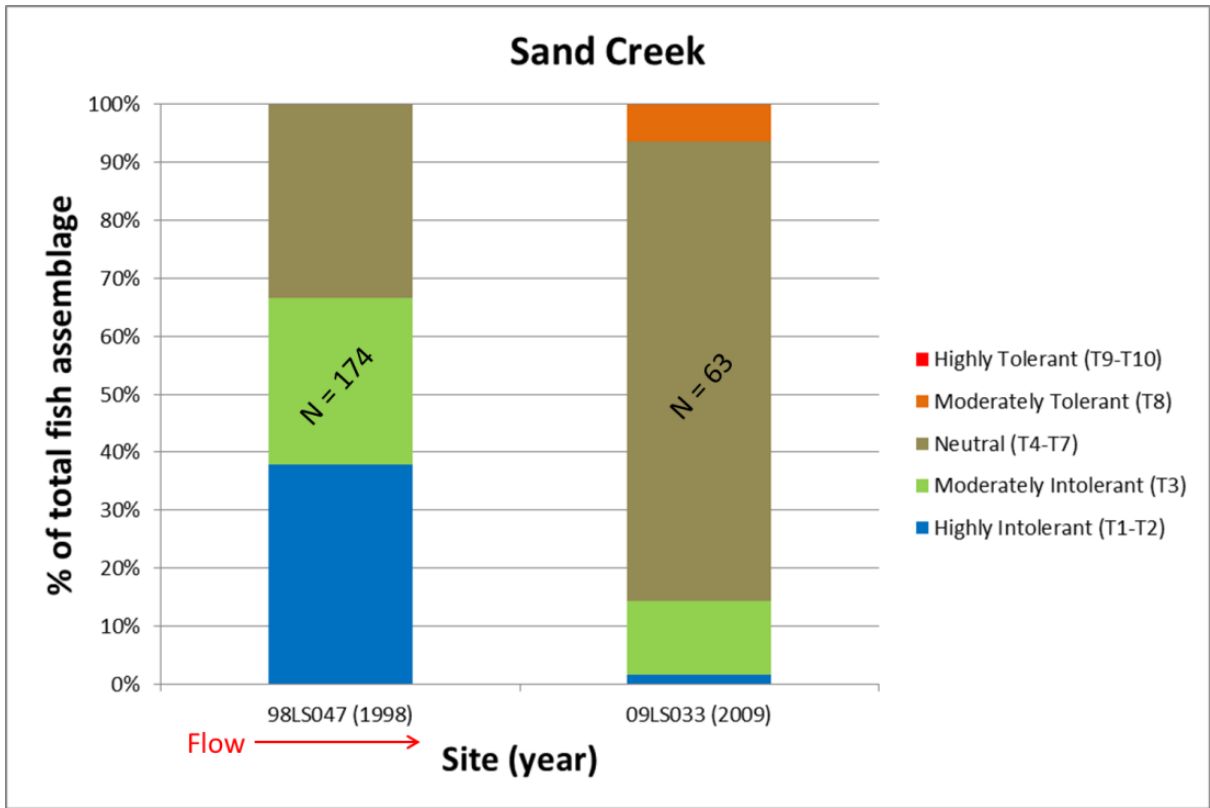
Figure BLANK: TSS tolerance of fish assemblages by site in Sand Creek (n = number of fish)
