St. Louis River Watershed Stressor Identification Report

Minnesota Pollution Control Agency

May 2015

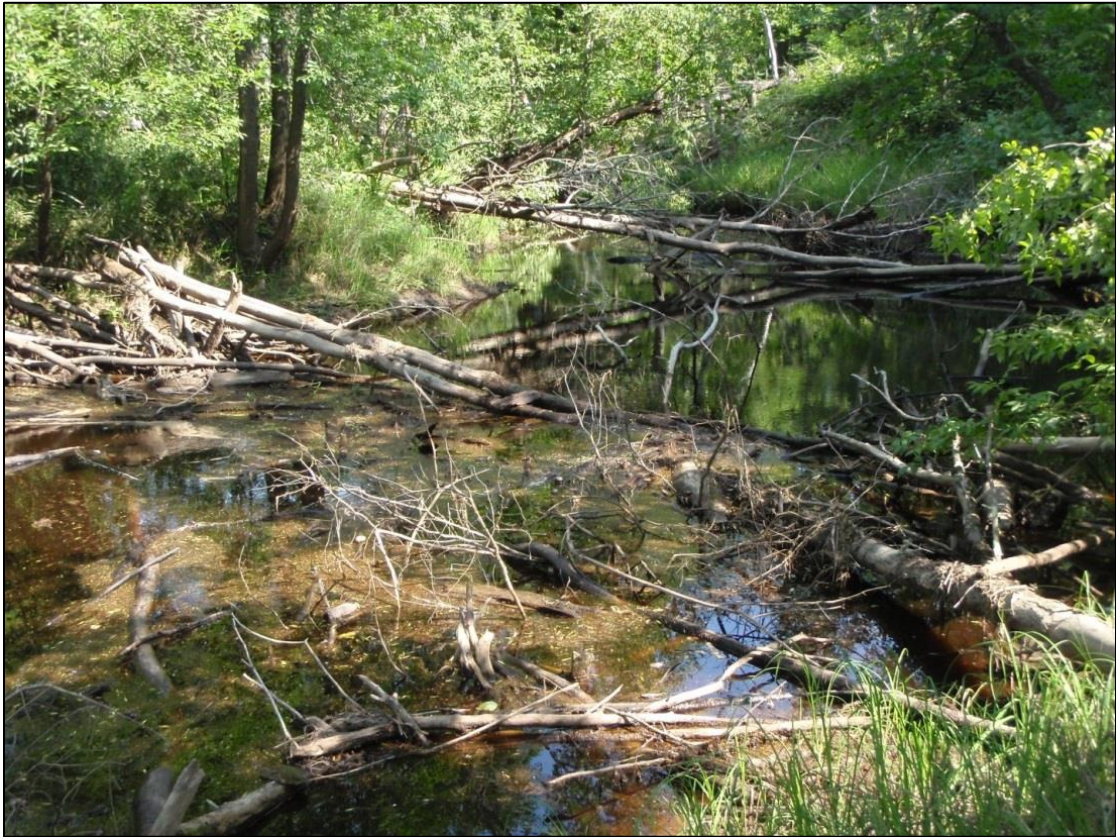
Figure BLANK: Leaning trees and massive debris jams are a sign of channel instability in Stony Creek

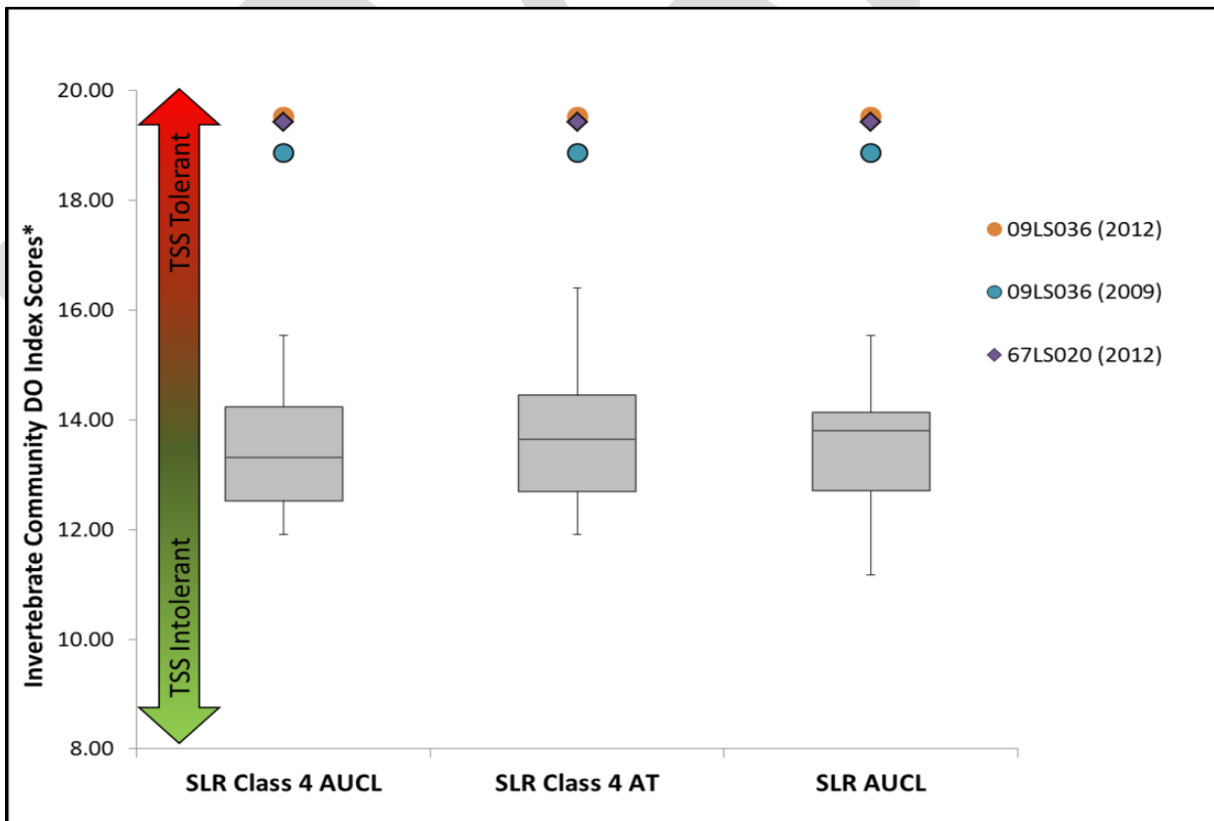
Figure BLANK: Macroinvertebrate community TSS TIVs for Stony Creek, compared to unimpaired streams

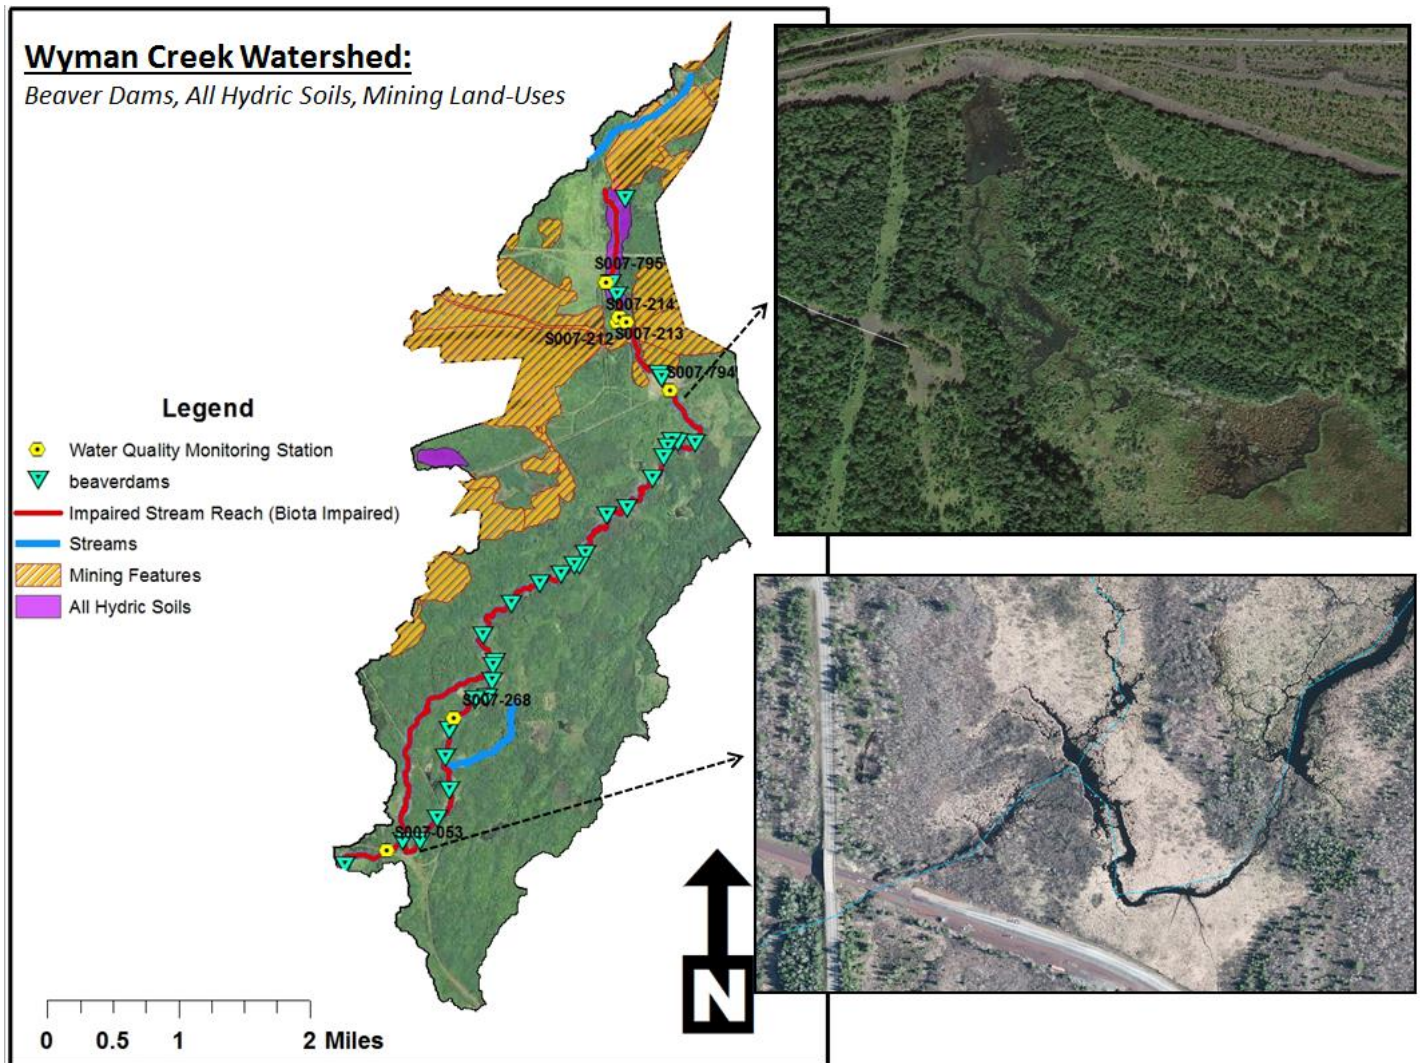
Figure BLANK: Map of beaver dam locations, mining-related land-use features, and all hydric soil types within the Wyman Creek watershed.

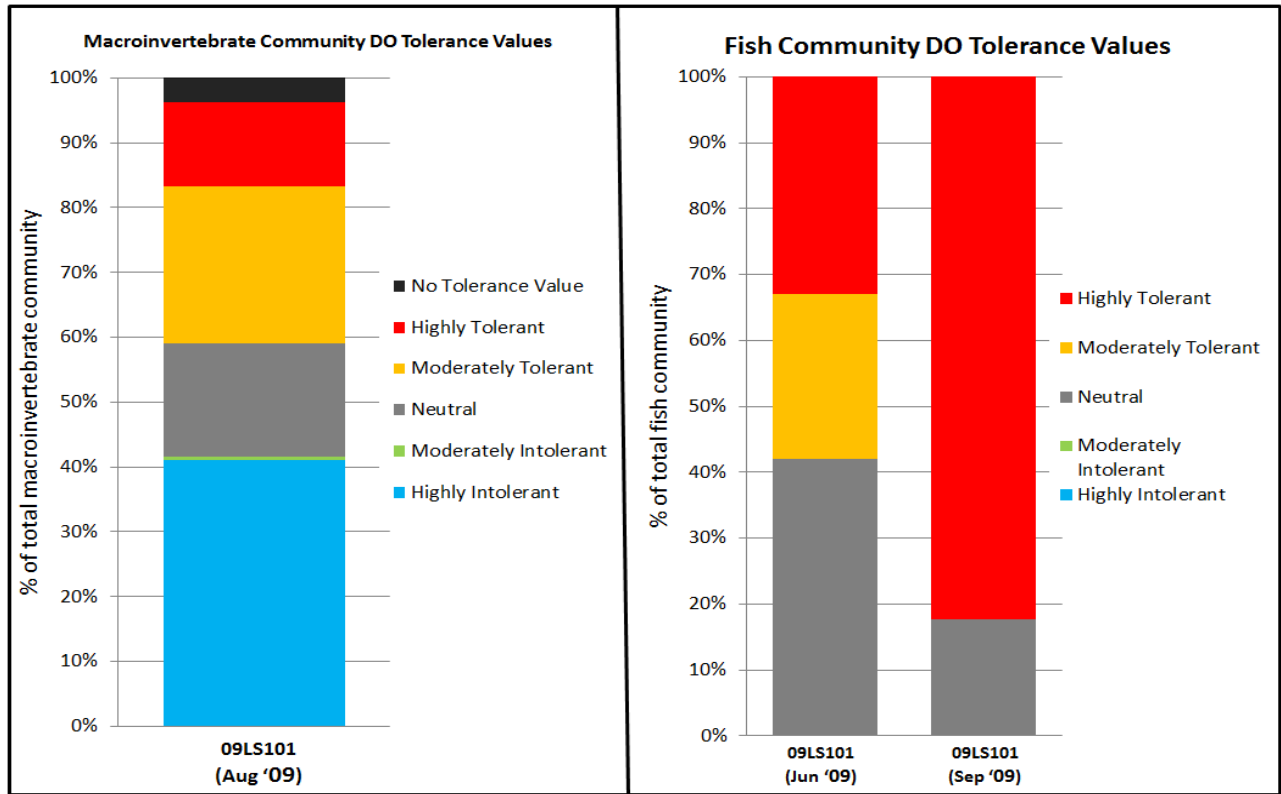
Figure BLANK: Proportion of fish and macroinvertebrate population in Spring Mine Creek that are tolerant, neutral, or intolerant of low dissolved oxygen concentrations

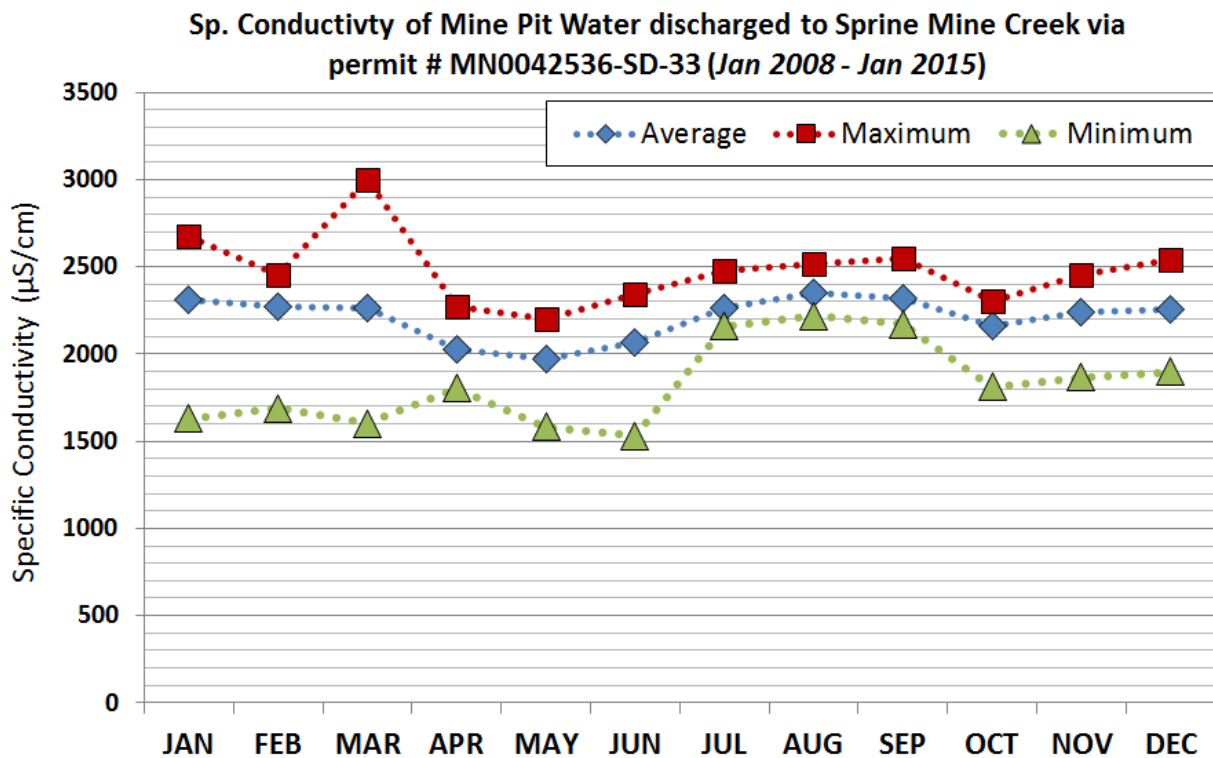
Figure BLANK: Continuous specific conductivity data collected at the outlet of the abandoned mine pit that serves as the headwaters of Spring Mine Creek.

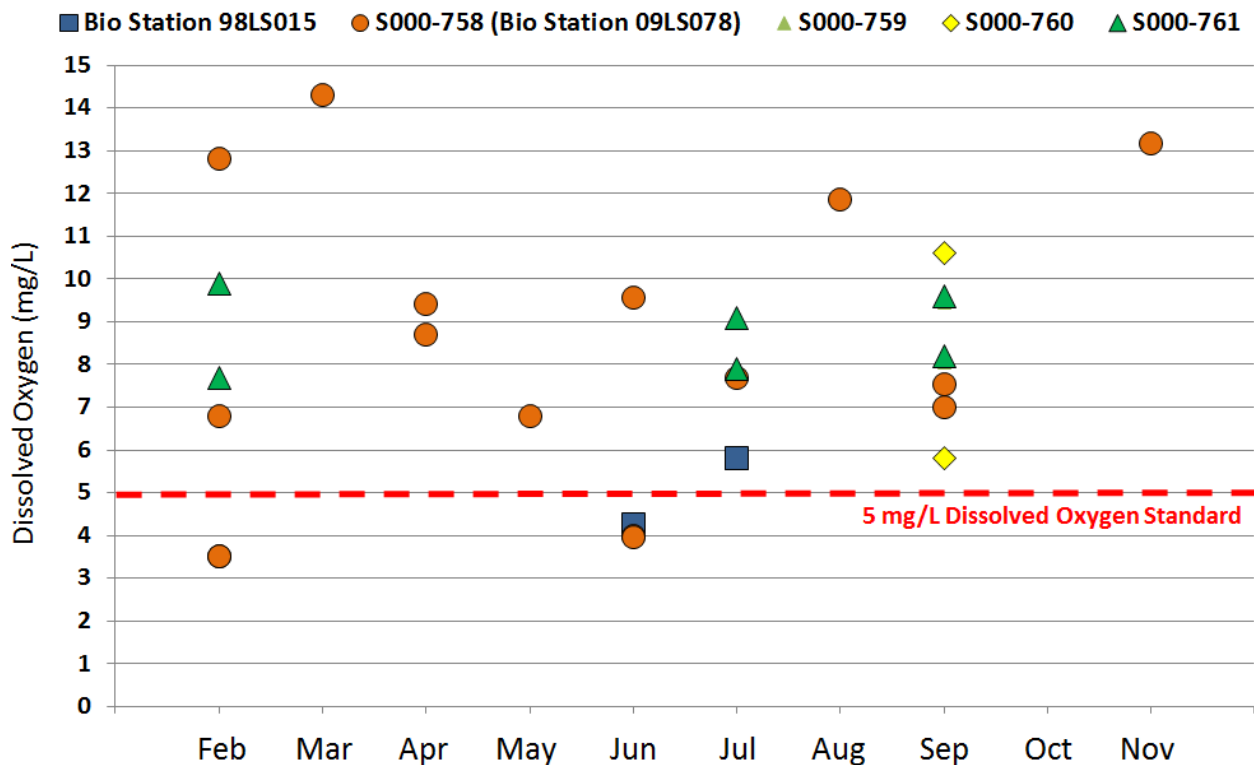
Figure BLANK: Point measurements of dissolved oxygen collected from Manganika Creek

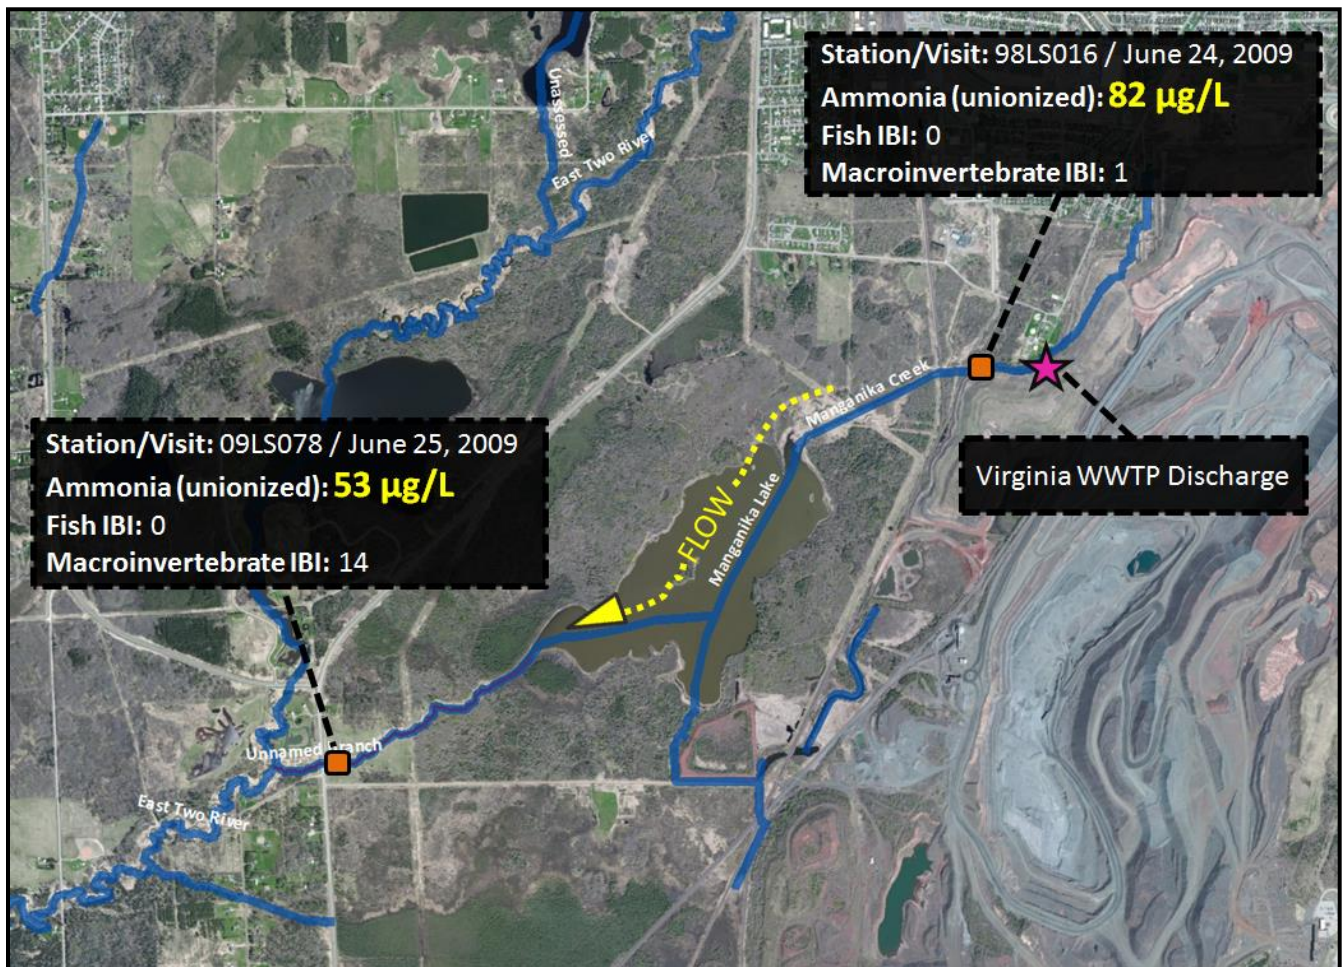
Figure BLANK: Eutrophic conditions in Manganika Lake may be resulting in reduced ammonia concentrations downstream.

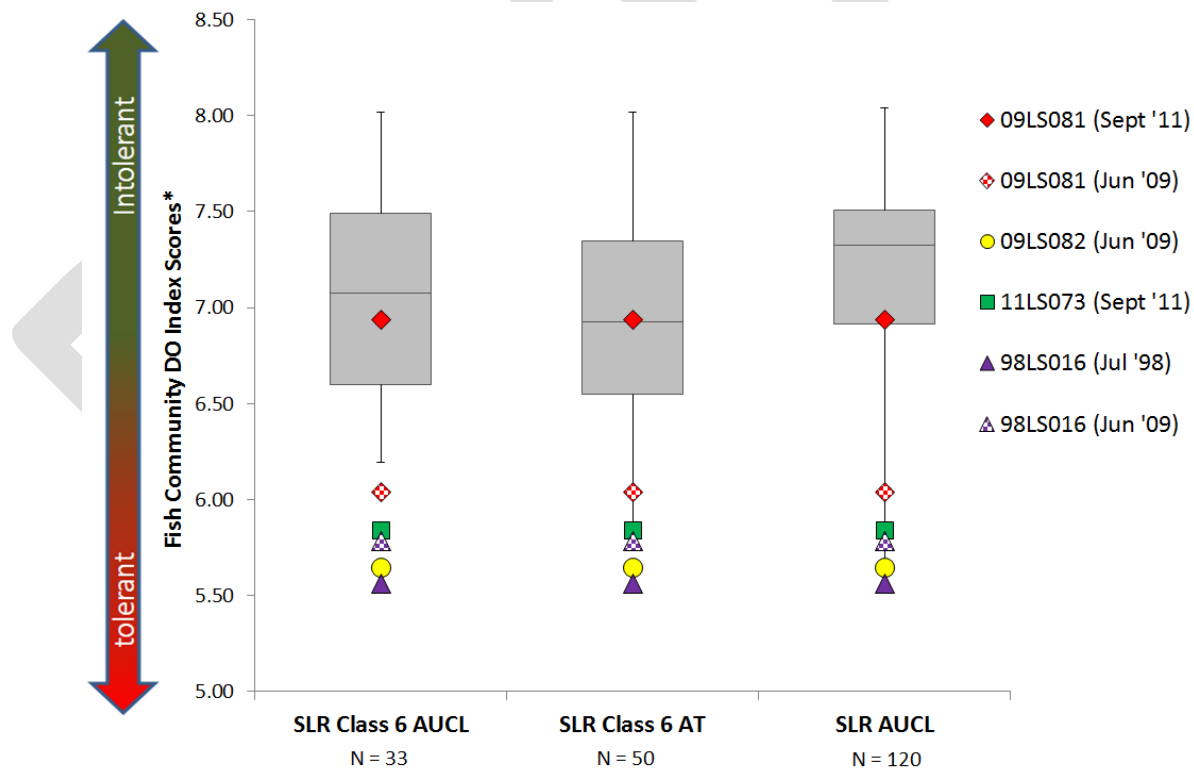
Figure BLANK: Fish community DO TIV results for Elbow Creek monitoring sites compared to high quality reference stations

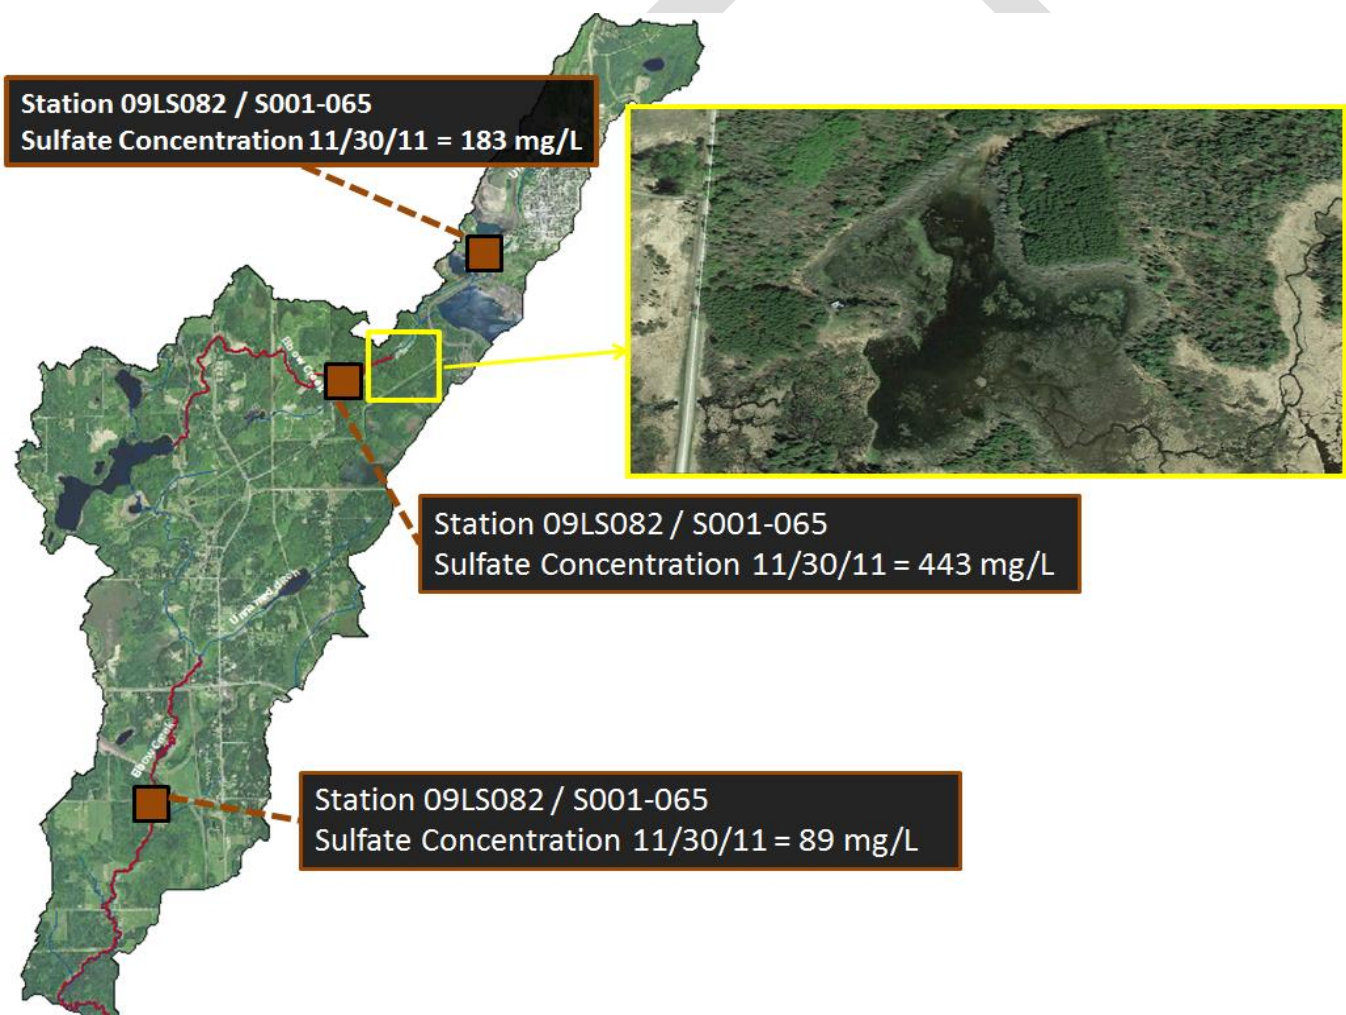
Figure BLANK: Sulfate monitoring results at three locations on Elbow Creek, 11/30/11. A significant increase in sulfate concentration was observed between the two upper monitoring stations where mining waste rock stockpiles are located.

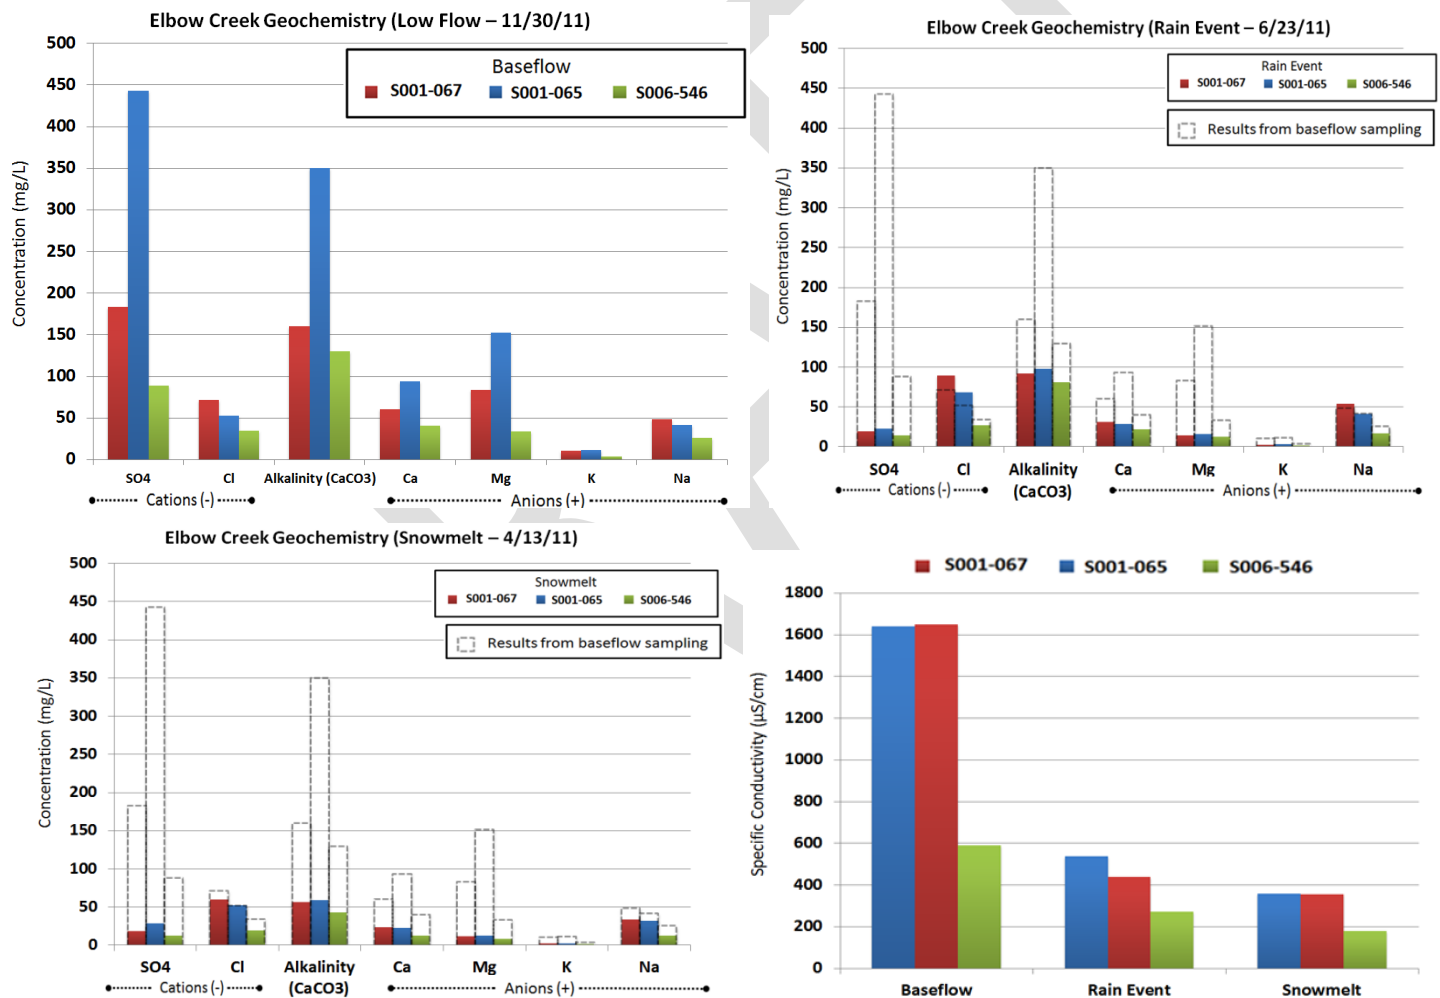
Figure BLANK: Geochemistry sampling results for Elbow Creek during baseflow (upper left), rain event flow (upper right), and snowmelt flow (lower left). Specific conductivity readings for the three monitoring events are shown (lower right)

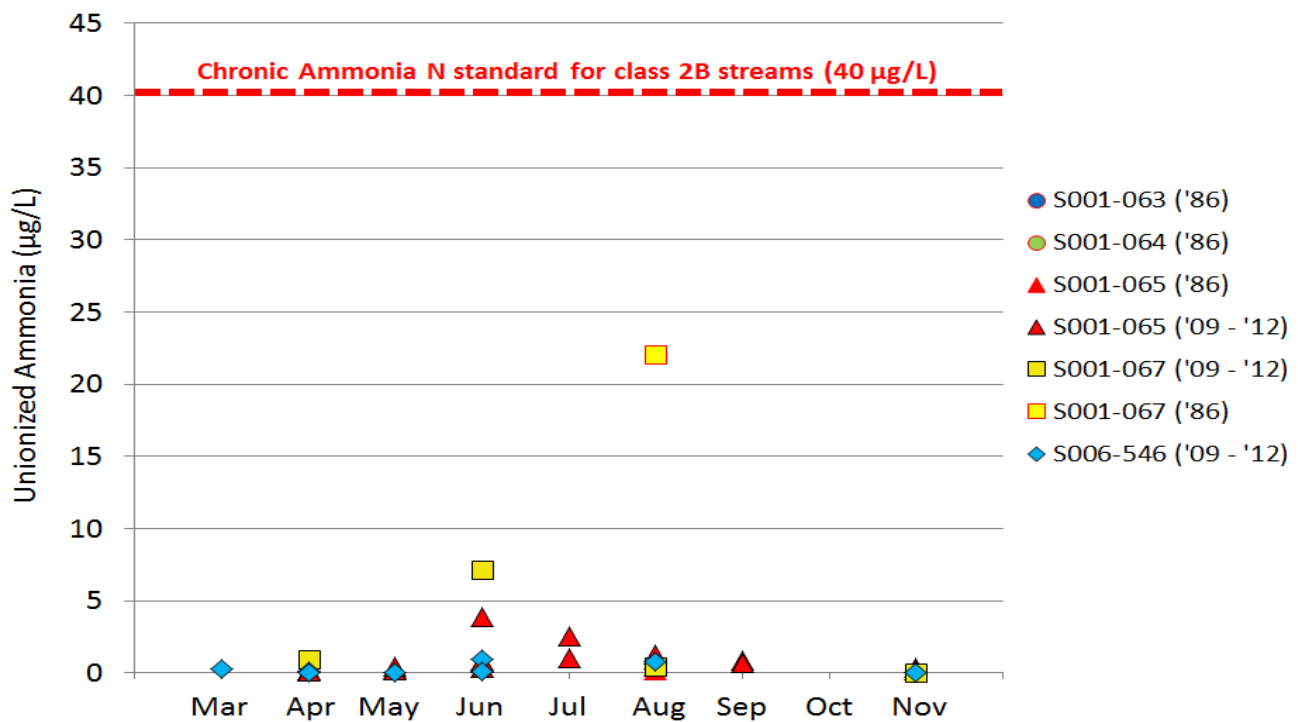
Figure BLANK: Unionized ammonia nitrogen results observed at Elbow Creek monitoring stations, arranged by month

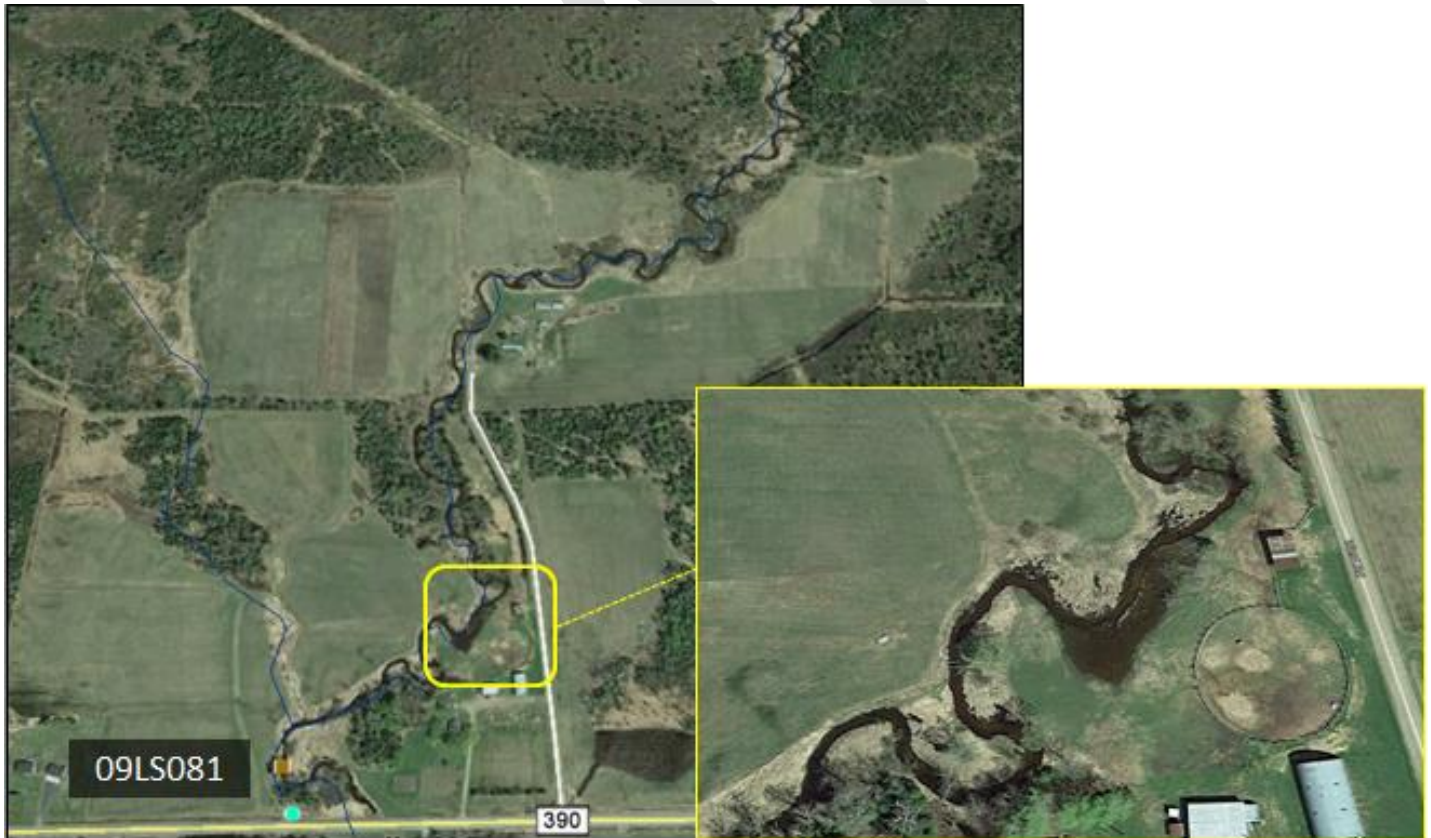
Figure BLANK: Aerial photo of landscape around station 09LS081. Hay/pasture lands border this monitoring station and along the stream corridor for approximately ½ mile upstream. Riparian buffer conditions are fairly poor along the biological monitoring reach (inset photo on right).

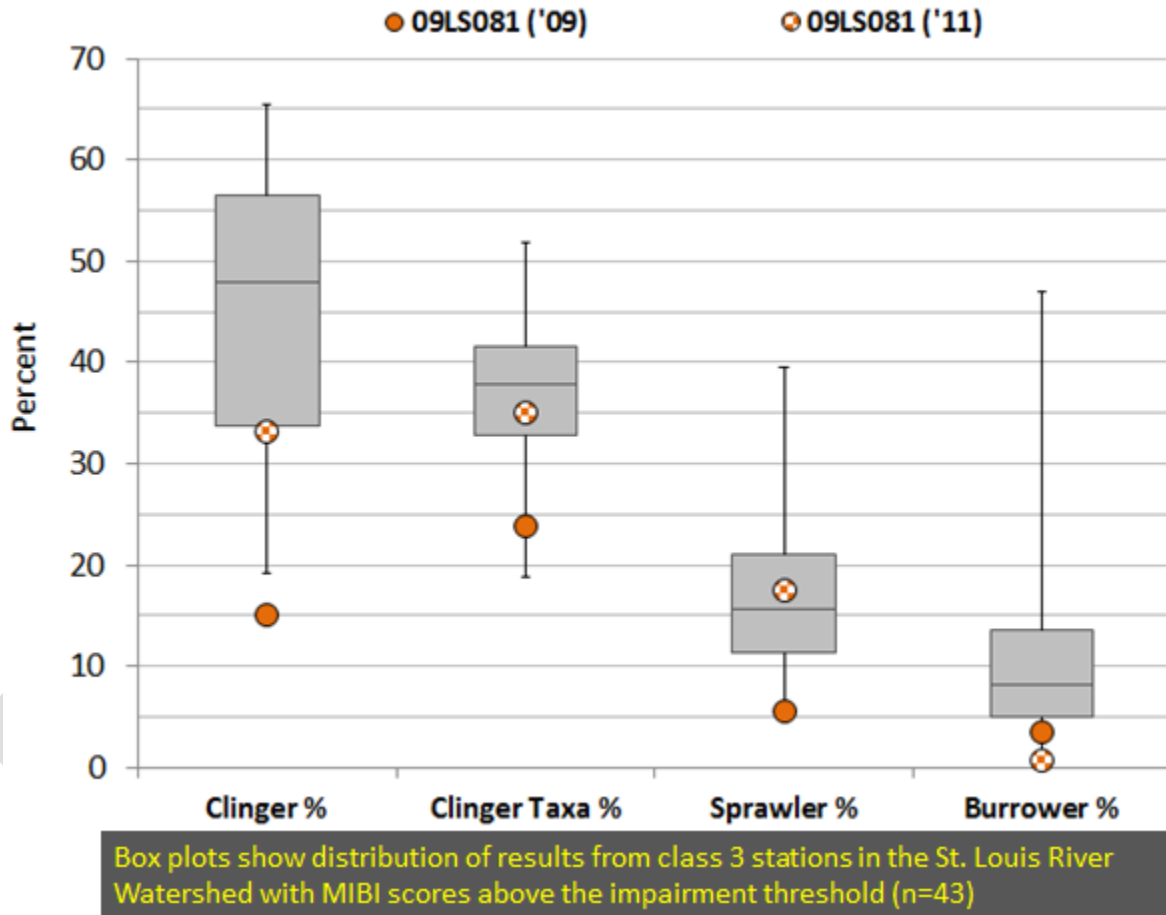
Figure BLANK: Results for select MIBI metrics observed at Elbow Creek station 09LS081 compared to class 3 stations scoring above the MIBI impairment threshold

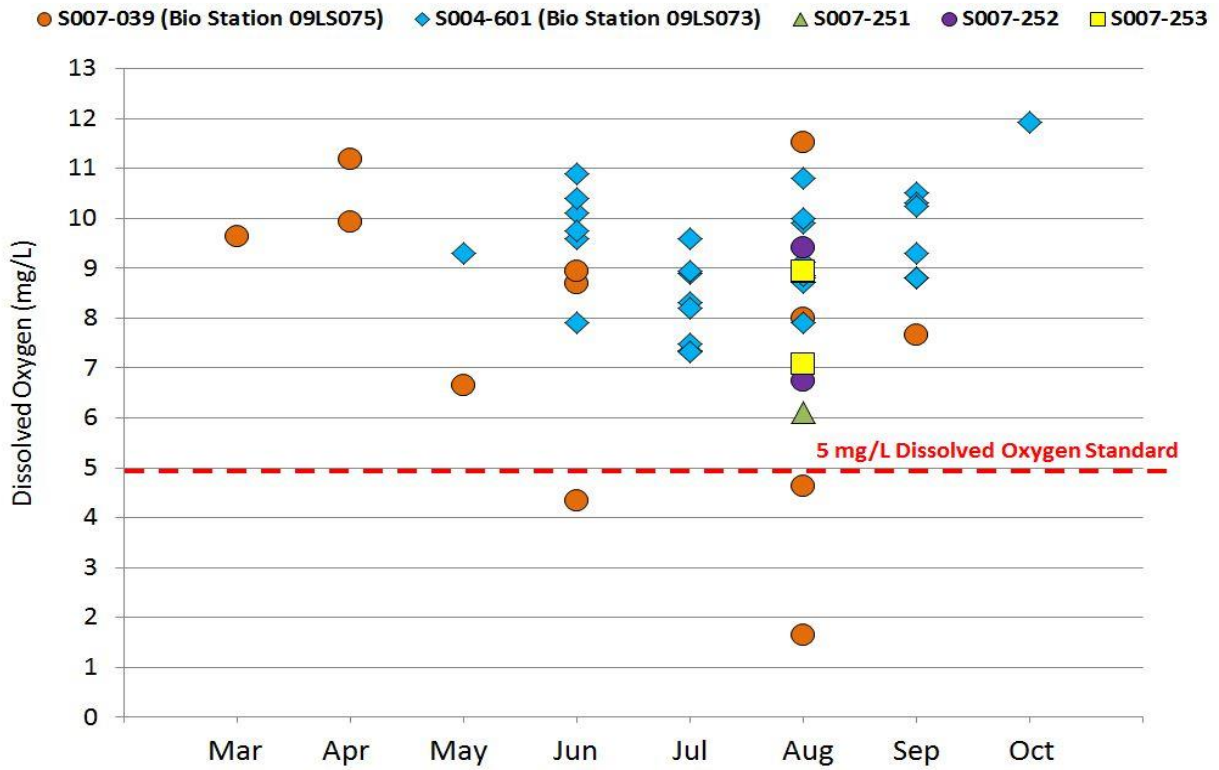
Figure BLANK: Point measurements of dissolved oxygen collected from the West Two River

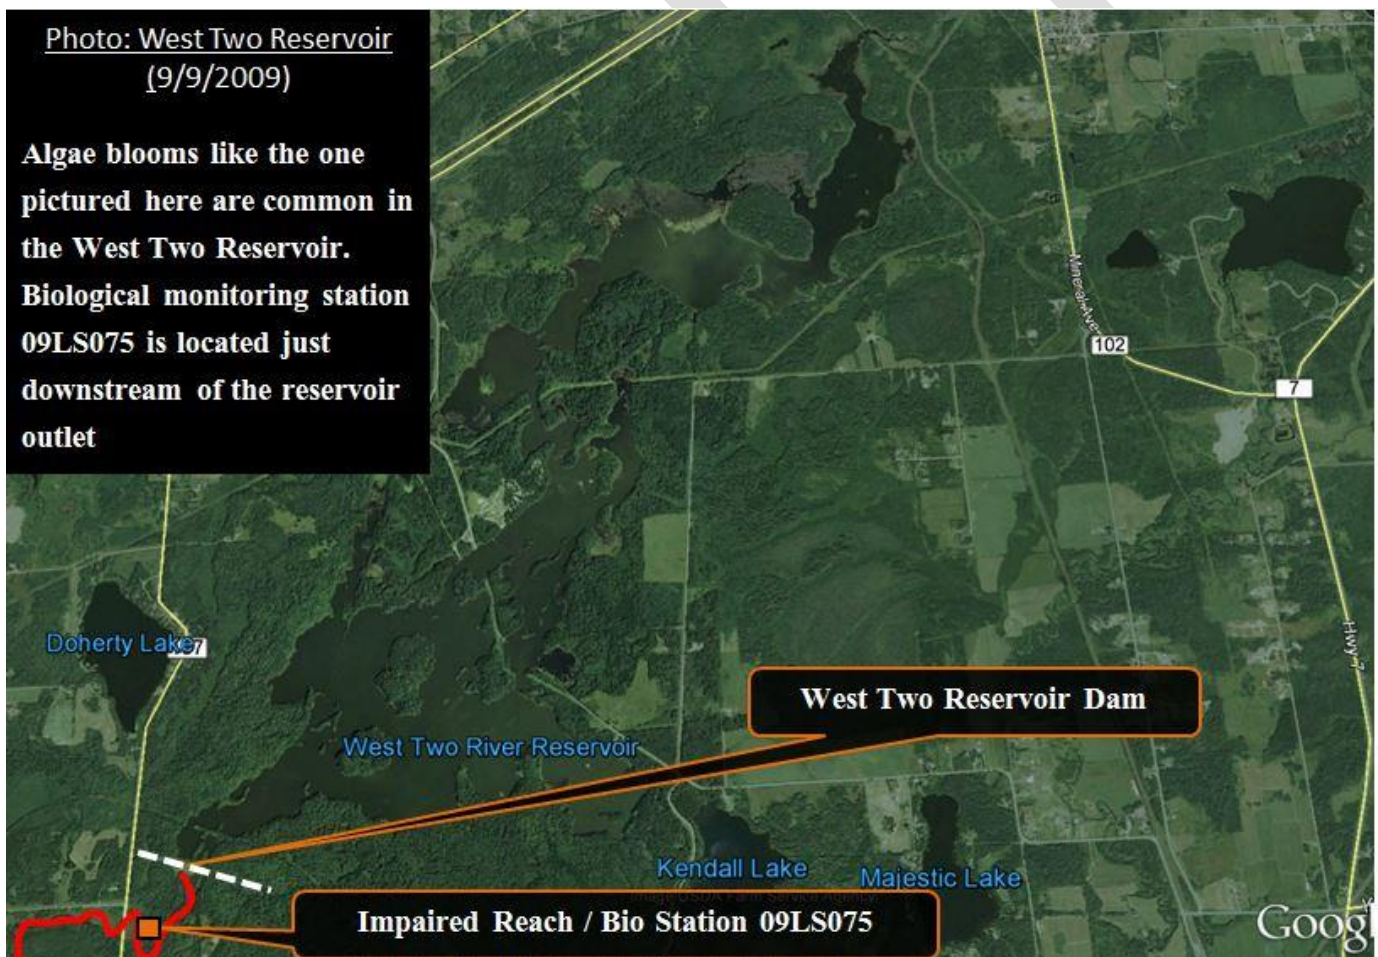
Figure BLANK: Aerial photo showing algae bloom in the West Two Reservoir, and location of biological monitoring station 09LS075 in relation to the reservoir outlet

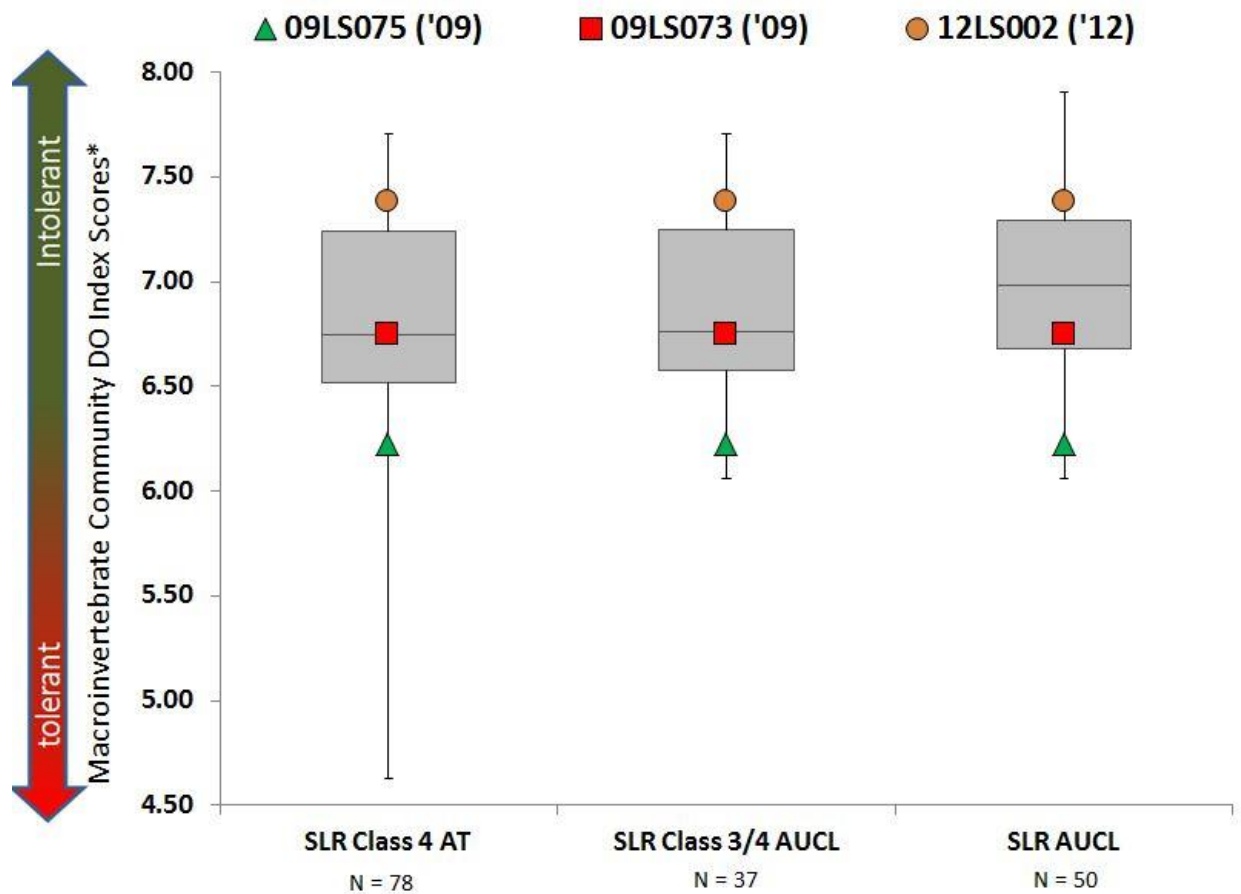
Figure BLANK: Macroinvertebrate community tolerance indicator values (TIV) for dissolved oxygen at West Two River monitoring sites compared to non-impaired streams in the SLRW

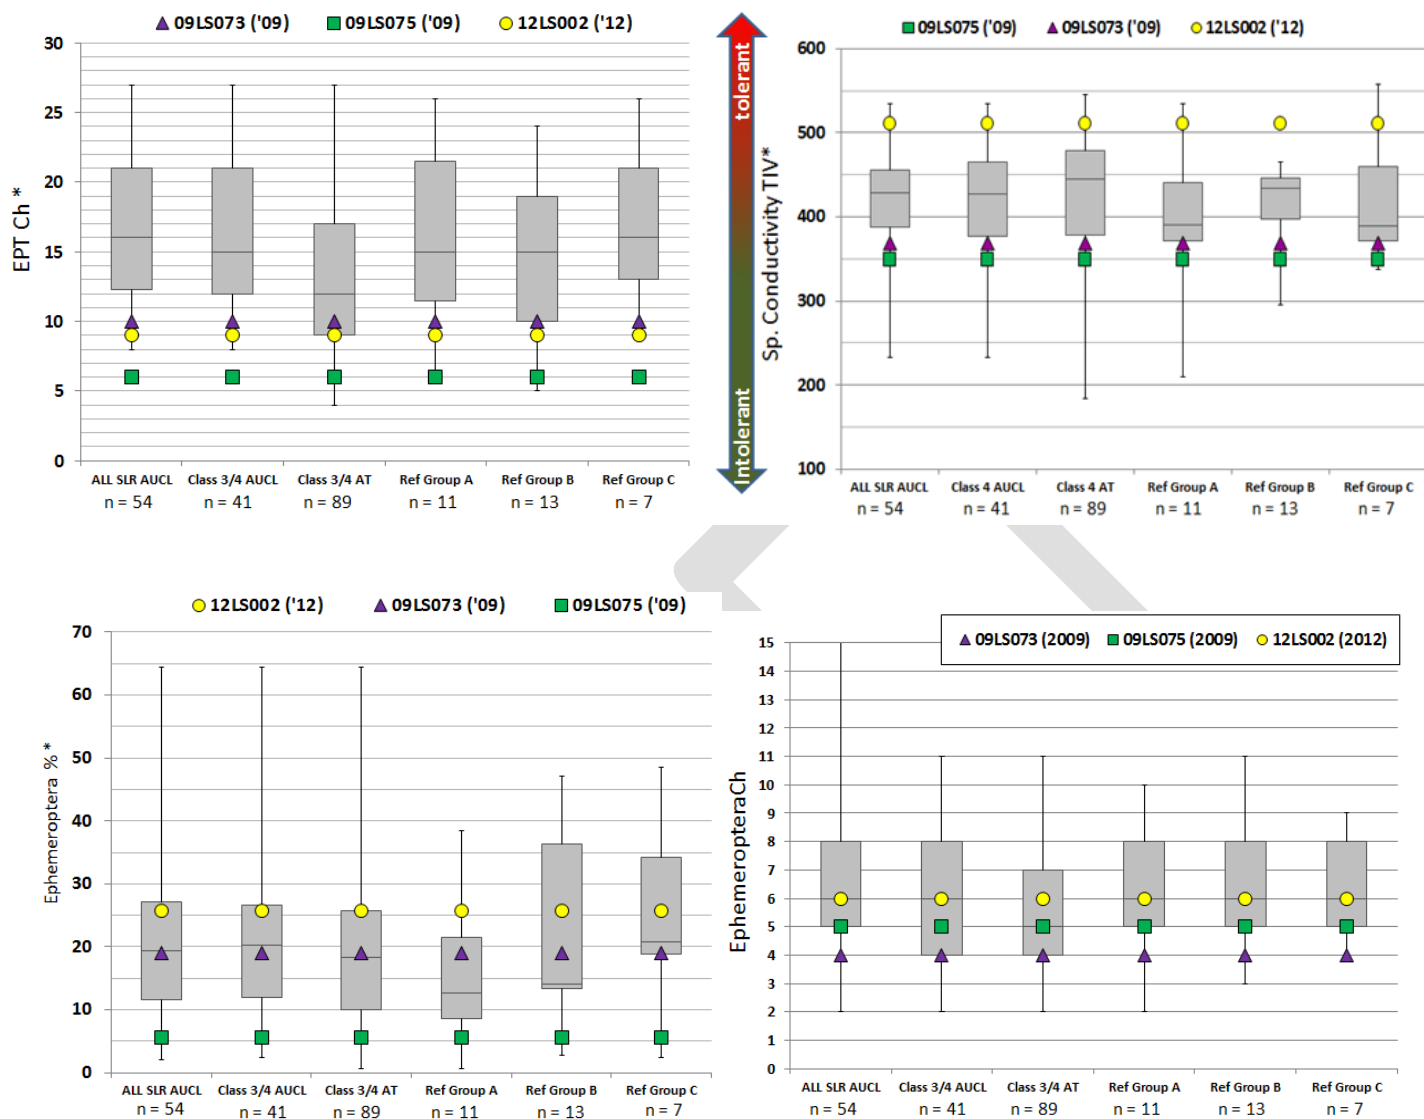
Figure BLANK: Comparison of results for several macroinvertebrate metrics between West Two River stations and non-impaired SLRW reference stations: EPT Taxa Richness (top left); macroinvertebrate community tolerance indicator values (TIV) for specific conductivity (top right); % Ephemeroptera in sample (lower left); Ephemeroptera taxa richness (lower right)

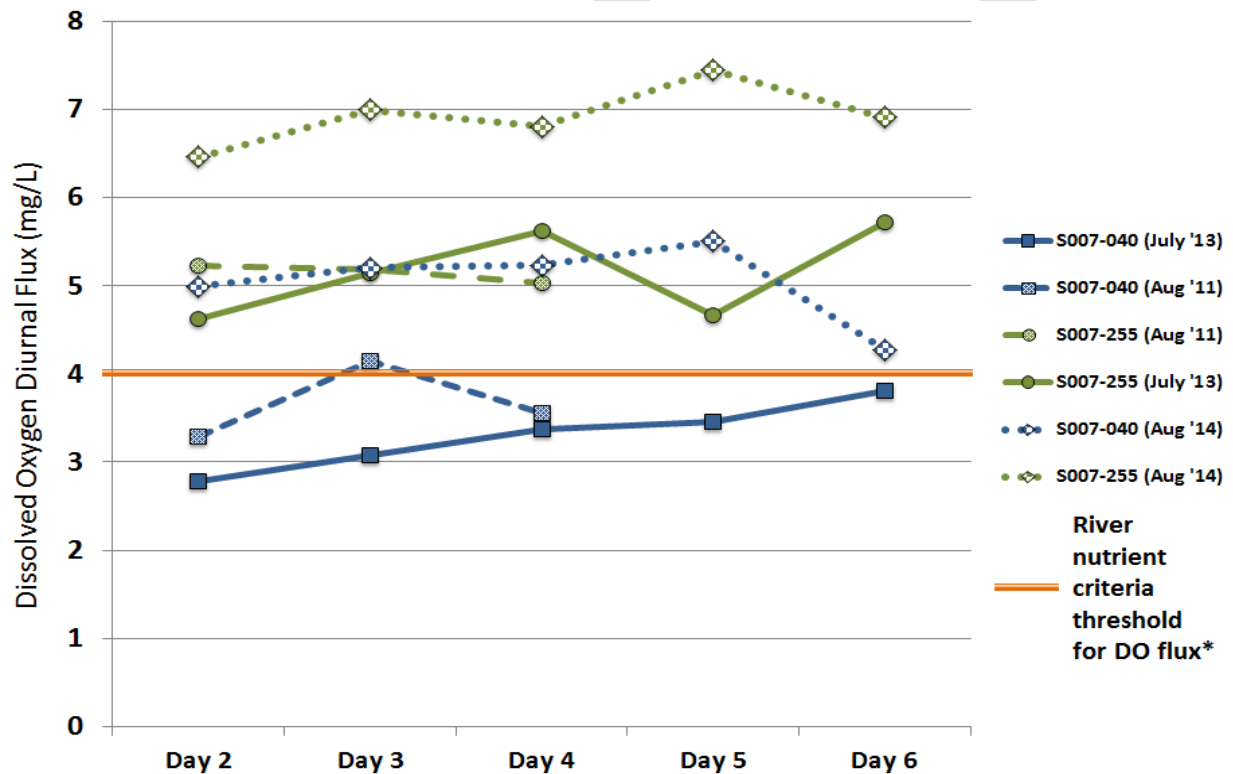
Figure BLANK: 24-hour (diurnal) fluctuation in dissolved oxygen concentration observed at Kinney Creek monitoring stations during continuous monitoring

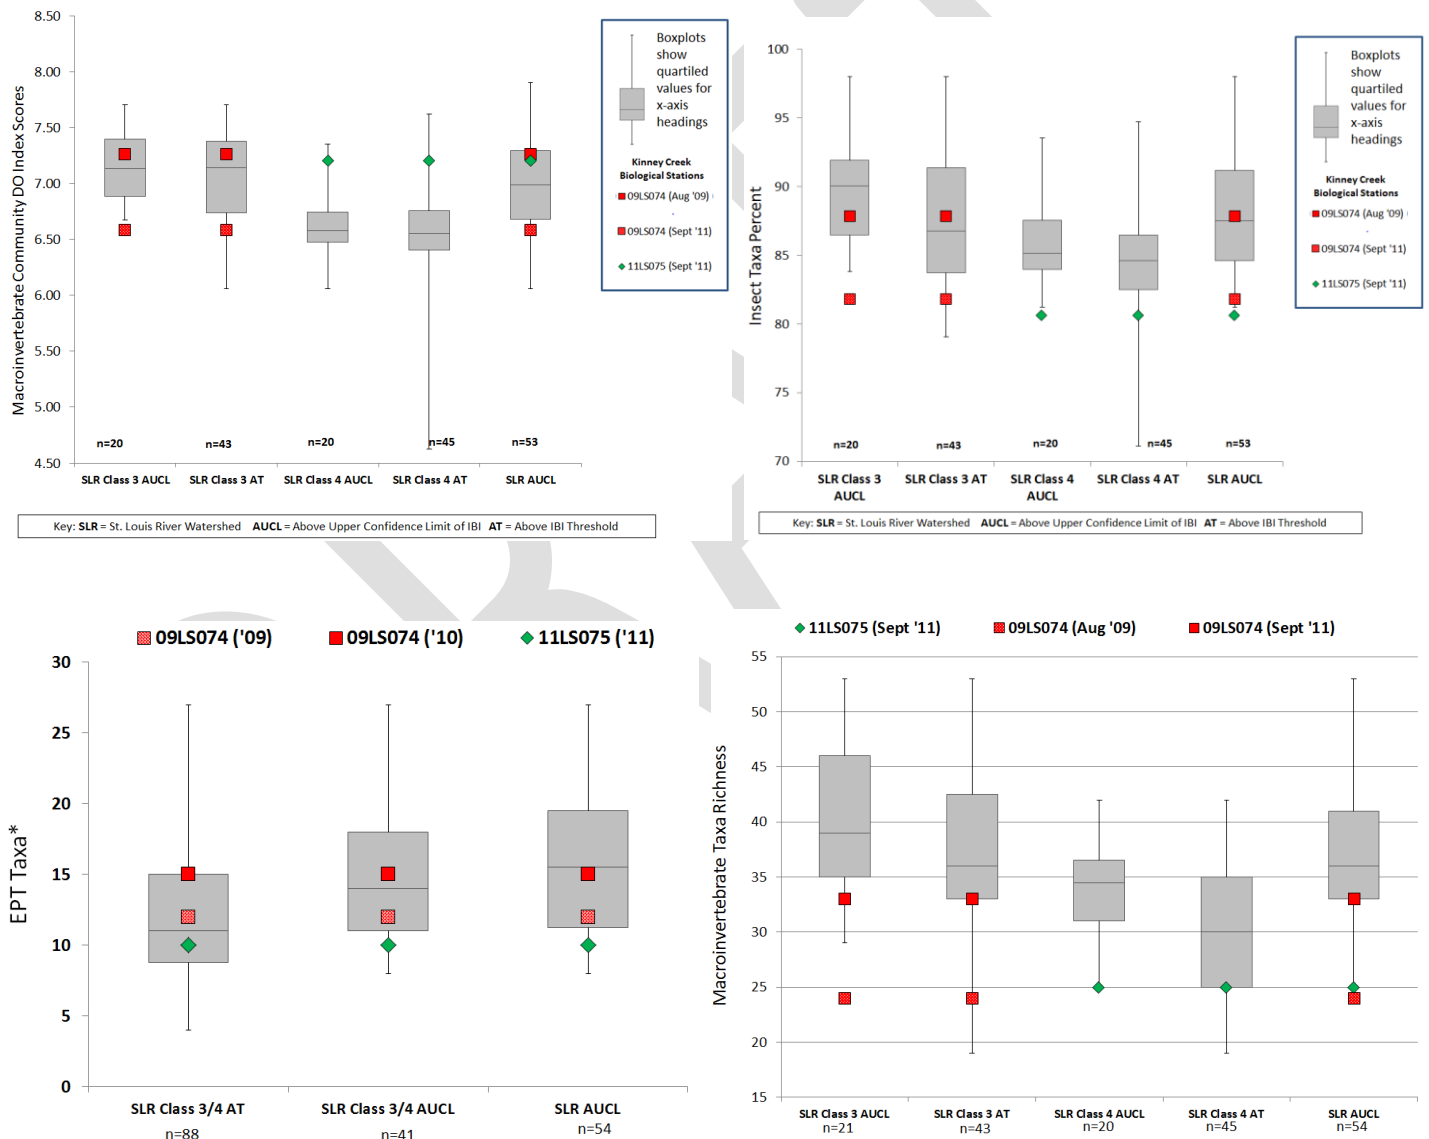
Figure BLANK: Comparison of results for several macroinvertebrate metrics between Kinney Creek stations and non-impaired SLRW reference stations: macroinvertebrate community DO tolerance indicator values (TIV) (top left), % Insect Taxa (top right); EPT Taxa Richness (lower left); overall macroinvertebrate taxa richness (lower right)
