St. Louis River Watershed Stressor Identification Report

Minnesota Pollution Control Agency

May 2015

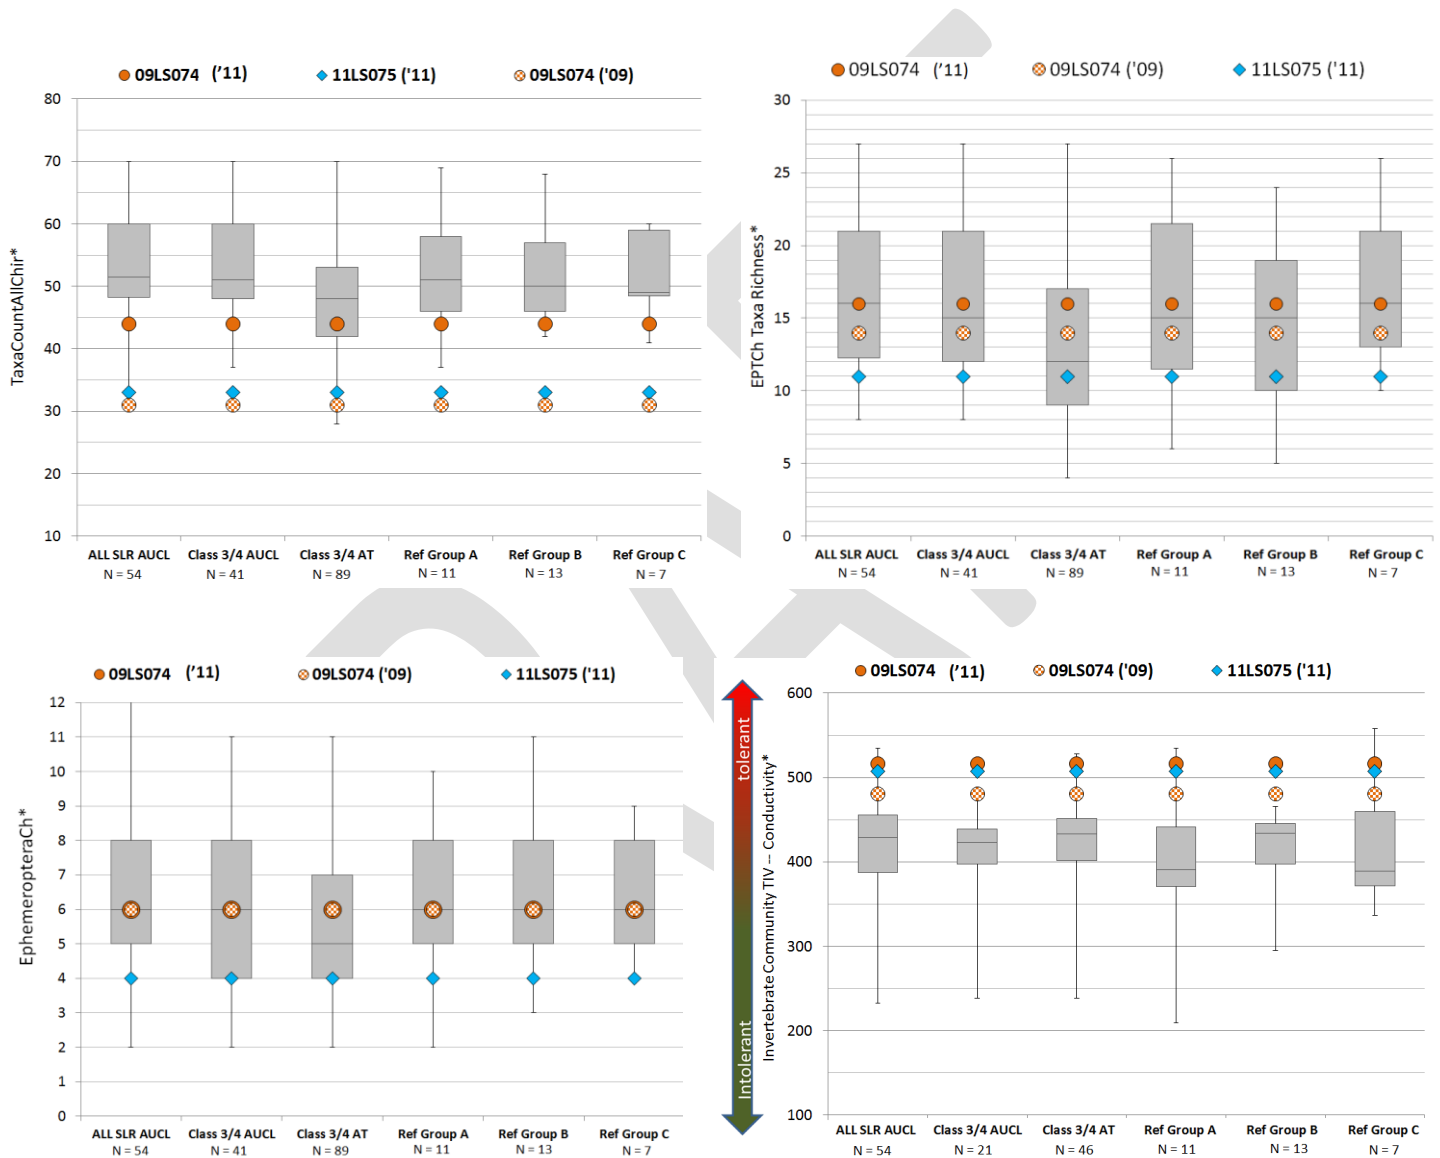
Figure BLANK: Comparison of results for several macroinvertebrate metrics between Kinney Creek stations and non-impaired SLRW reference stations: overall macroinvertebrate taxa richness (upper left); EPT Taxa Richness (upper right); Ephemeroptera taxa richness (lower left); macroinvertebrate community DO tolerance indicator values (TIV) (lower right).

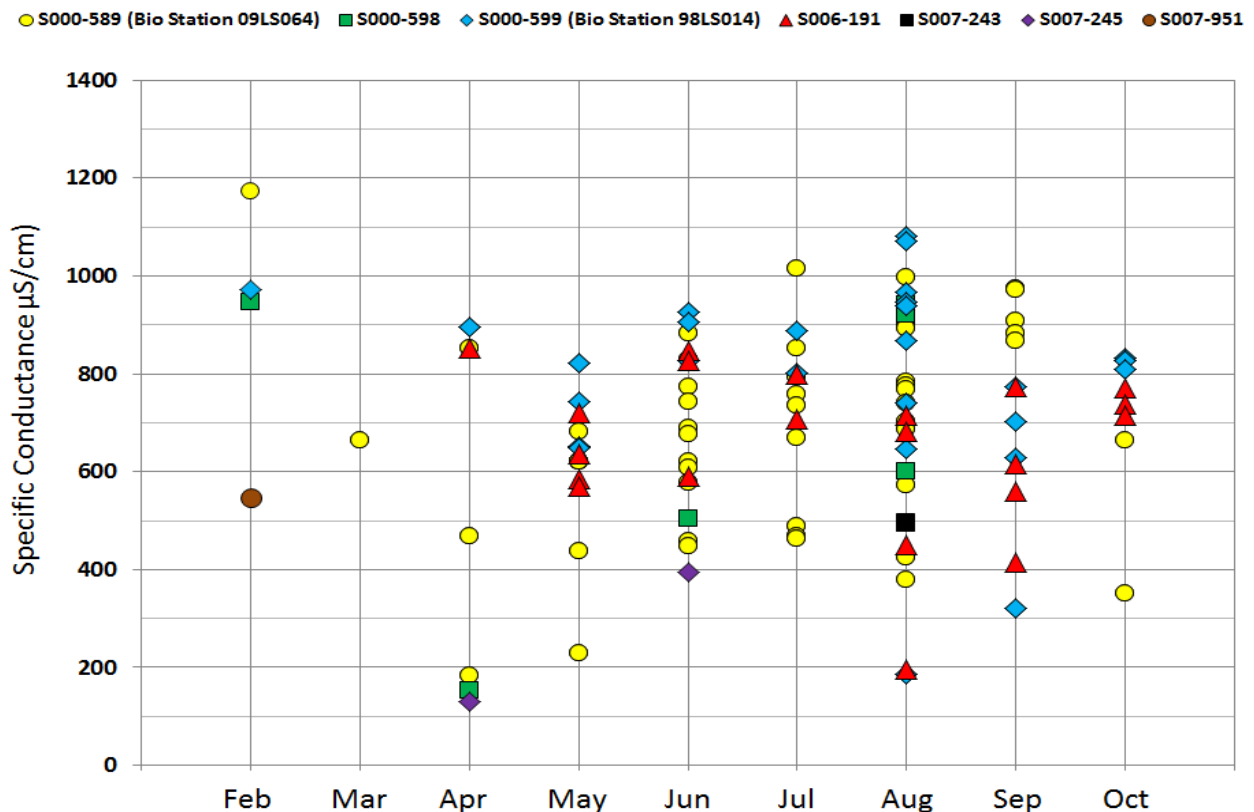
Figure BLANK: Point measurements of specific conductivity collected from East Swan Creek by monitoring station and calendar month

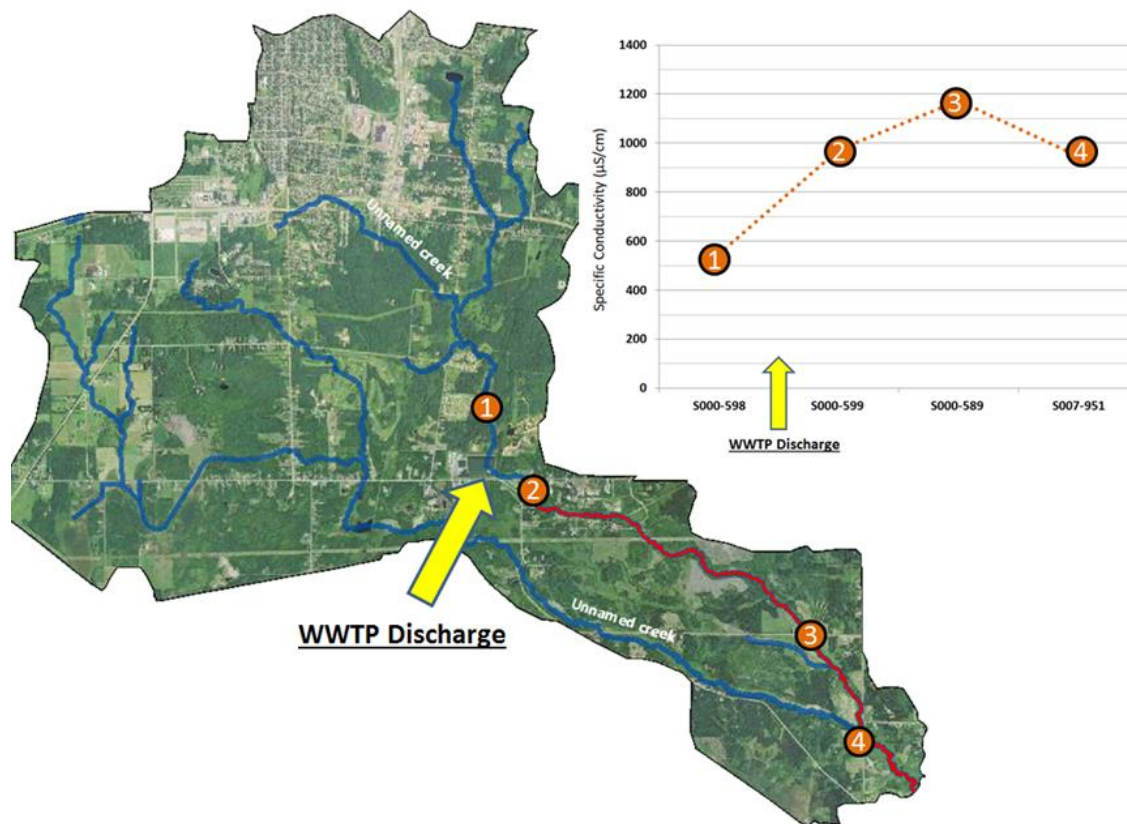
Figure BLANK: Longitudinal measurements of specific conductivity from East Swan Creek collected in February 2014

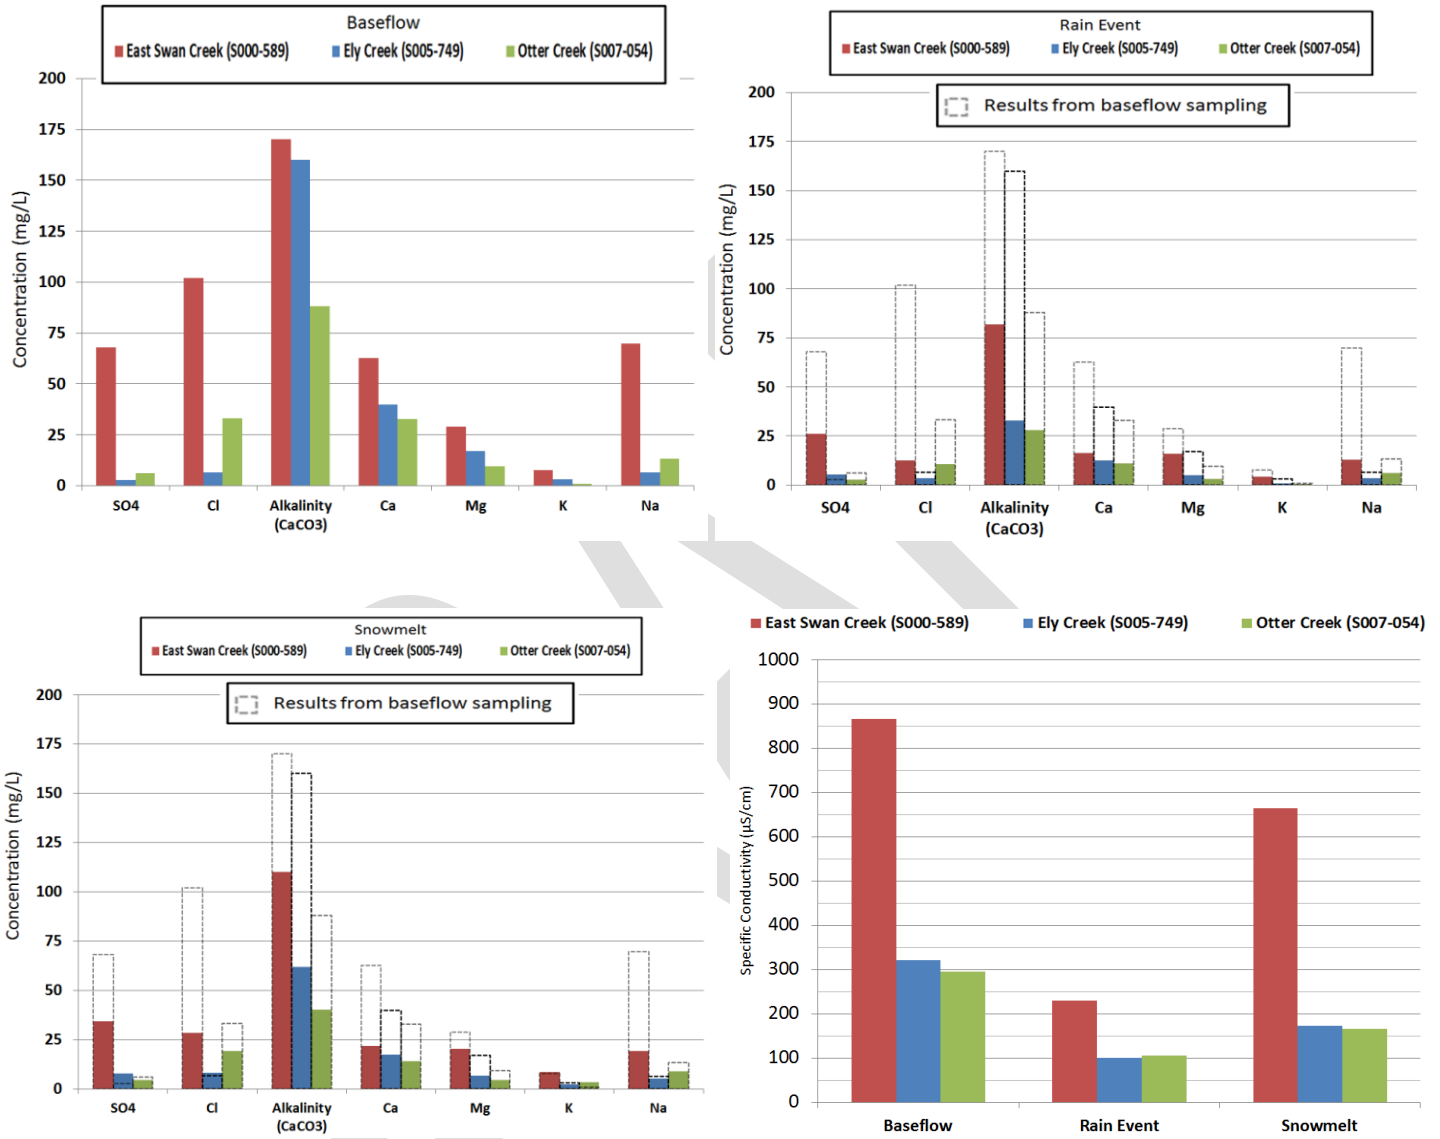
Figure BLANK: Comparison of geochemistry sampling results for major cations and anions in East Swan Creek, Ely Creek, and Otter Creek under various flow conditions; baseflow (upper left), rain event (upper right), snowmelt (lower left). Specific conductivity comparisons for East Swan Creek, Ely Creek, and Otter Creek during the same sampling events (lower right).

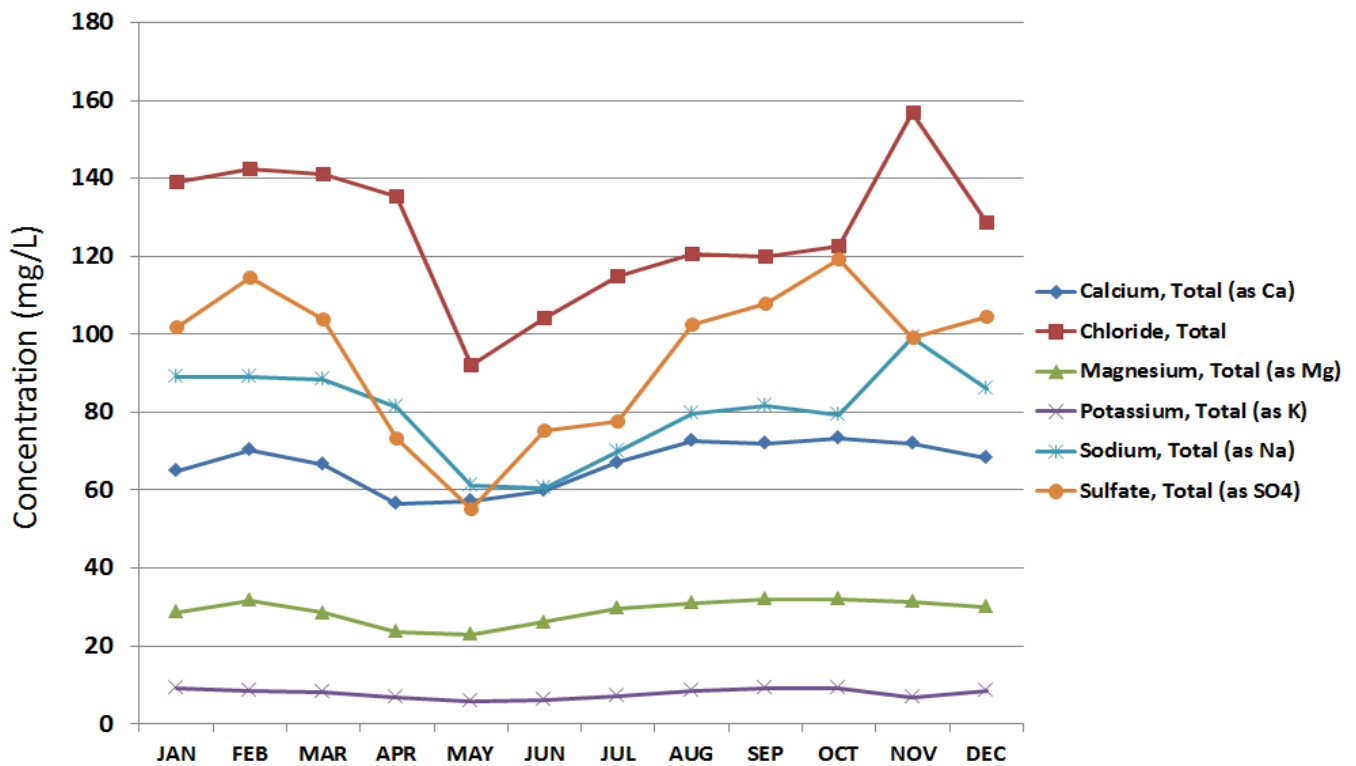
Figure BLANK: Average calendar month maximum concentrations of various parameters measured in the effluent from Hibbing WWTP

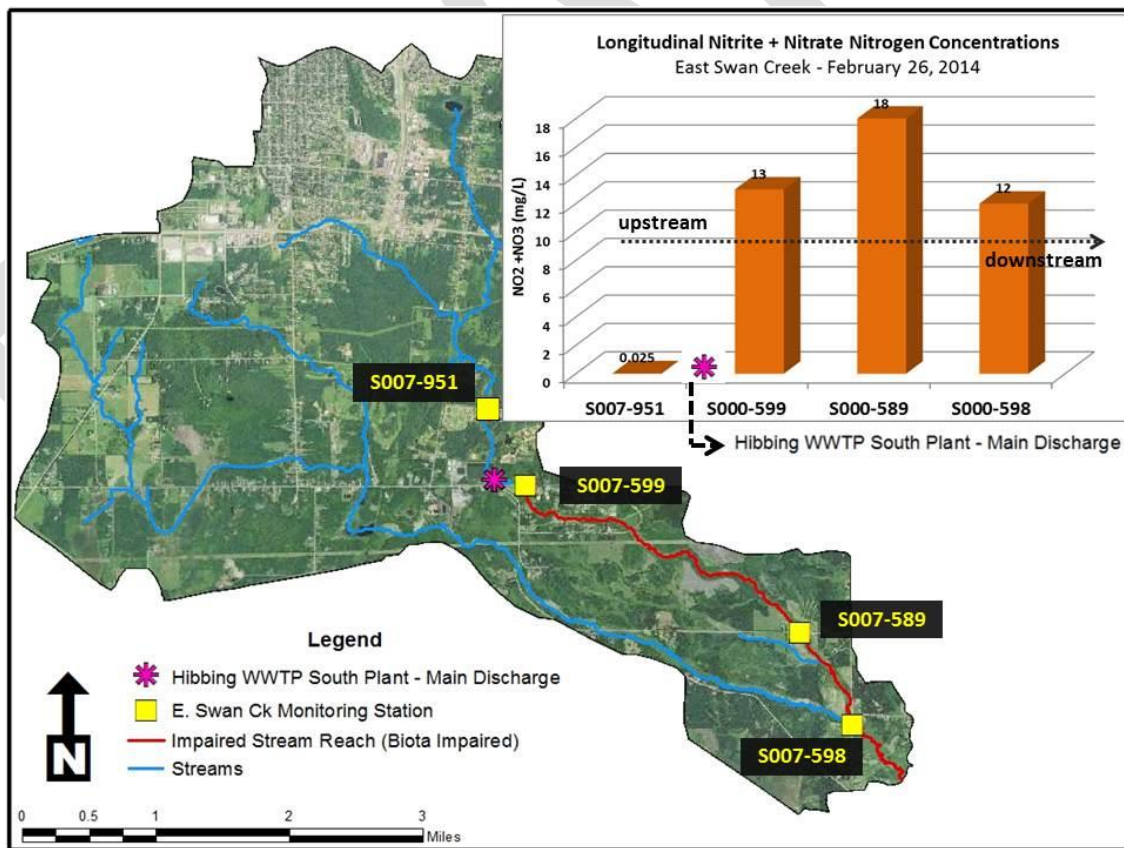
Figure BLANK: Nitrate concentrations observed in East Swan Creek during a February 2014 longitudinal sampling event

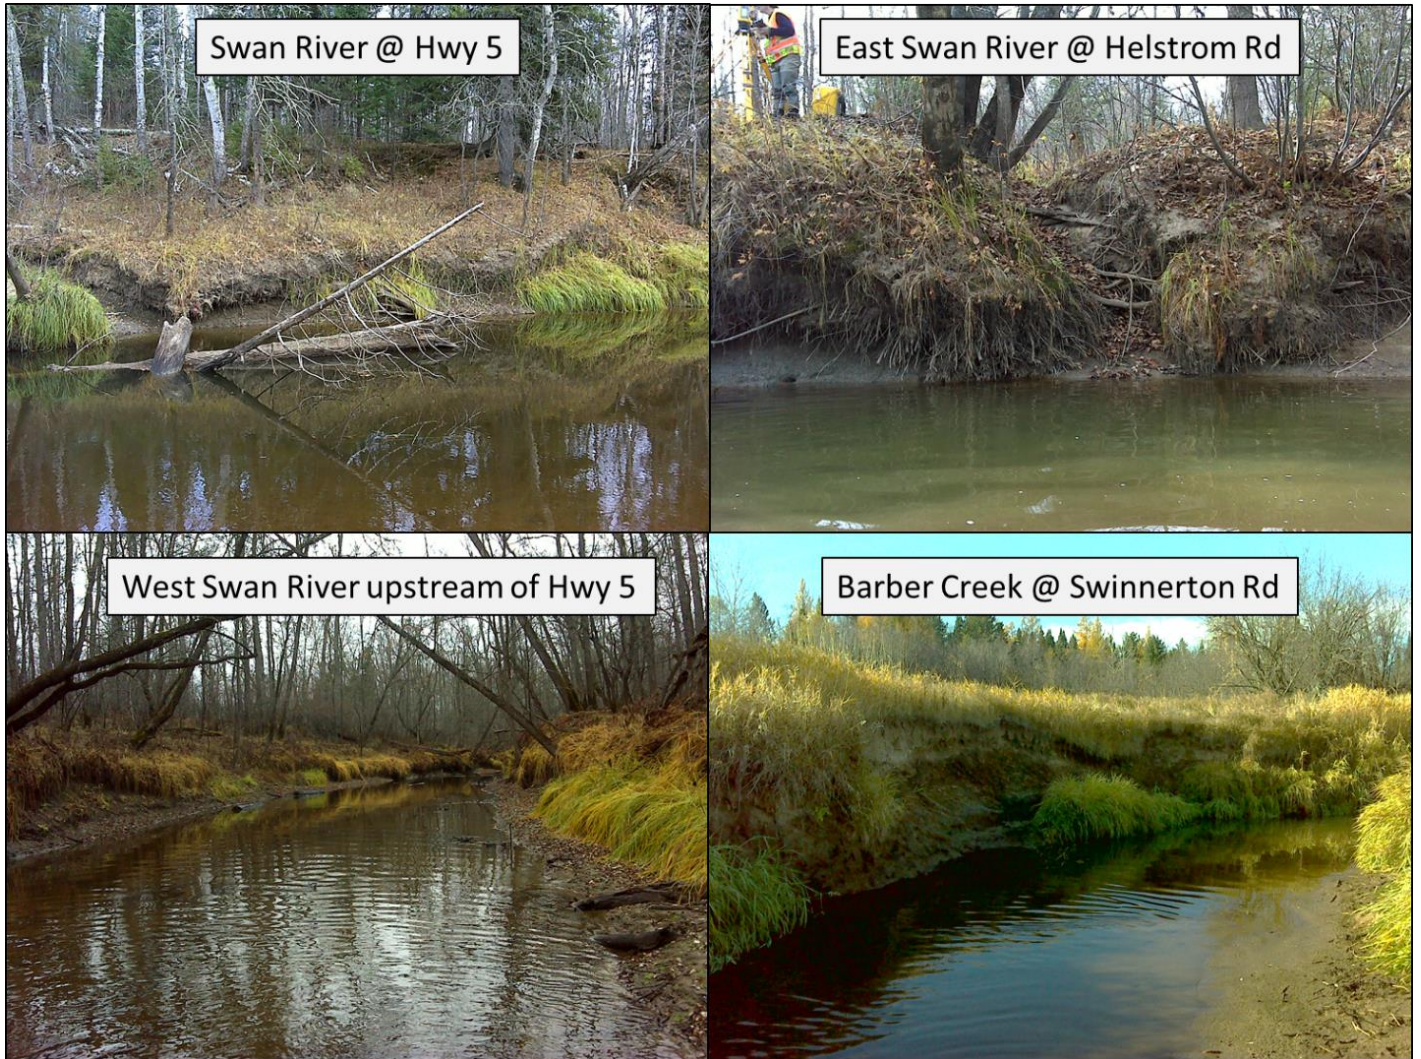
Figure BLANK: Examples of bank erosion and channel instability in the Swan River watershed
