Technical Memorandum

To: Craig Hartmann, Cliffs Erie
From: Kevin Menken and Rachel Walker, Barr Engineering
Subject: Wild Rice Literature Review and 2011 Field Survey for the Dunka Mining Area
Date: December 20, 2011
Project: 23/69-1241

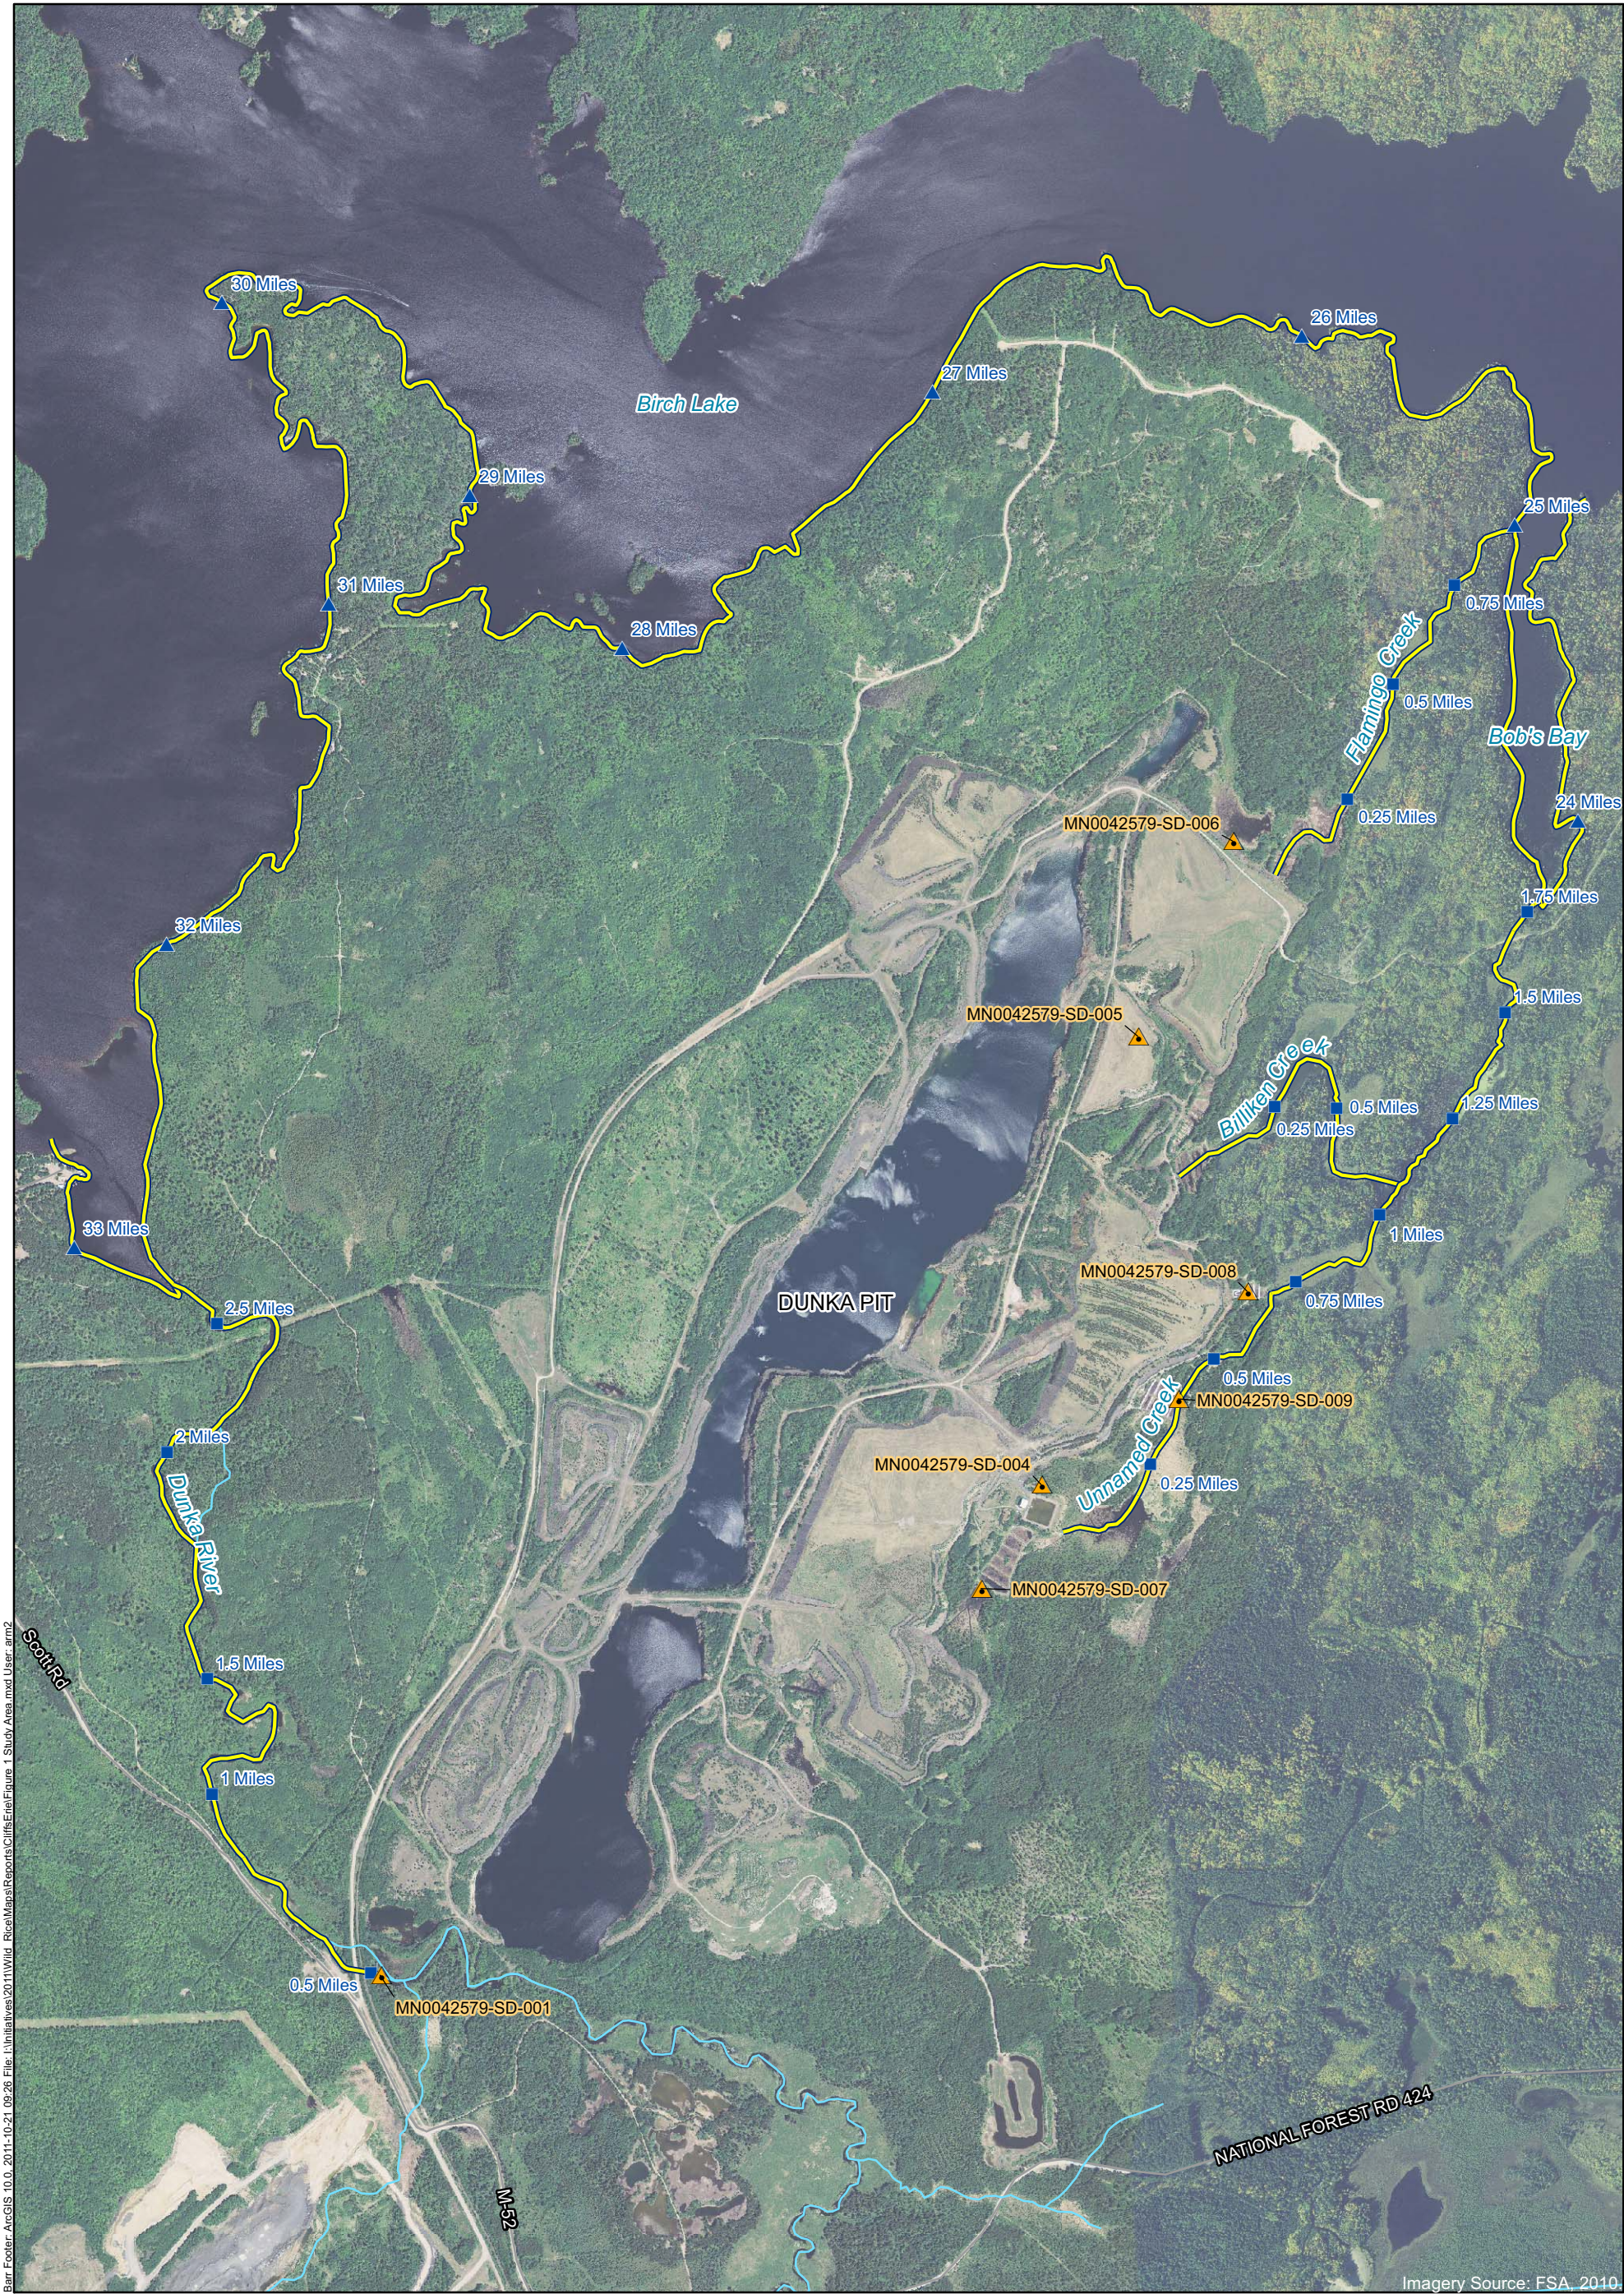
DRAFT
Figure 1
2011 WILD RICE STUDY AREA
Cliffs Erie - Dunka
St. Louis County, MN

These water bodies (shown on Figure 1) make up the Study Area for the literature review and field survey described in this memorandum. The work was conducted by Barr on behalf of Cliffs Erie.

The wild rice survey for Cliffs Erie consisted of evaluating approximately 7 miles of stream and 9 miles of Birch Lake shoreline (Figure 1), as identified by the MPCA, to document the presence or absence of wild rice in the water bodies. The fieldwork was completed between August 15 and August 22, 2011. Birch Lake was surveyed by canoe, and the streams were surveyed either by foot, by kayak, or by examination of aerial photographs combined with visual observations from the nearest accessible locations.

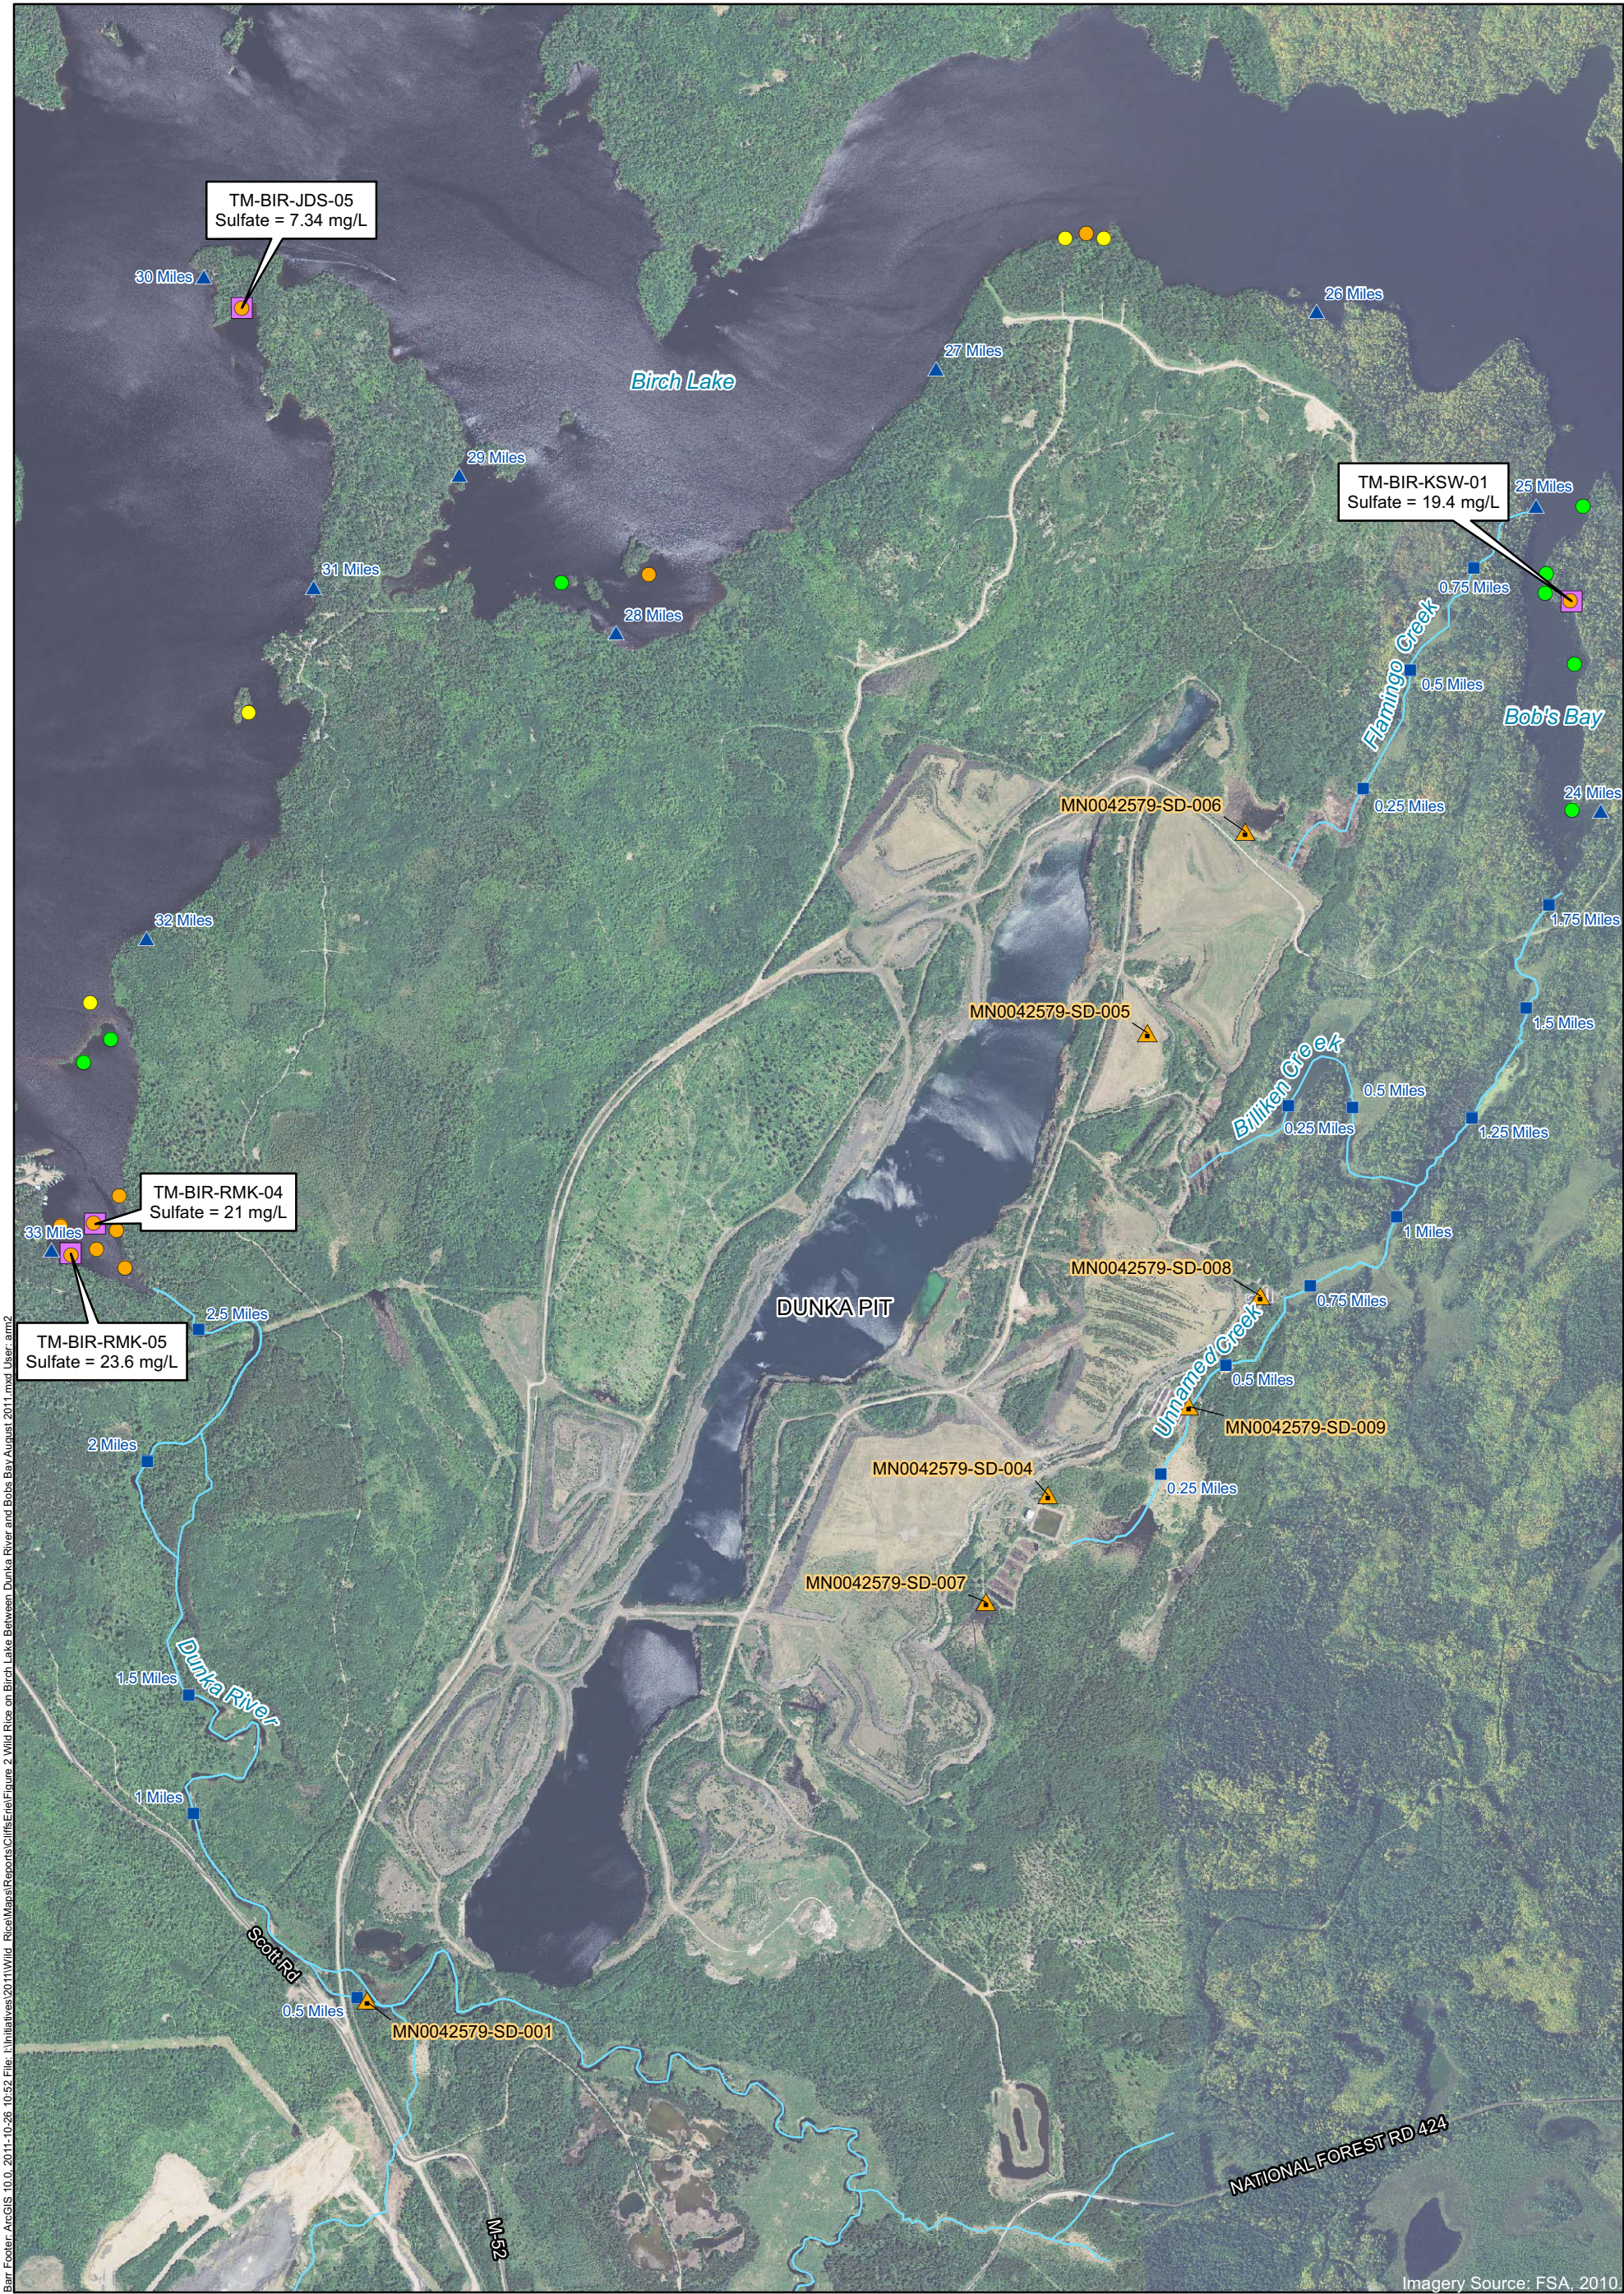
DRAFT
Figure 2
WILD RICE OBSERVED IN STUDY AREA
AUGUST 2011
Cliffs Erie - Dunka
St. Louis County, MN

Sulfate concentrations in water samples collected from Birch Lake during the 2011 survey (Table 3) ranged from 7.34 to 23.6 mg/L. Sulfate concentrations are listed on Figure 2 at the locations where samples were collected.

Wild rice was found with density ratings between 1 and 3 (on a scale of 1 to 5) in Birch Lake (Figures 2 and 3).

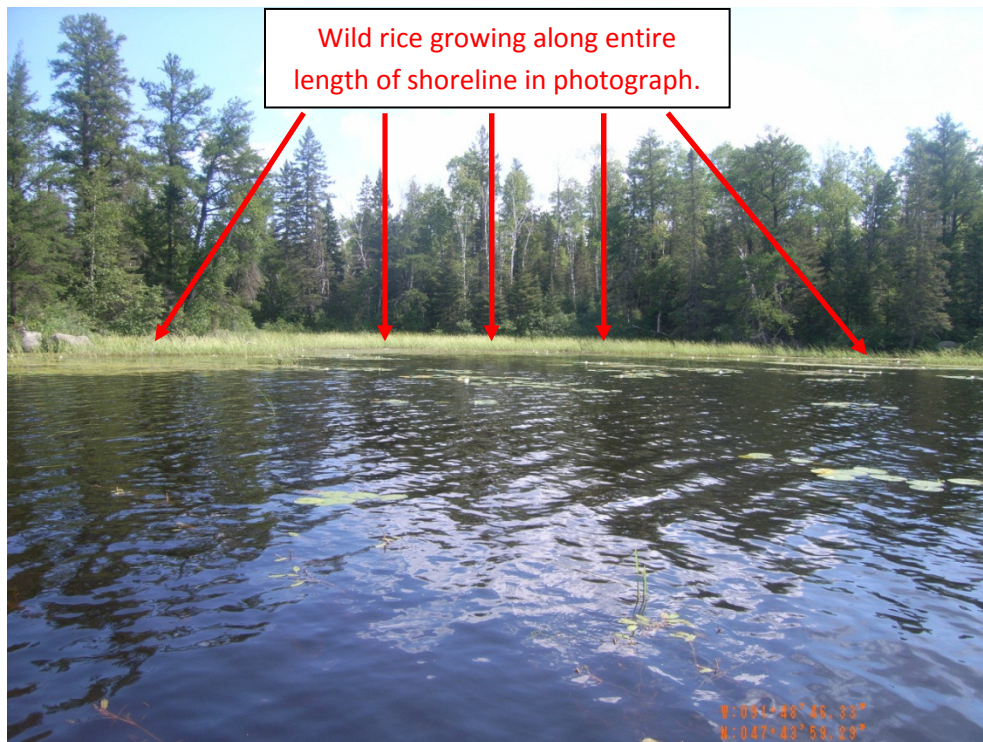
Birch Lake, Bob's Bay, 8/15/2011, wild rice growing along shoreline. Shoreline vegetation is predominantly wild rice. Photo taken at reference location RL4.

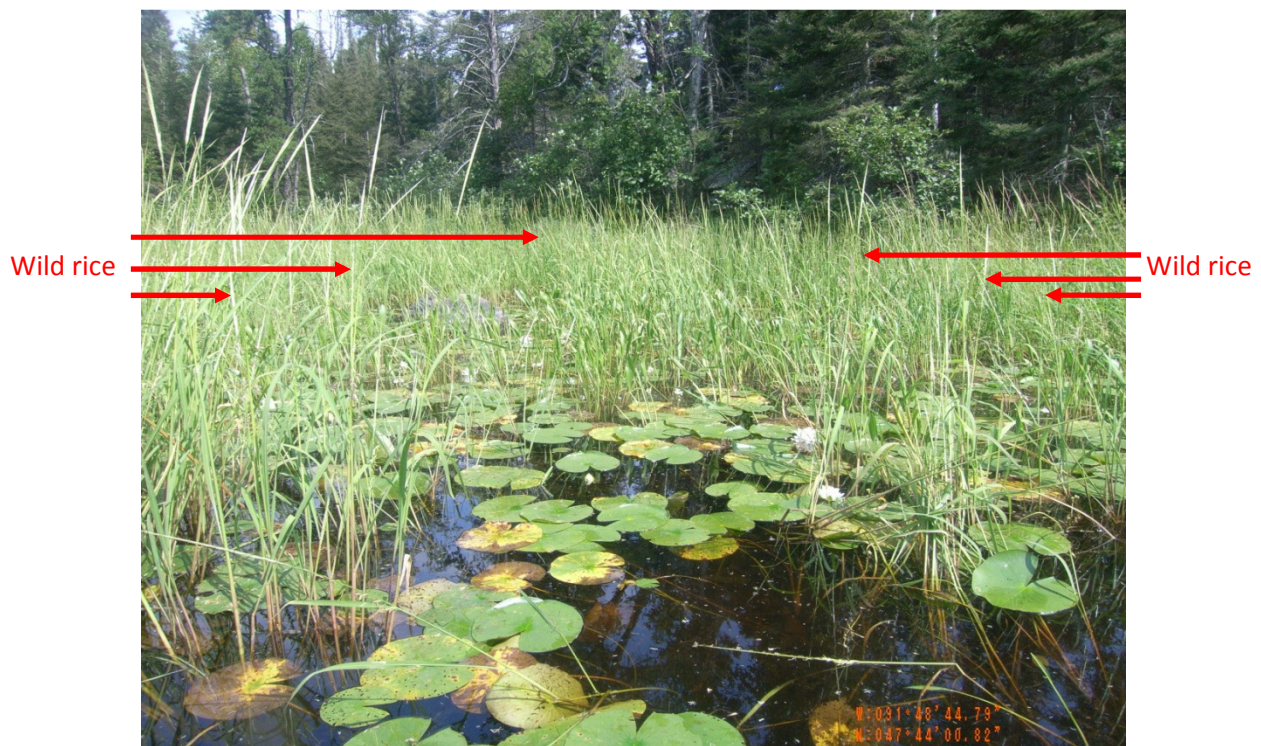
Birch Lake, Bob's Bay, 8/15/2011, wild rice and lily pads. Emergent vegetation is predominantly wild rice. Photo taken at reference location RL4.

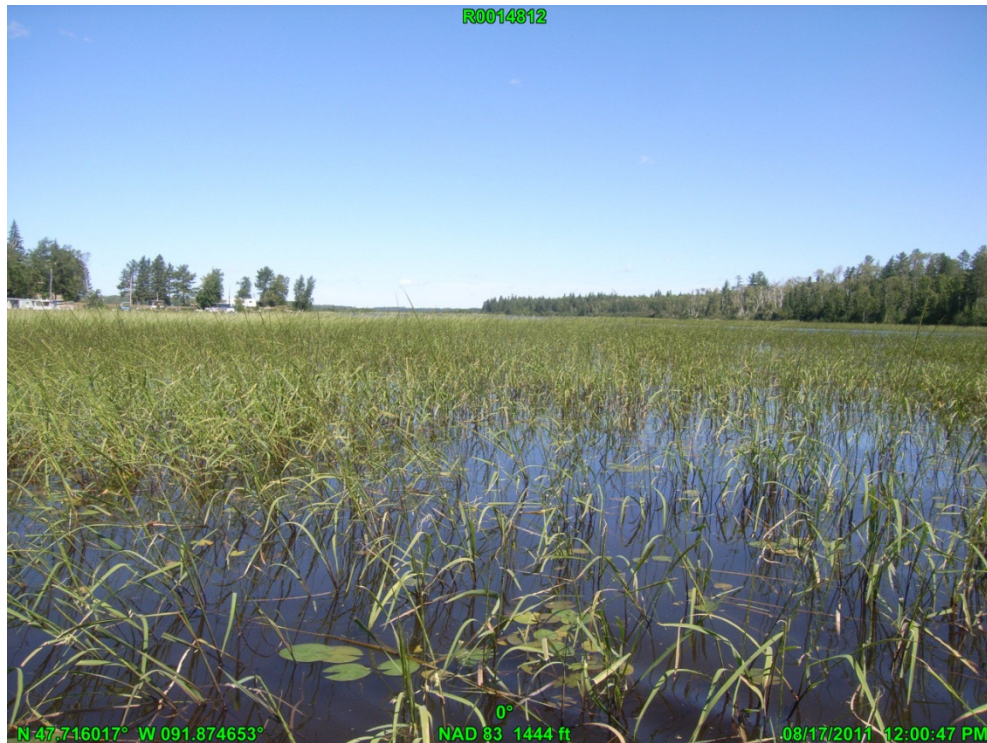
Birch Lake, 8/17/2011, wild rice near Dunka River outlet, facing north. Vegetation in photograph is predominantly wild rice. Photo taken at reference location RL18.

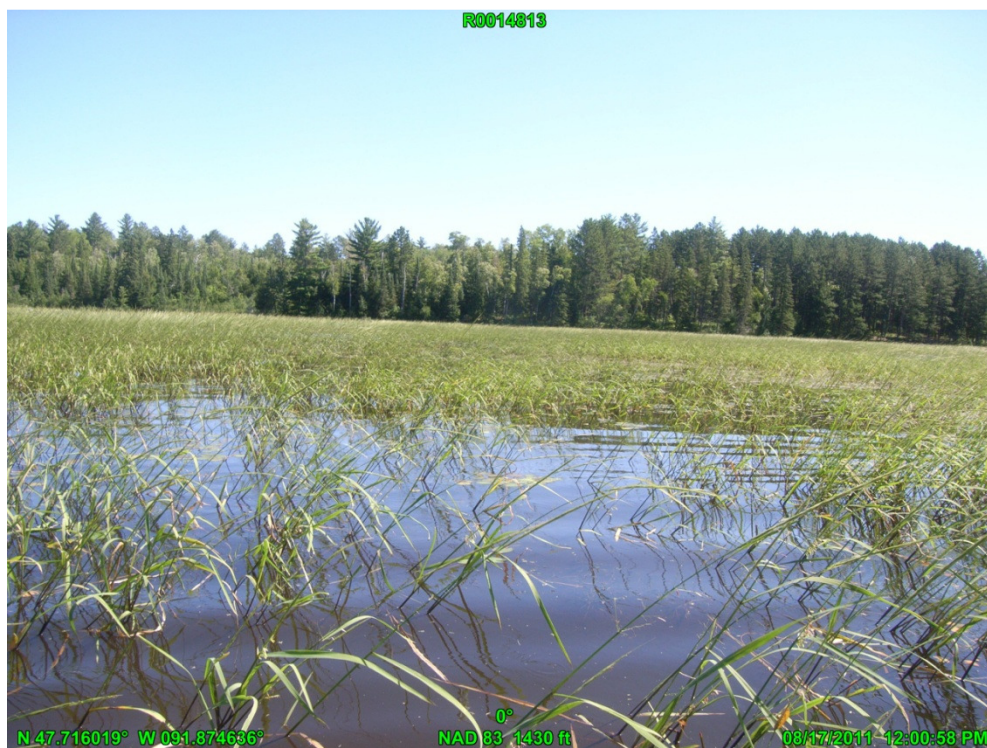
Birch Lake, 8/17/2011, wild rice near Dunka River outlet, facing east. Vegetation in photograph is predominantly wild rice. Photo taken at reference location RL18.

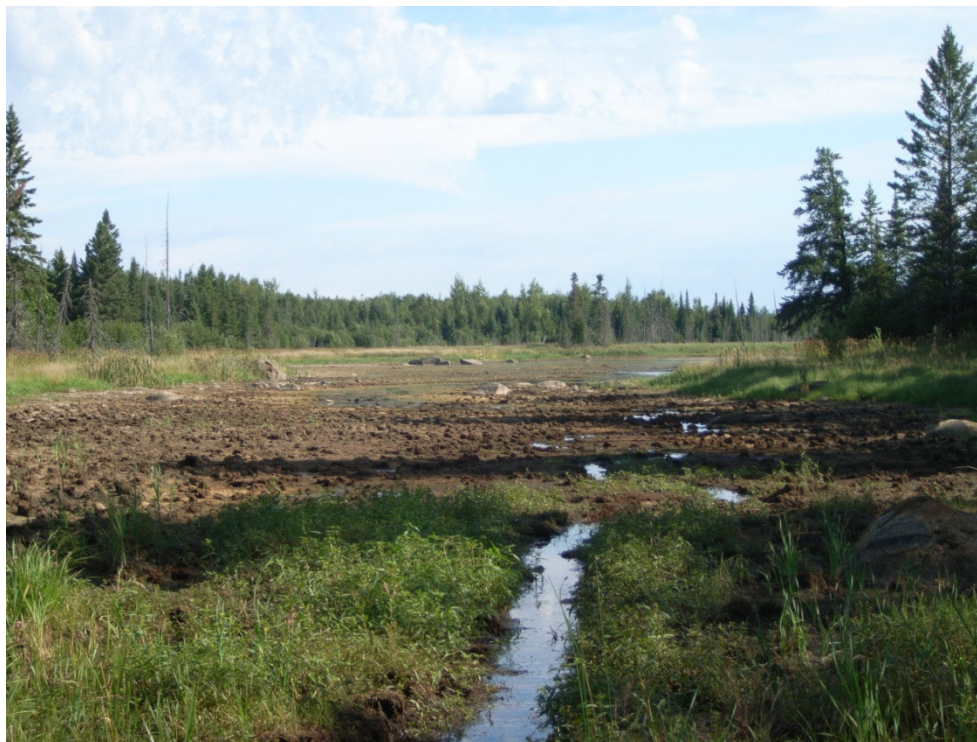
Mile 0.0 to Mile 0.25 was surveyed while walking (and dragging the kayak) in the creek channel or alongside the channel. The channel was initially dominated by a dense stand of *Typha* spp. and then transitioned to an open area with a wet, exposed, mucky substrate. Little or no surface water was present in the *Typha* spp. stand. There was up to 6 inches of water in the creek channel in the open area. Channel vegetation was initially dominated by *Typha* spp. and transitioned to a mix of *Typha* spp., *Carex* spp. and *Calamagrostis canadensis*.

Billiken Creek, 8/22/2011, looking northeast towards Mile 0.25 – no wild rice

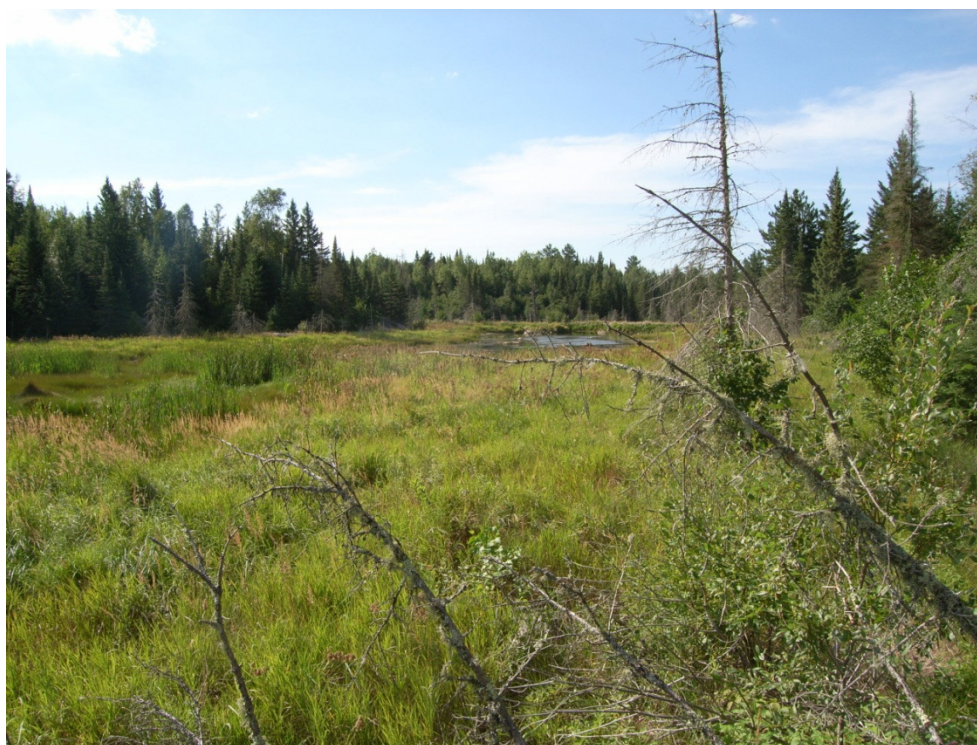
Billiken Creek, 8/22/2011, near Mile 0.5 – no wild rice

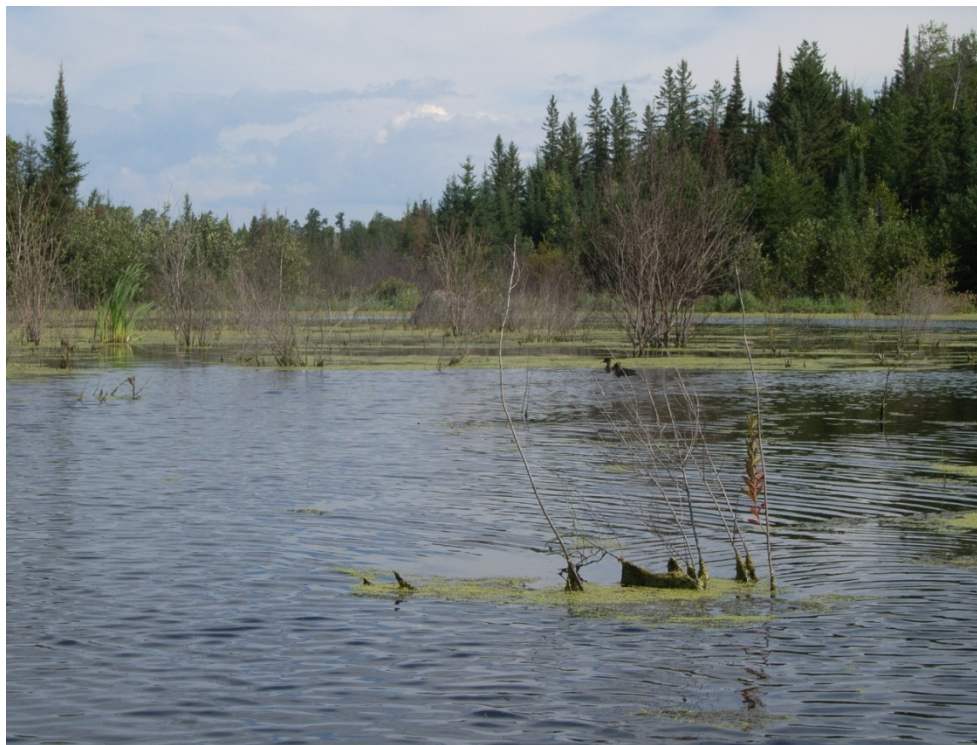
Mile 1.0 to 1.4 was surveyed by kayaking through open water and dragging the kayaks over multiple beaver dams. Water ponded behind the beaver dams was 2 to 5 feet deep. The ponds were up to 200 feet in width. Dead *Alnus* spp. was found throughout these ponded areas with scattered dead *Picea mariana* and *Larix laricina* also observed. In some areas, the surface of the water was either covered with 1 to 3 inches of *Lemna* spp. or the water was covered by dense mats of aquatic vegetation. The shoreline of the ponded areas was generally rocky. Vegetation along the shoreline included *Calamagrostis canadensis*, *Alnus* spp., and conifers, which shaded the edge of the water.

Unnamed Creek, 8/22/2011, between Mile 1.0 and 1.5 – no wild rice

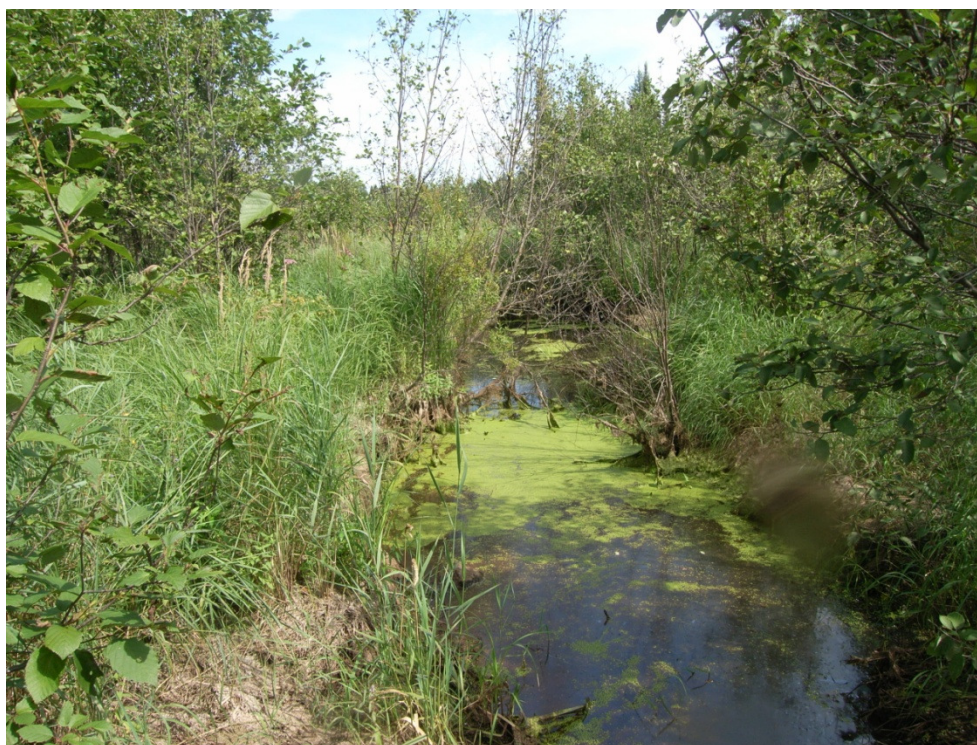
Unnamed Creek, 8/22/2011, north of Mile 1.5 – no wild rice

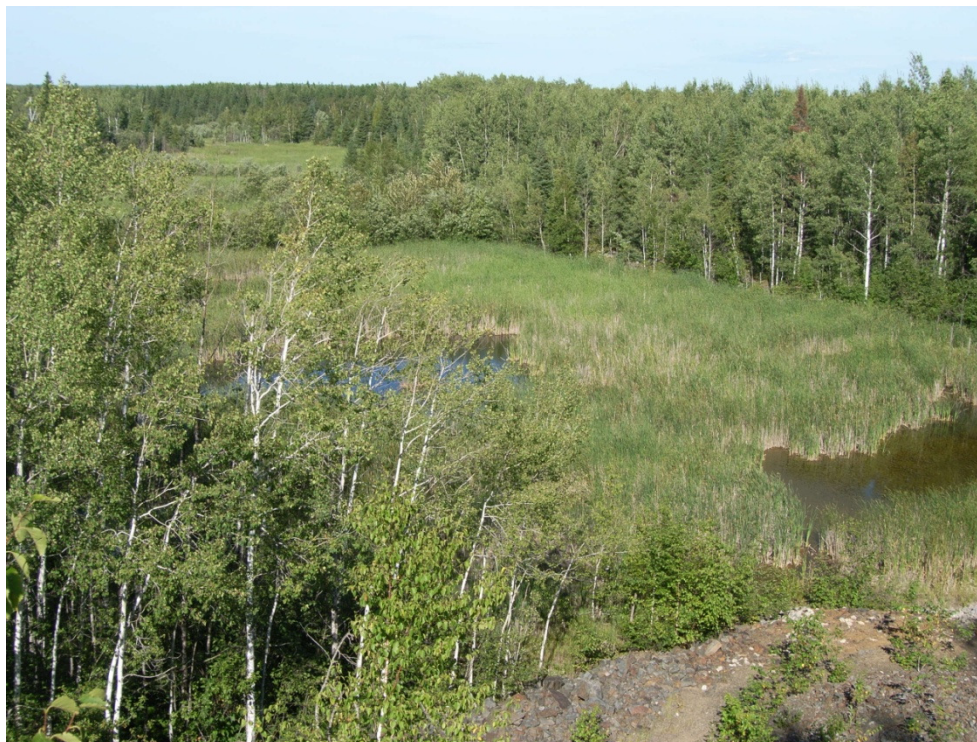
Mile 0.0 to 0.3 was analyzed by visual observation from an overlook above Mile 0.0 and an overlook at Mile 0.3. There is no defined creek channel or observed surface water flow in this reach. The creek is located within a 200-foot wide wetland complex from Mile 0.00 to Mile 0.25, with small shallow, open water areas. The wetland is dominated by a dense stand of *Typha* spp. with some areas of *Alnus* spp. The dominant tree species along the edge of the wetland included *Populus tremuloides* and other deciduous trees.

Flamingo Creek, 8/22/2011, looking north from Mile 0.0 – no wild rice

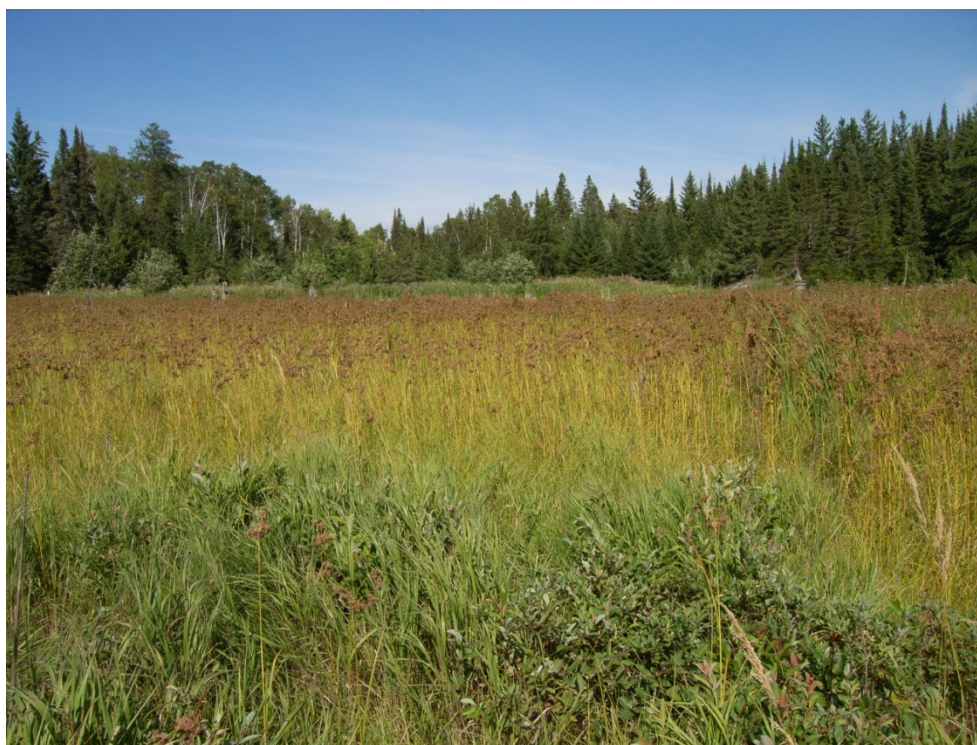
Flamingo Creek, 8/22/2011, looking south just past Mile 0.5 – no wild rice

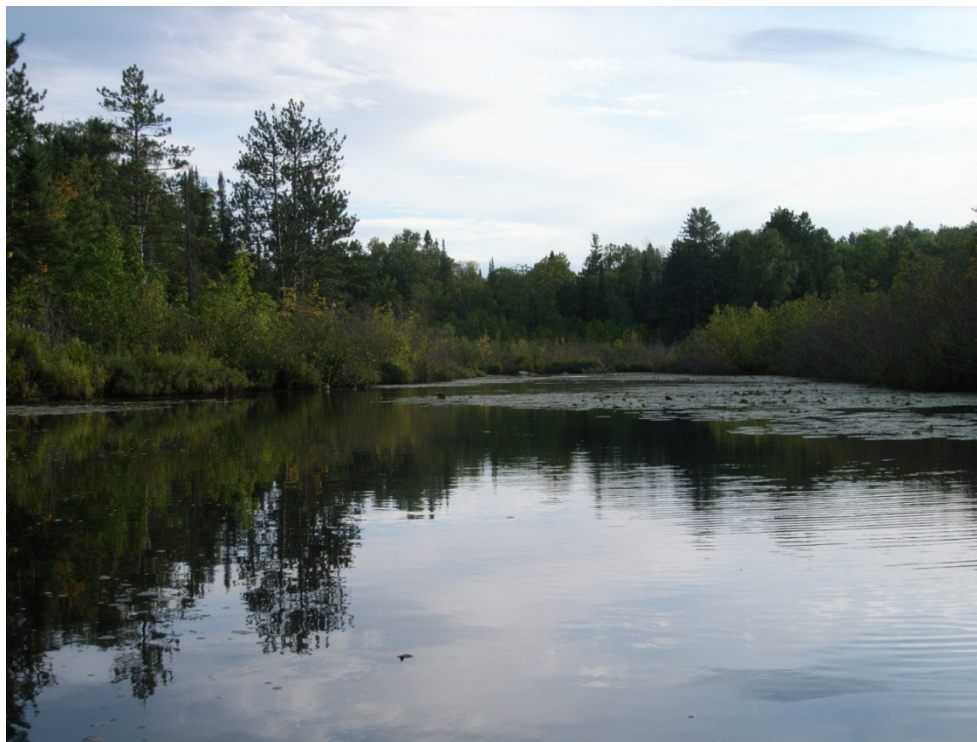
Mile 0.5 to approximately Mile 0.8 was surveyed by kayak. At Mile 0.5, the river channel passes through two large culverts. East of the culverts, the stream channel ranged from 30 to 40 feet in width. At approximately Mile 0.55, a trail crossed the channel where the substrate was comprised of shifting, fine sand and the stream was 4 to 6 inches deep. Signs of ATV traffic were present in the area and included tracks in the stream channel and trails on the shoreline. West of the trail crossing, the river channel was 2

Dunka River, 8/30/2011, upstream from culverts at Mile 0.5 – no wild rice

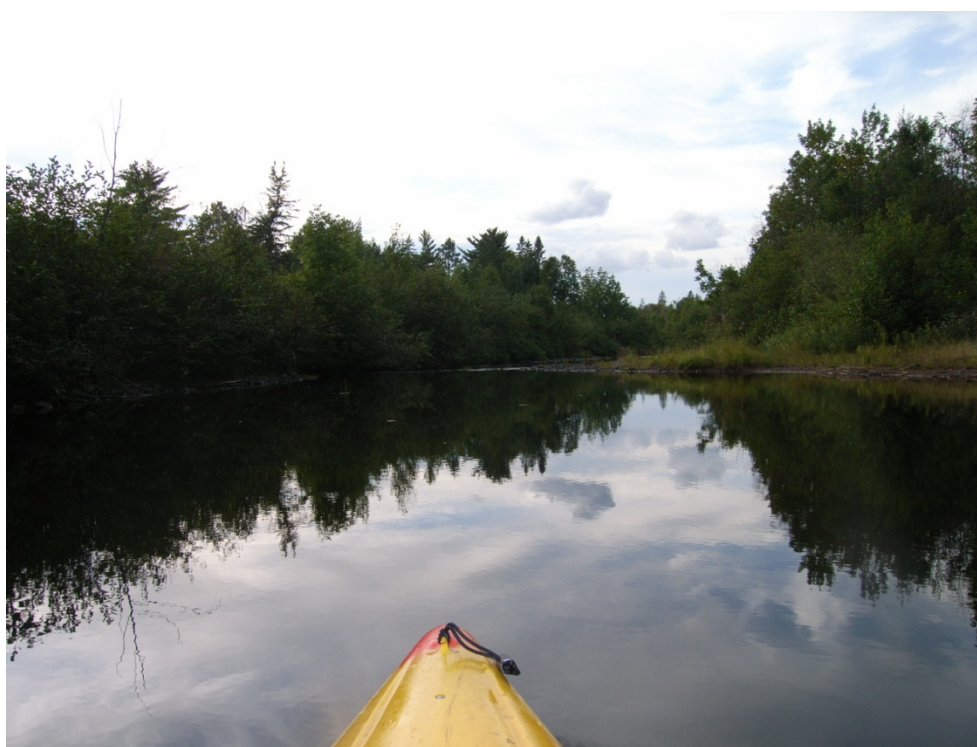
Dunka River, 8/30/2011, downstream from culverts at Mile 0.5 – no wild rice
