**Re: Wild Rice and Sulfate Water Quality Data Submittal
U. S. Steel – Keetac Expansion Project and Perry Pit NPDES Permit Application
Keewatin, Minnesota**

***2009 Water Quality, Hydrology, and Wild Rice
Monitoring***

Mesabi Nugget Phase II Project

***Prepared for
Steel Dynamics, Inc.
Mesabi Mining, LLC***

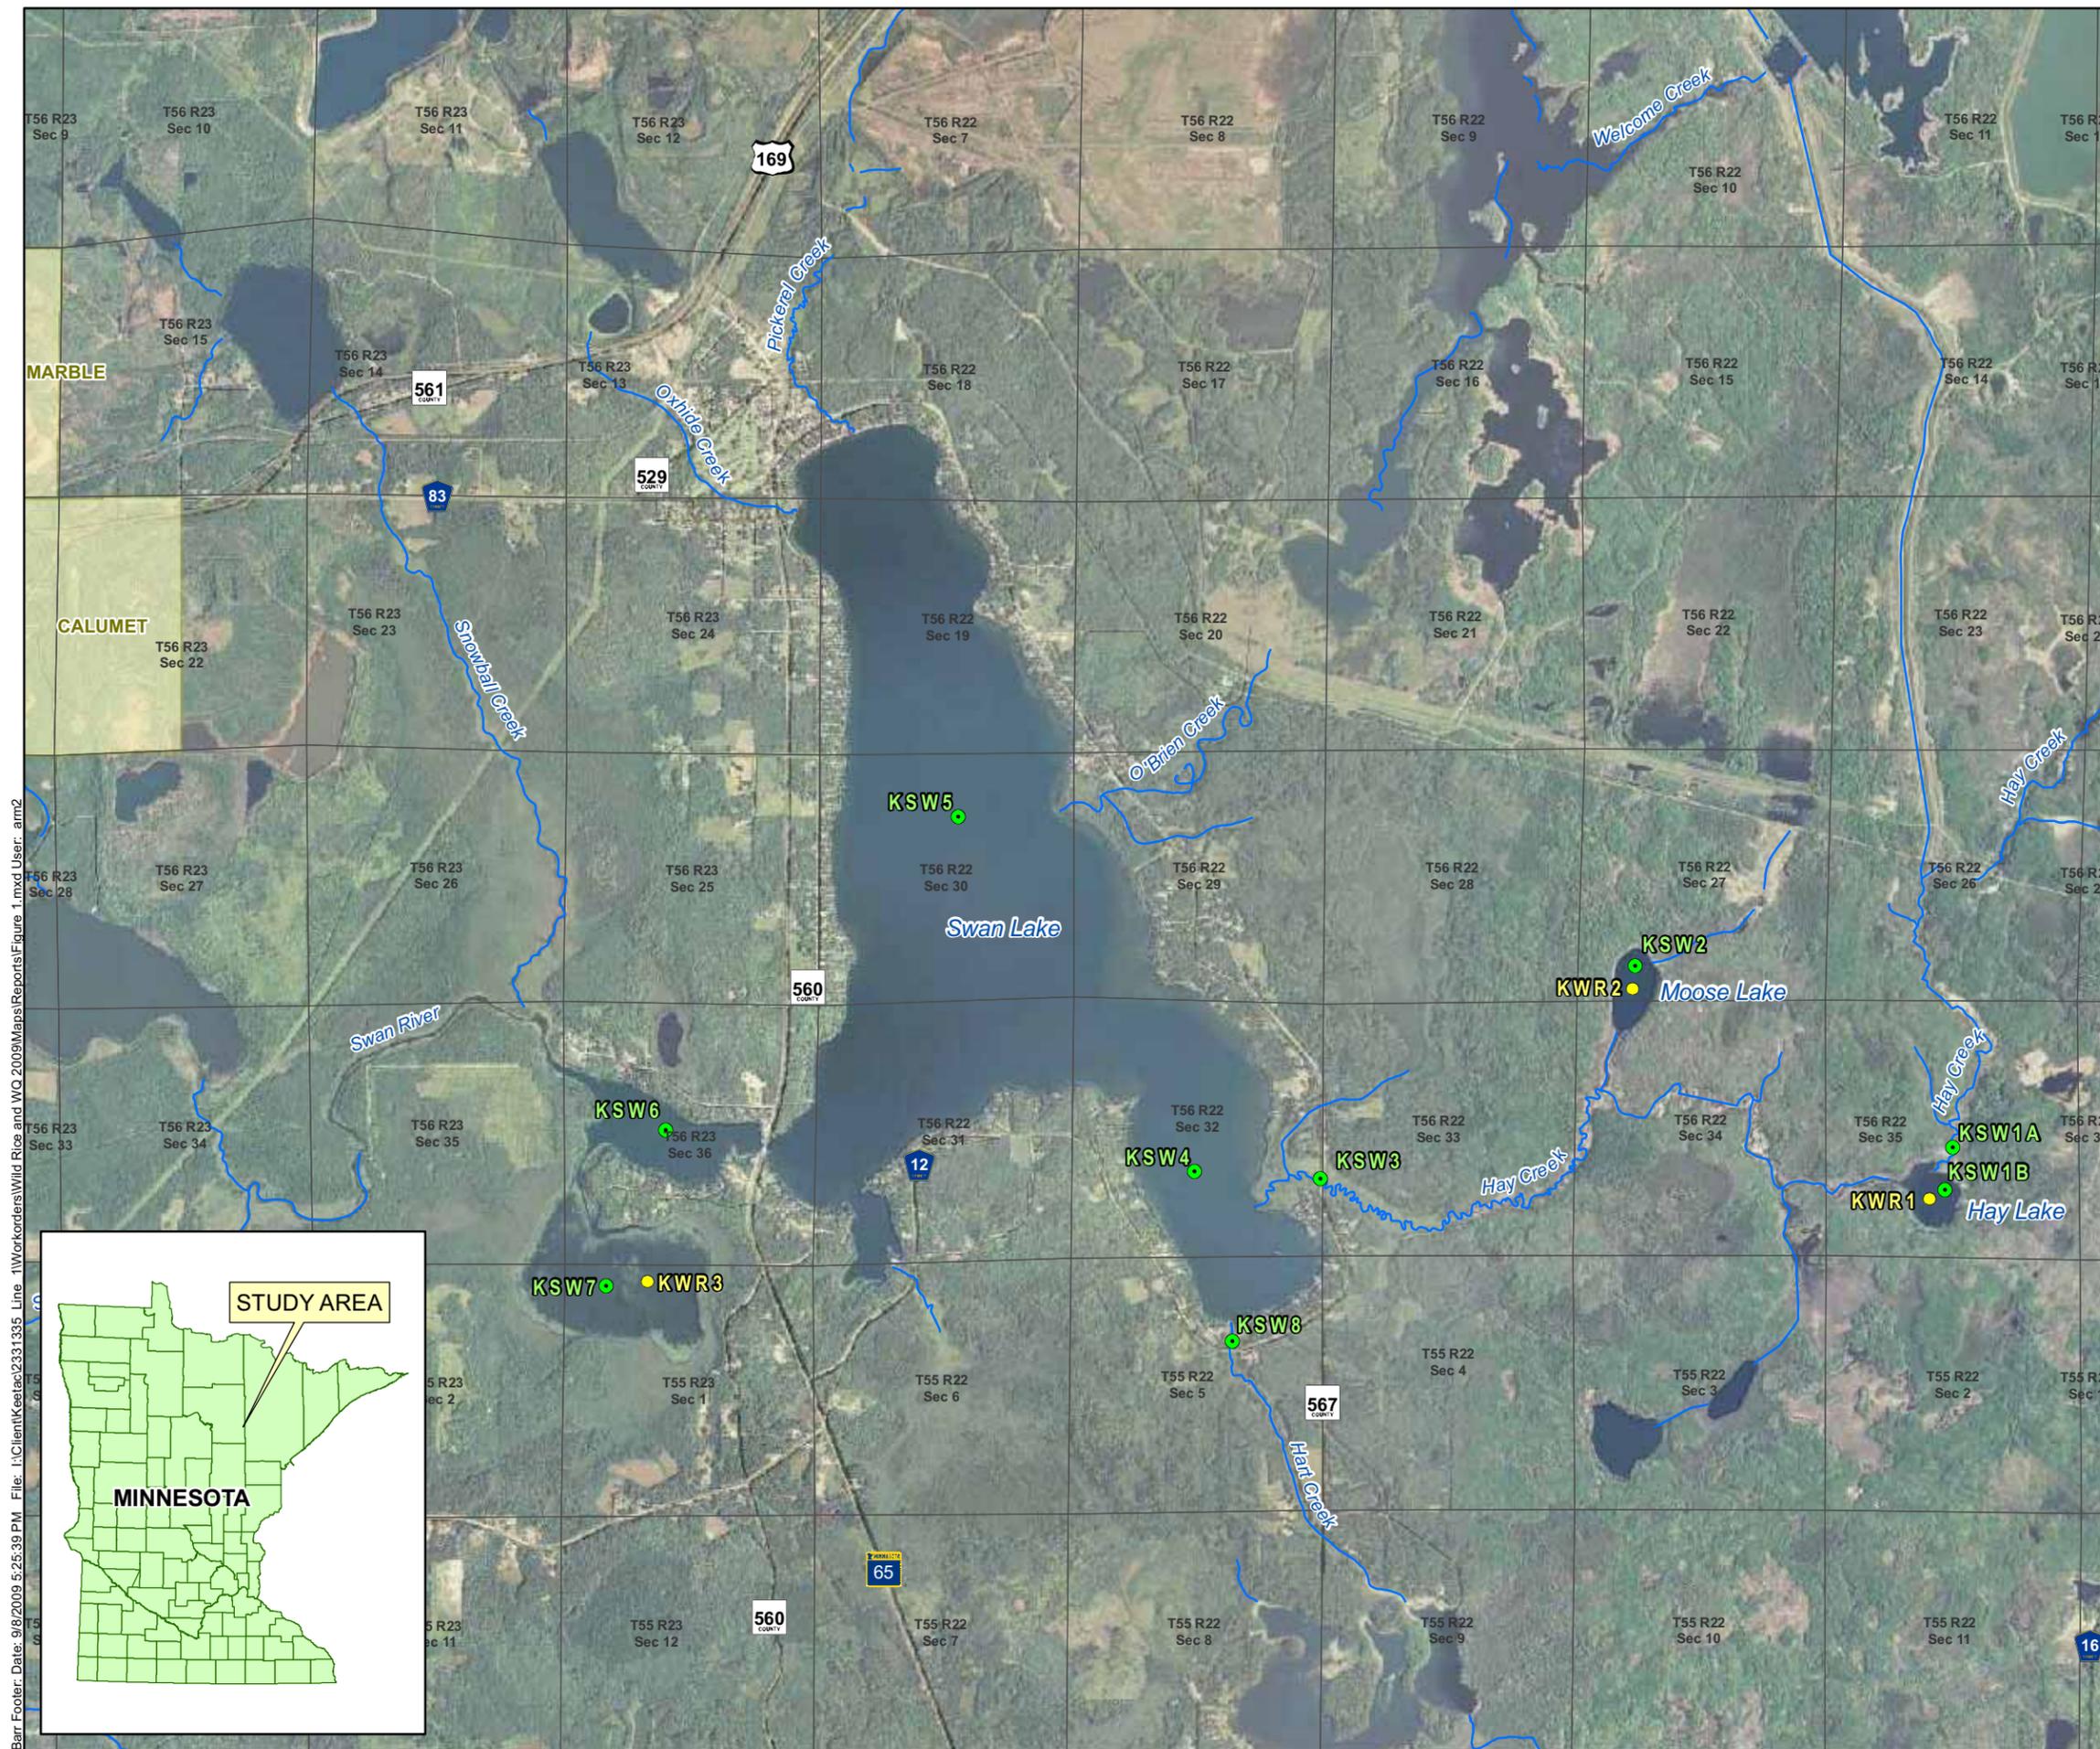
Figure 1
 2009 WATER QUALITY AND
 WILD RICE MONITORING LOCATIONS
 Keetac Expansion Project
 U. S. Steel Corp
 Keewatin, Minnesota

- Wild Rice Survey Location
 - Water Quality Monitoring Location
 - ~ Stream/River
 - Sections Boundaries
 - City Boundaries
- Imagery Source: FSA, 2008

The water quality monitoring locations are identified in [Figure 1](#). The water discharges from the Keetac facility all end up flowing into Hay Creek upstream of Hay Lake. Hay Creek flows through Hay Lake and eventually discharges to the southeast corner of Swan Lake. Swan Lake discharges to the Swan River west of monitoring location KSW6. Monitoring location KSW7 is located in a shallow (approximately 2- to 3-feet deep) unnamed bay at the southwest corner of Swan Lake near the outlet to the Swan River. The bay, further referred to in this report as Swan Lake Southwest Bay, is attached to the main body of Swan Lake by a small channel. There are no other substantial inlets or outlets to Swan Lake Southwest Bay.

Hydrologic monitoring was conducted in Hay Creek upstream of Hay Lake (KSW1A) and Hay Creek upstream of Swan Lake (KSW3), as identified on [Figure 1](#). Additionally, water levels in Hay Lake were monitored.

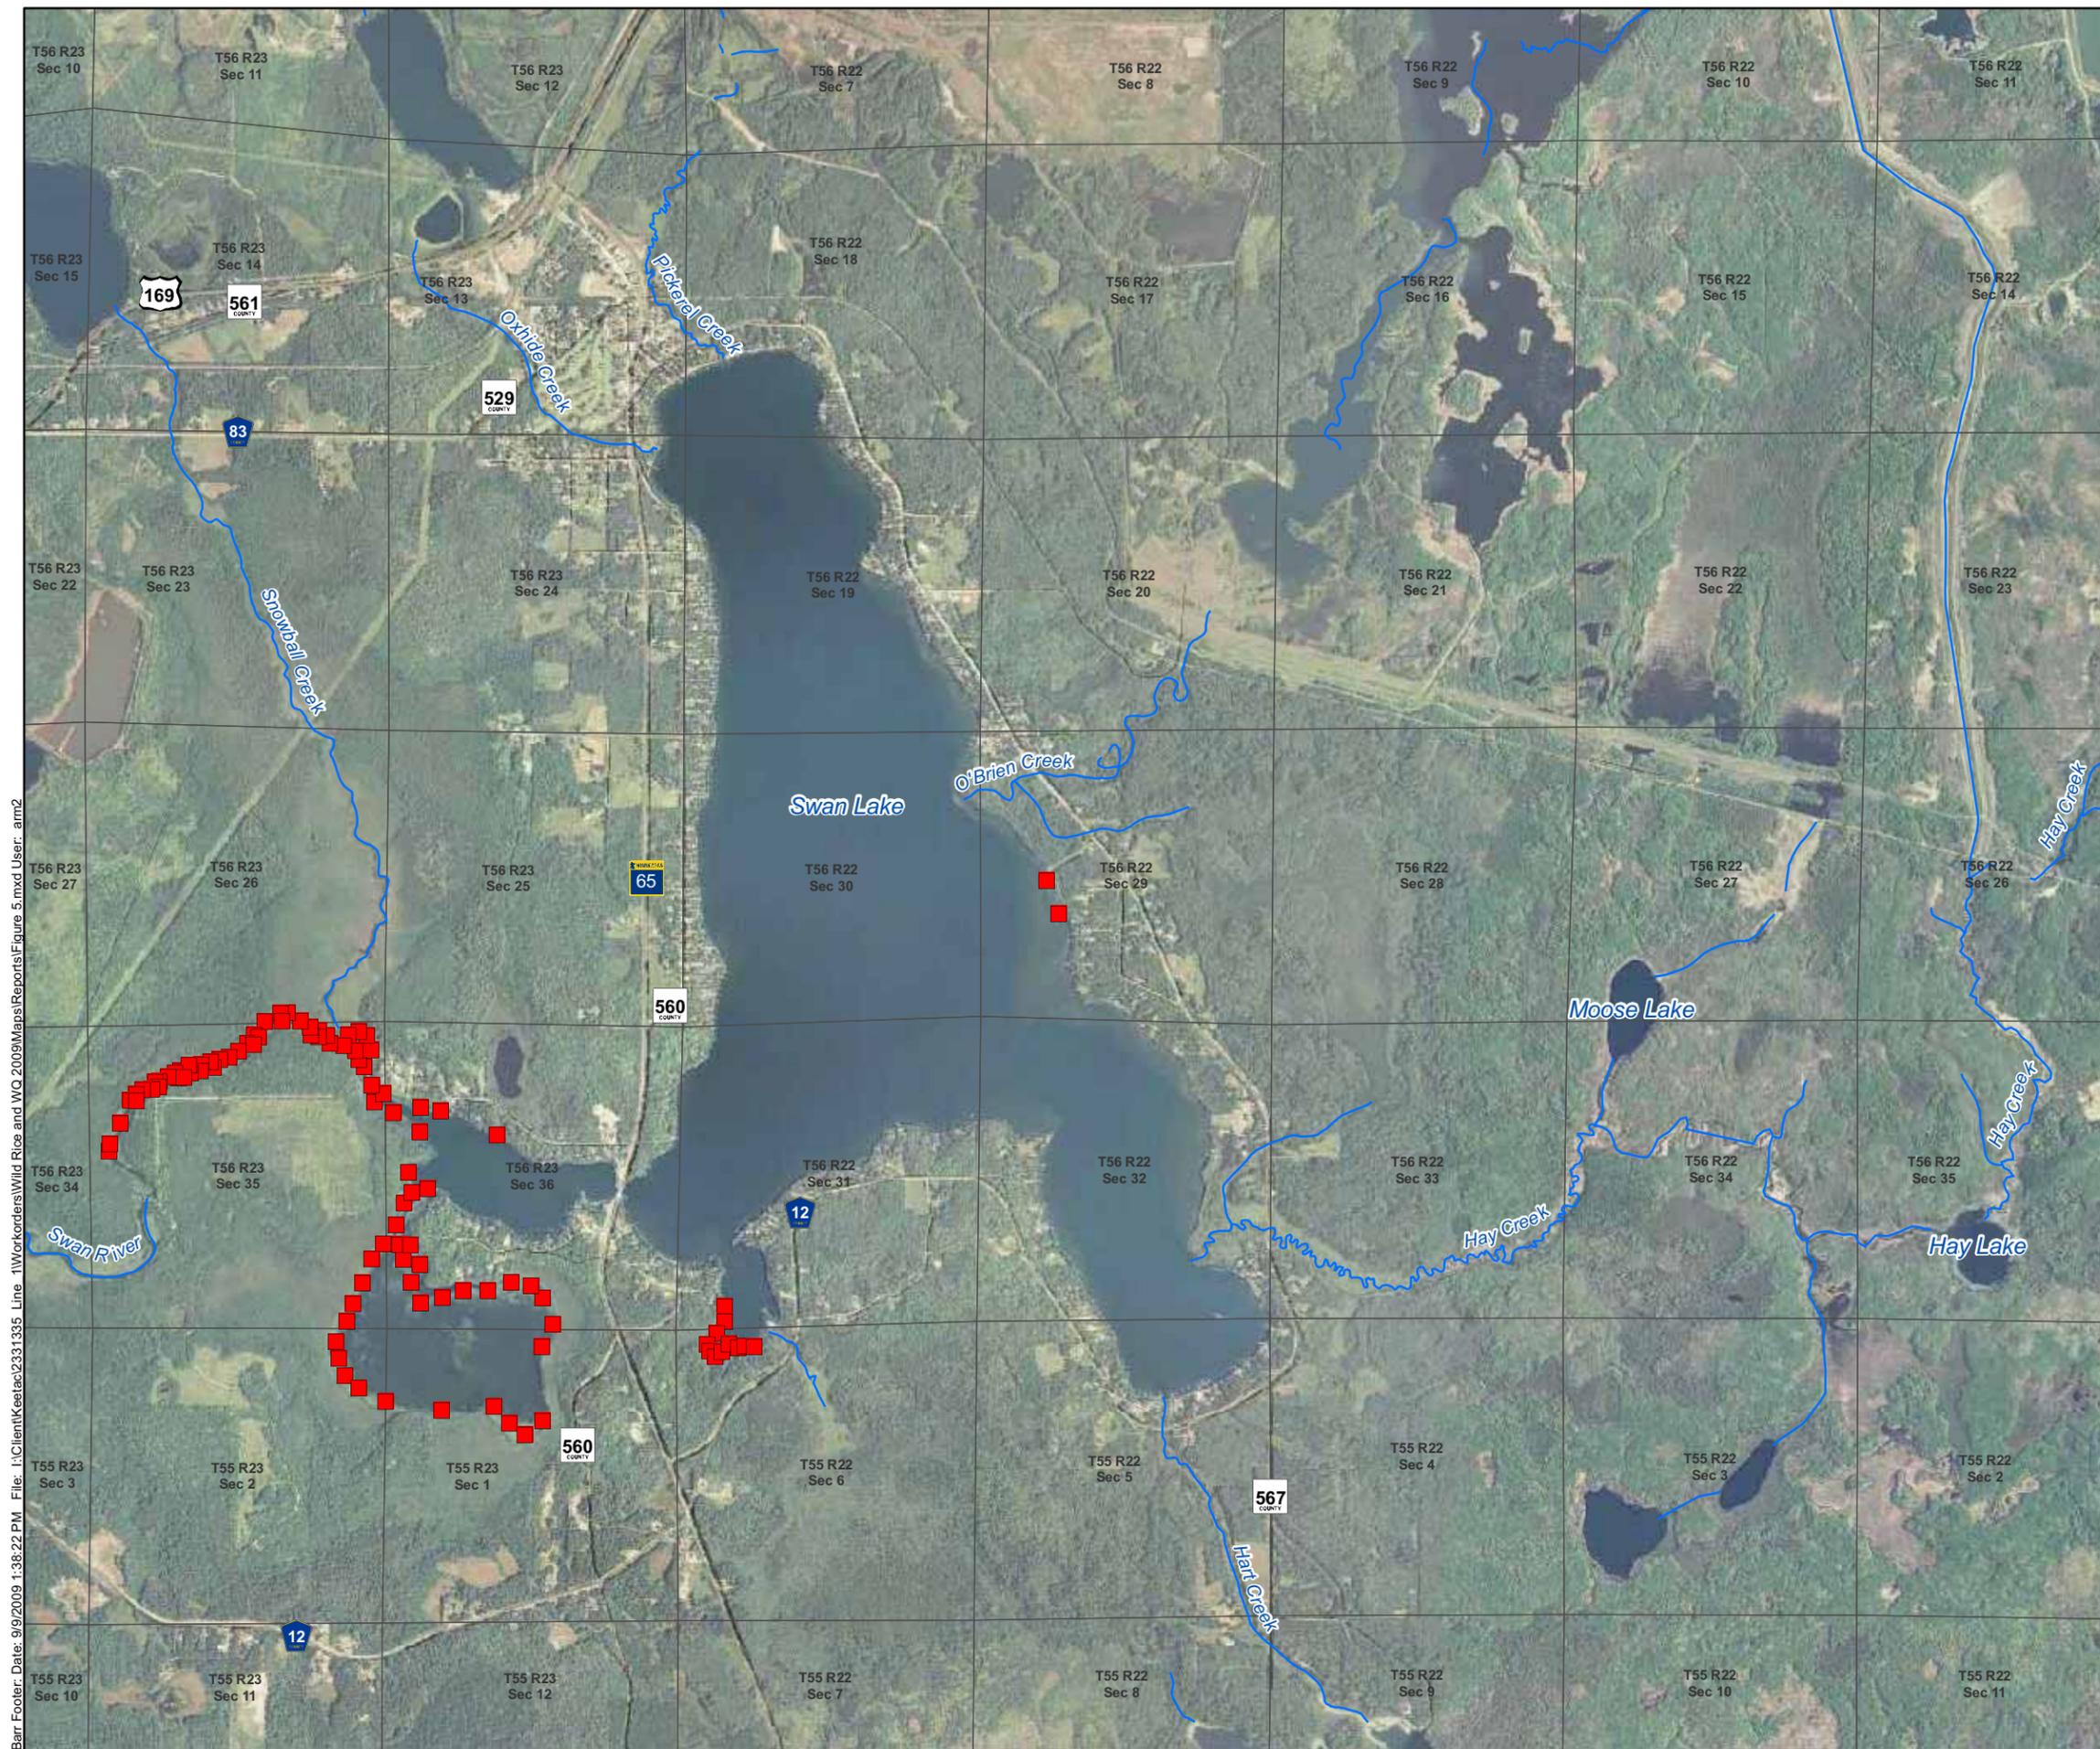
Figure 5
 POTENTIAL WILD RICE USGS PHOTOGRAPHIC
 SURVEY RESULTS, AUGUST 2008
 Keetac Expansion Project
 U. S. Steel Corp
 Keewatin, Minnesota

■ Potential Wild Rice Location - 2008
— Stream/River
 Sections Boundaries
 Imagery Source: FSA, 2008.

The potential presence of wild rice identified from the historic aerial photographic imagery analysis is marked with red dots (2008 photos) and pink squares (2004 photos) (Figure 5). This method of identification did not include any estimates for bed size, overall acreage, or density. The 2004 NAIP aerial imagery for Swan Lake, Moose Lake, and Hay Lake were acquired during the period of June 10-19, 2004. The 2008 NAIP aerial imagery for Swan Lake was taken August 9, 2008, while the imagery for Moose Lake and Hay Lake were taken June 1, 2008. Wild rice does not typically begin to emerge above the water level until July in the project area. Therefore, only the 2008 NAIP aerial image for Swan Lake was suitable for identifying wild rice. Upon analyzing the 2008 NAIP imagery, the USGS identified wild rice along much of the perimeter of the Swan Lake Southwest Bay as well as along the channel connecting the bay to the main body of Swan Lake and Swan River flowing out of Swan Lake (Figure 5). Wild rice was not identified on either Moose or Hay Lakes in the aerial photography. Since the aerial imagery for Moose and Hay Lakes were acquired in early June in both 2004 and 2008, wild rice could not be identified by analysis of historic aerial imagery.

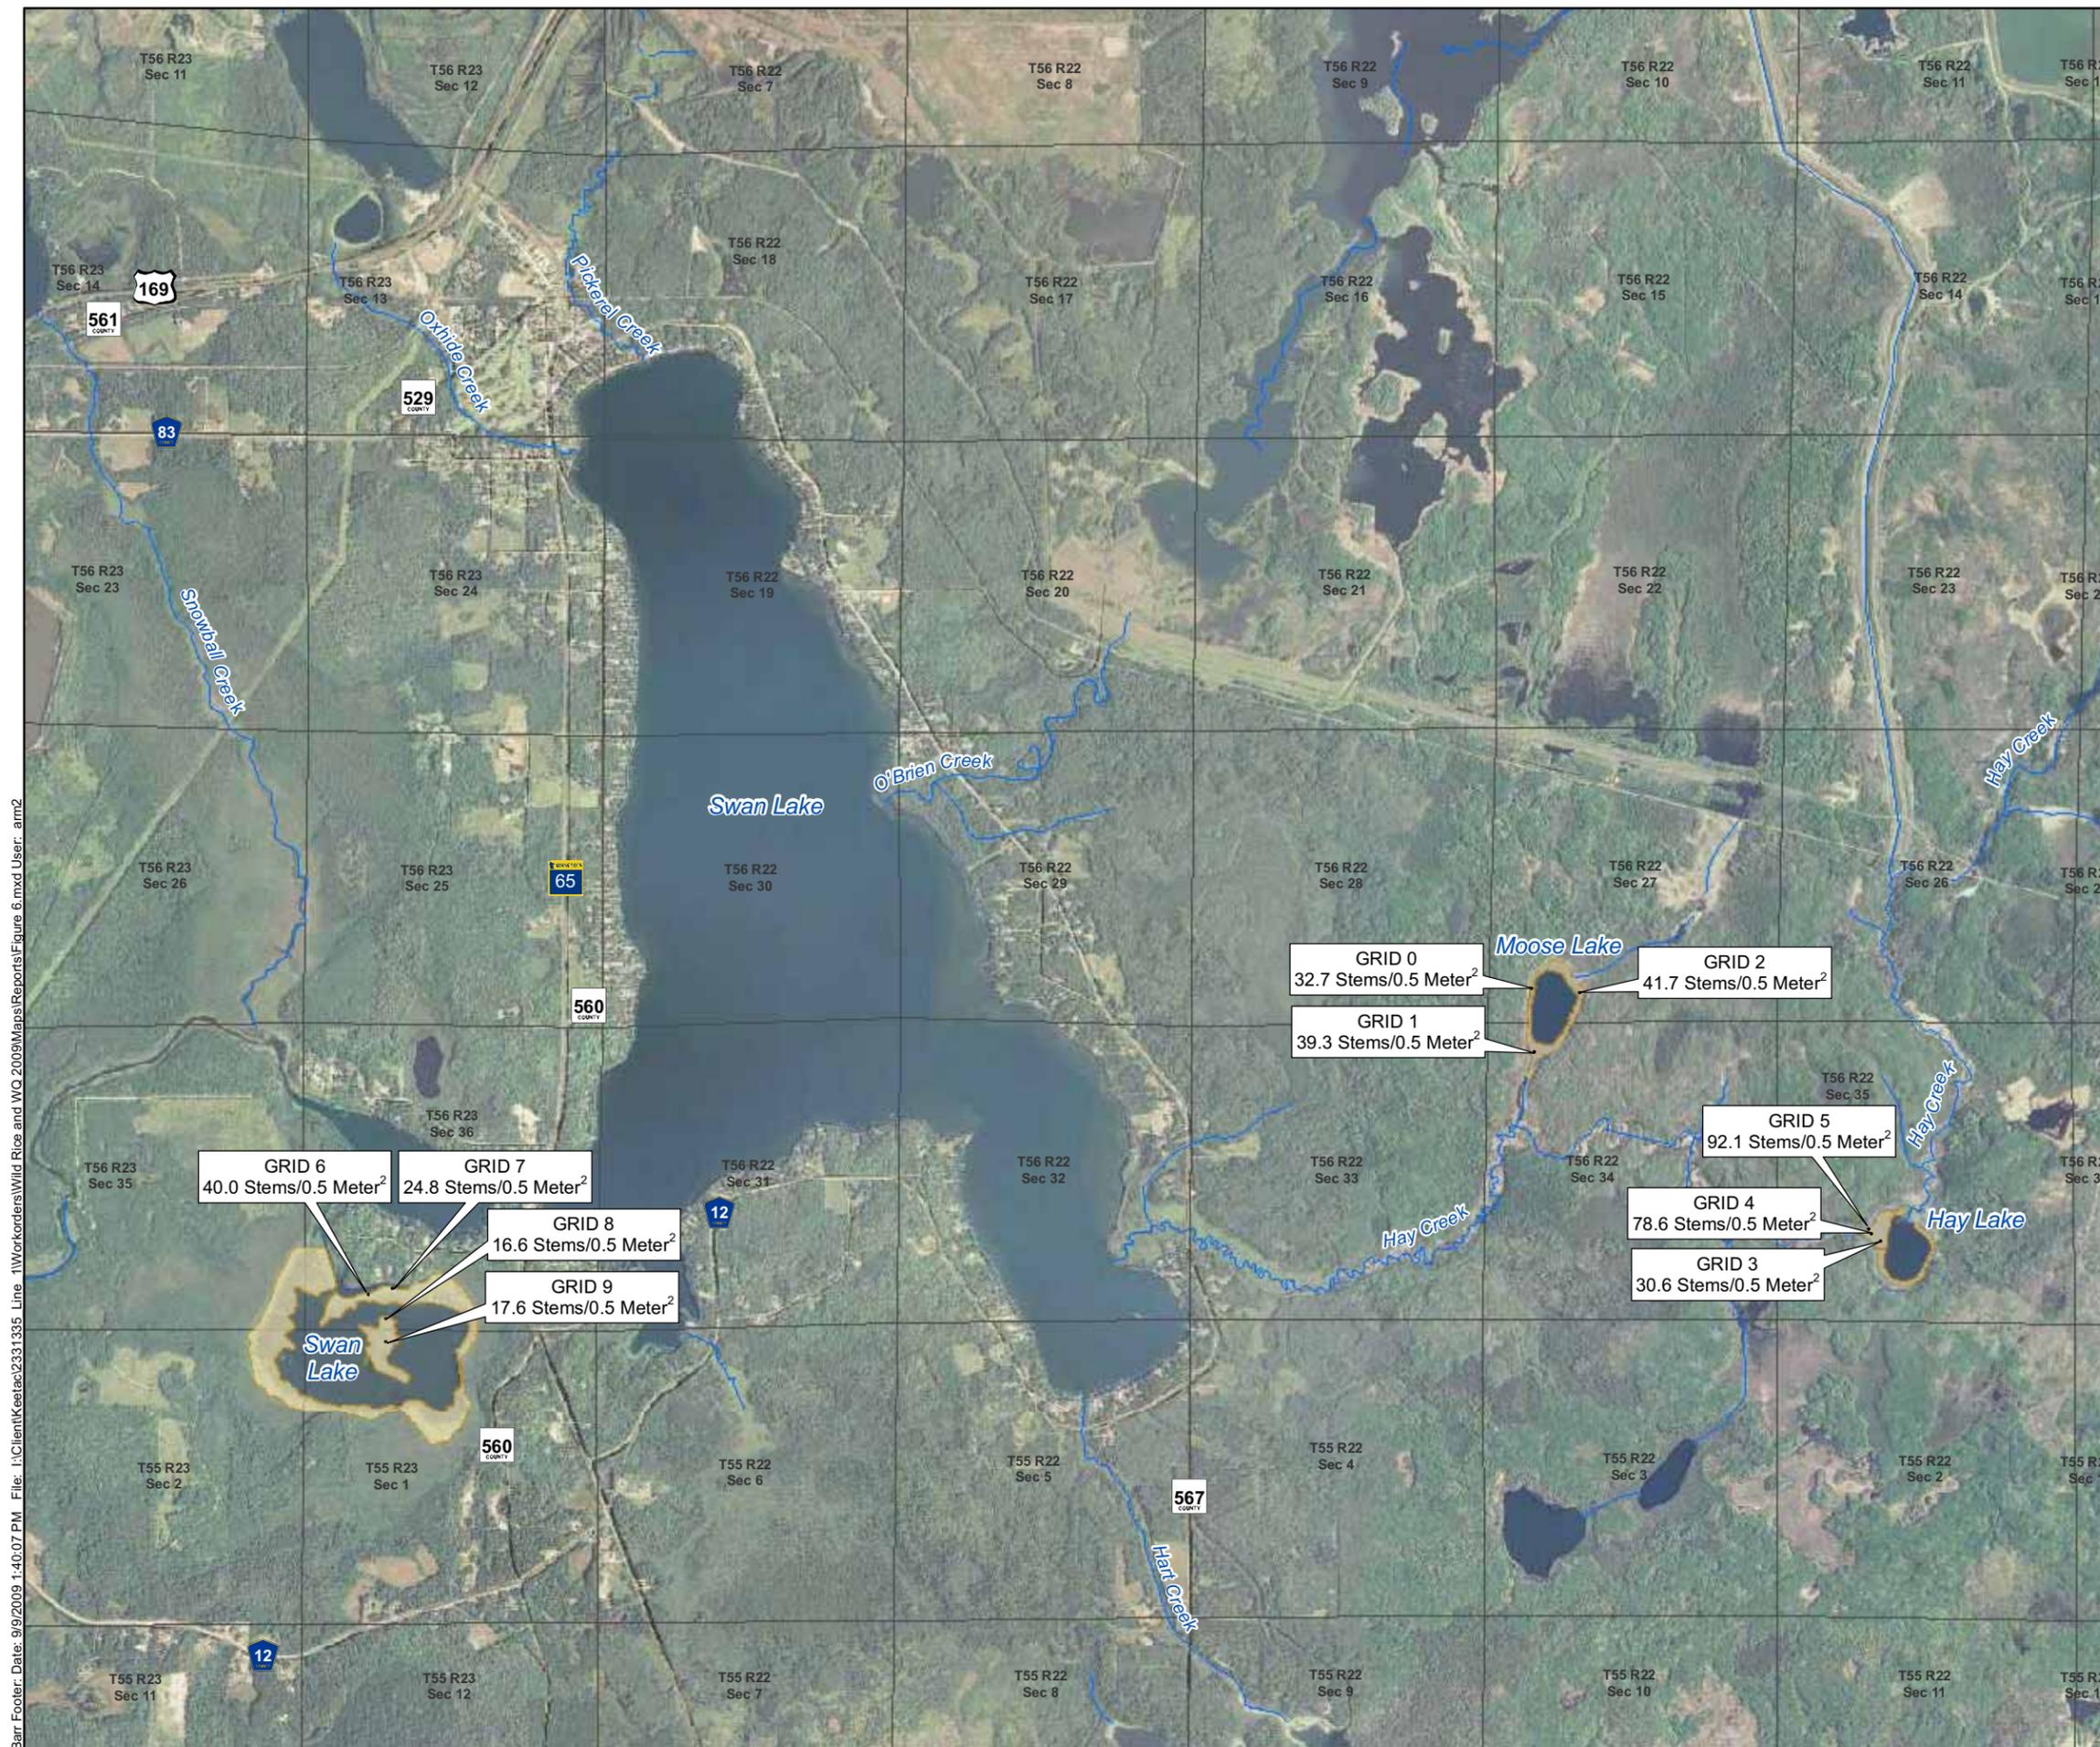
- 10x10 Meter Grid
- ~ Stream/River
- Approximate Extent of Wild Rice Stands
- Sections Boundaries

Wild rice was identified from ground surveys performed on Moose Lake, Hay Lake, and the Swan Lake Southwest Bay the week of July 27, 2009 (Figure 6). The aerial photography information was not obtained until after the field survey work was completed; therefore, the wild rice on the Swan River, which had not previously been identified in the other information sources, was not field surveyed. The presence of wild rice on Swan River was verified at a road leading to the dam on the Swan River. No wild rice was found in the south bay shown to potentially contain wild rice in the aerial photography (see Figure 5). Swan Lake Southwest Bay had the largest overall acreage of wild rice, while both Hay Lake and Moose Lake had less acreage but denser stands of wild rice (greater than 80 percent coverage). Wild rice stands were identified along most of the perimeter of Moose Lake with approximately 30 percent coverage; the area located at the southern end near the outlet had

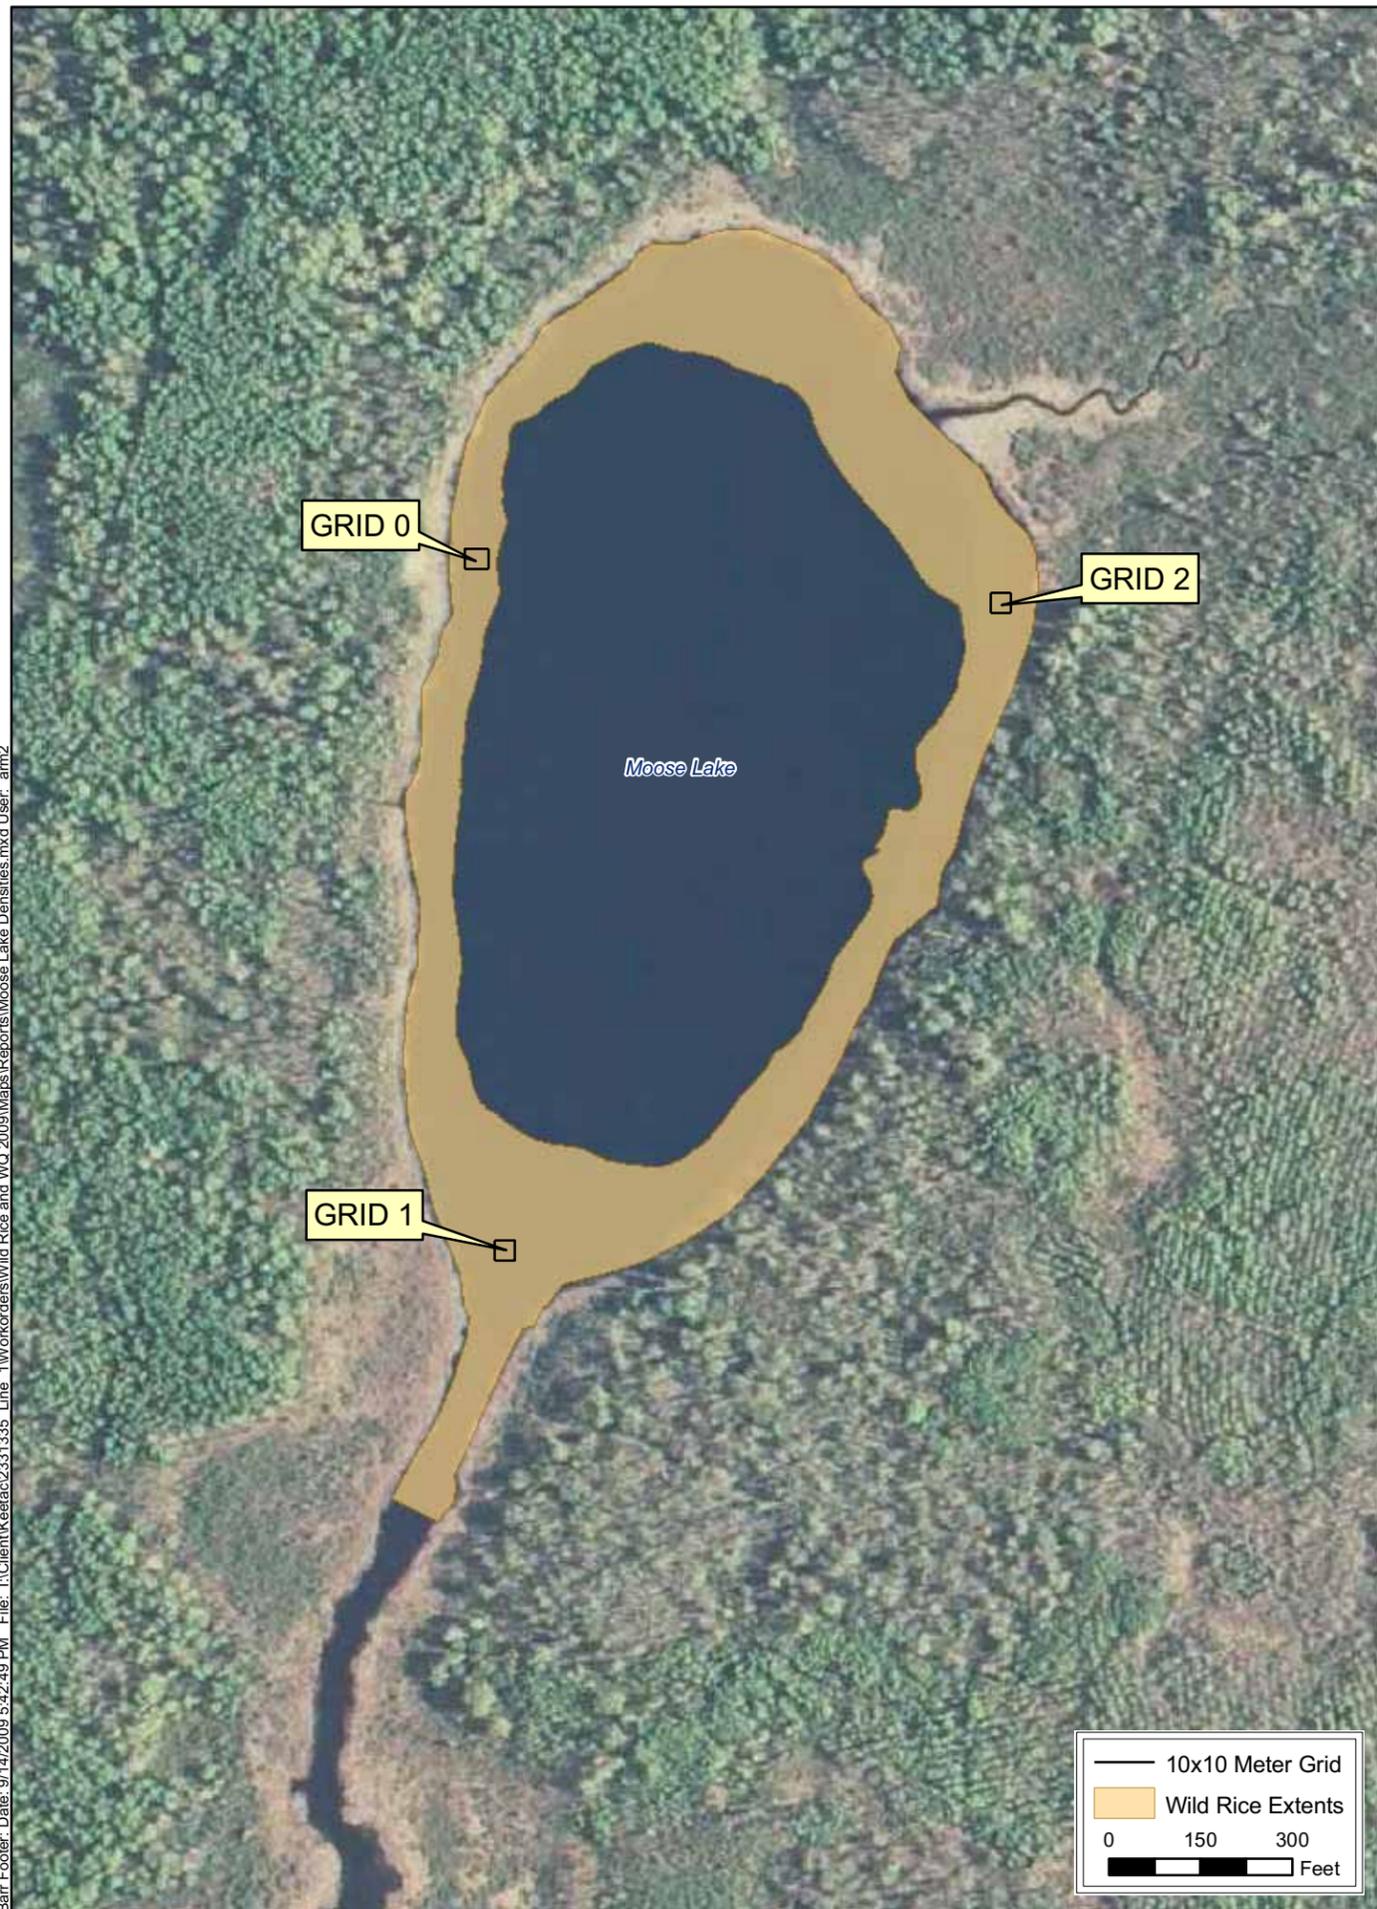
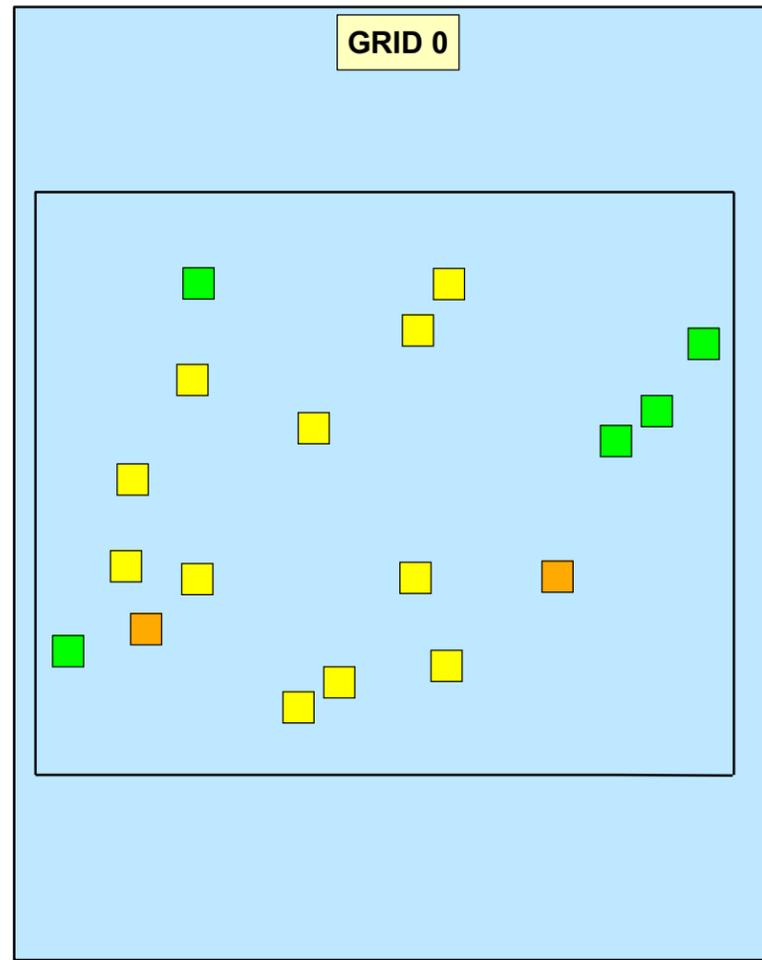
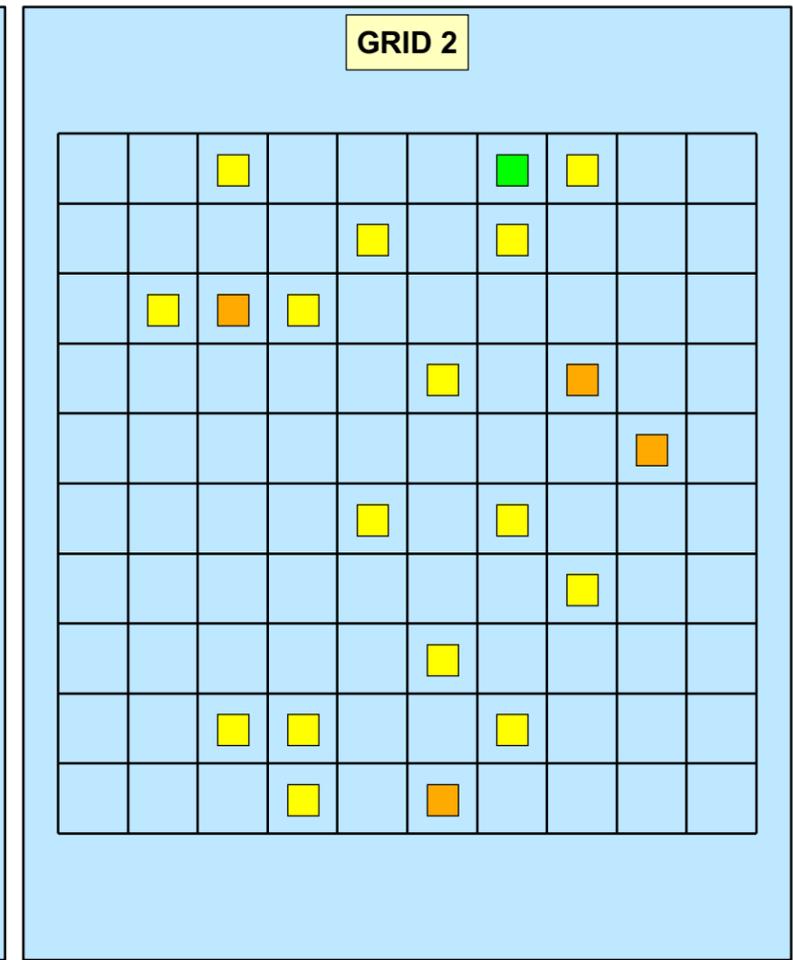
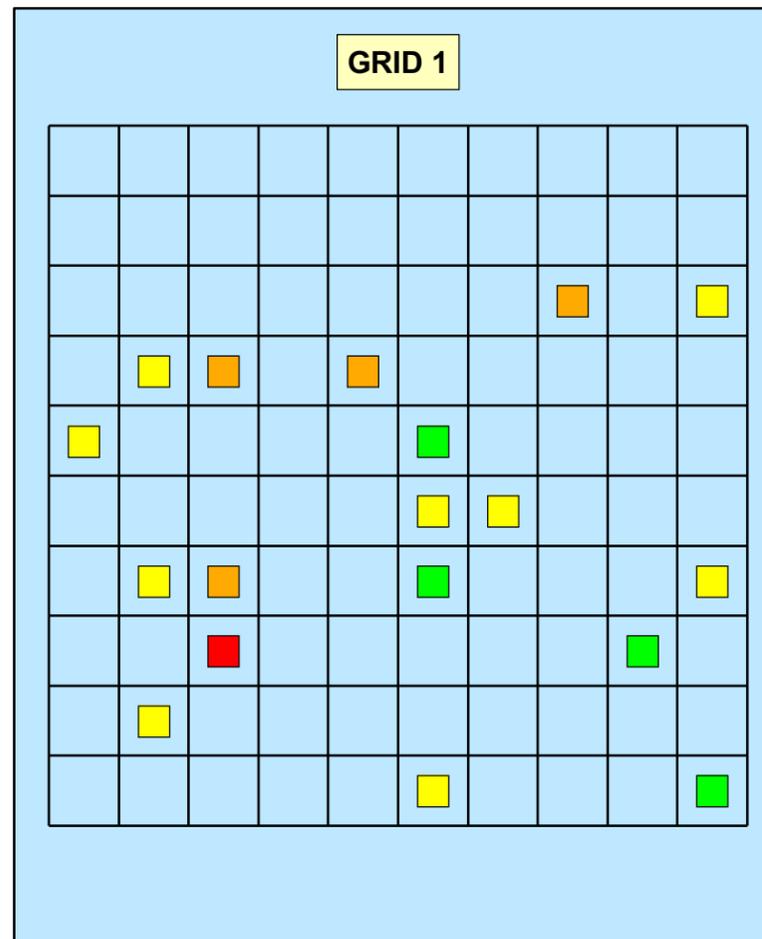
Appendix C-2
MOOSE LAKE WILD RICE SURVEY
 July 28, 2009
 U. S. Steel Corp.
 Keetac Expansion Project
 Keewatin, Minnesota

Stem Density/0.5m²
