LSI UPDATE & CLOSURE REQUEST

Subj: LSI Update Report - Closure Request

Montgomery Auto Parts - Sherburn, Minnesota
GeoTek #99-913-6 MPCA #00013087

LIMITED SITE INVESTIGATION REPORT
MONTGOMERY AUTO PARTS
SHERBURN, MINNESOTA

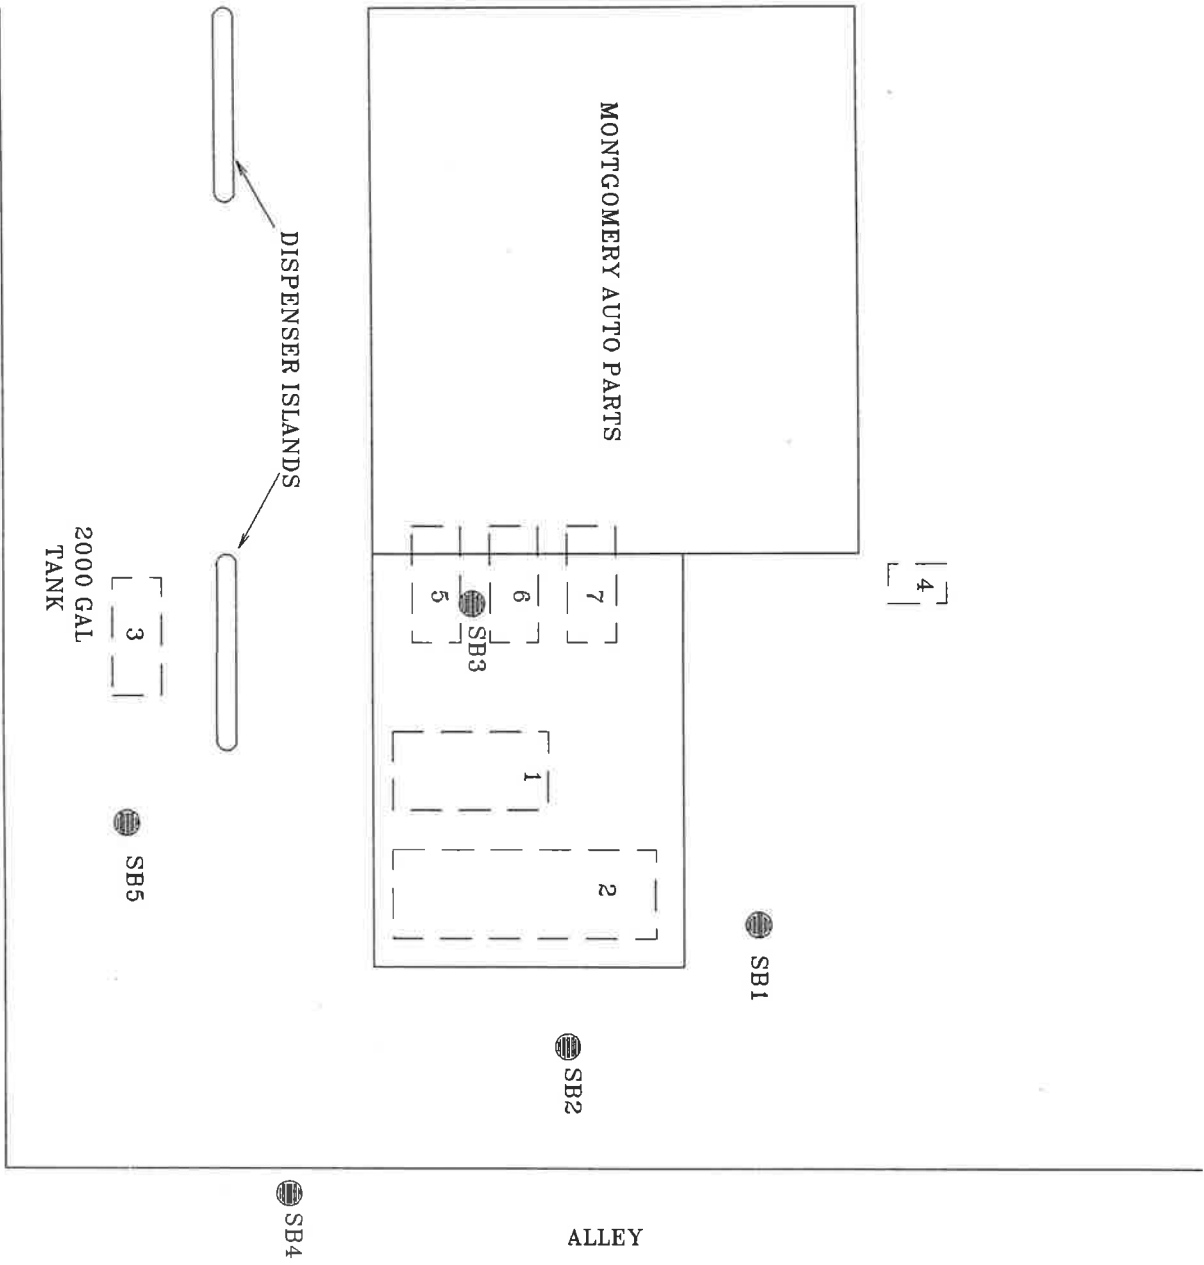
FIGURE 3
SOIL BORING LOCATIONS - APRIL 17, 2003
MONTGOMERY AUTO PARTS
SHERBURN, MN.

The additional work requested included soil borings, soil and groundwater sampling analysis, and a vapor survey of the sewers near the site. Soil borings SB6-SB12 were completed on May 2, 2003, and are indicated on Figure 3. The soil boring logs for SB6-SB12 are provided with this report.

TANKS 1-4 REMOVED 10/99
TANKS 5-7 ABANDONED IN PLACE

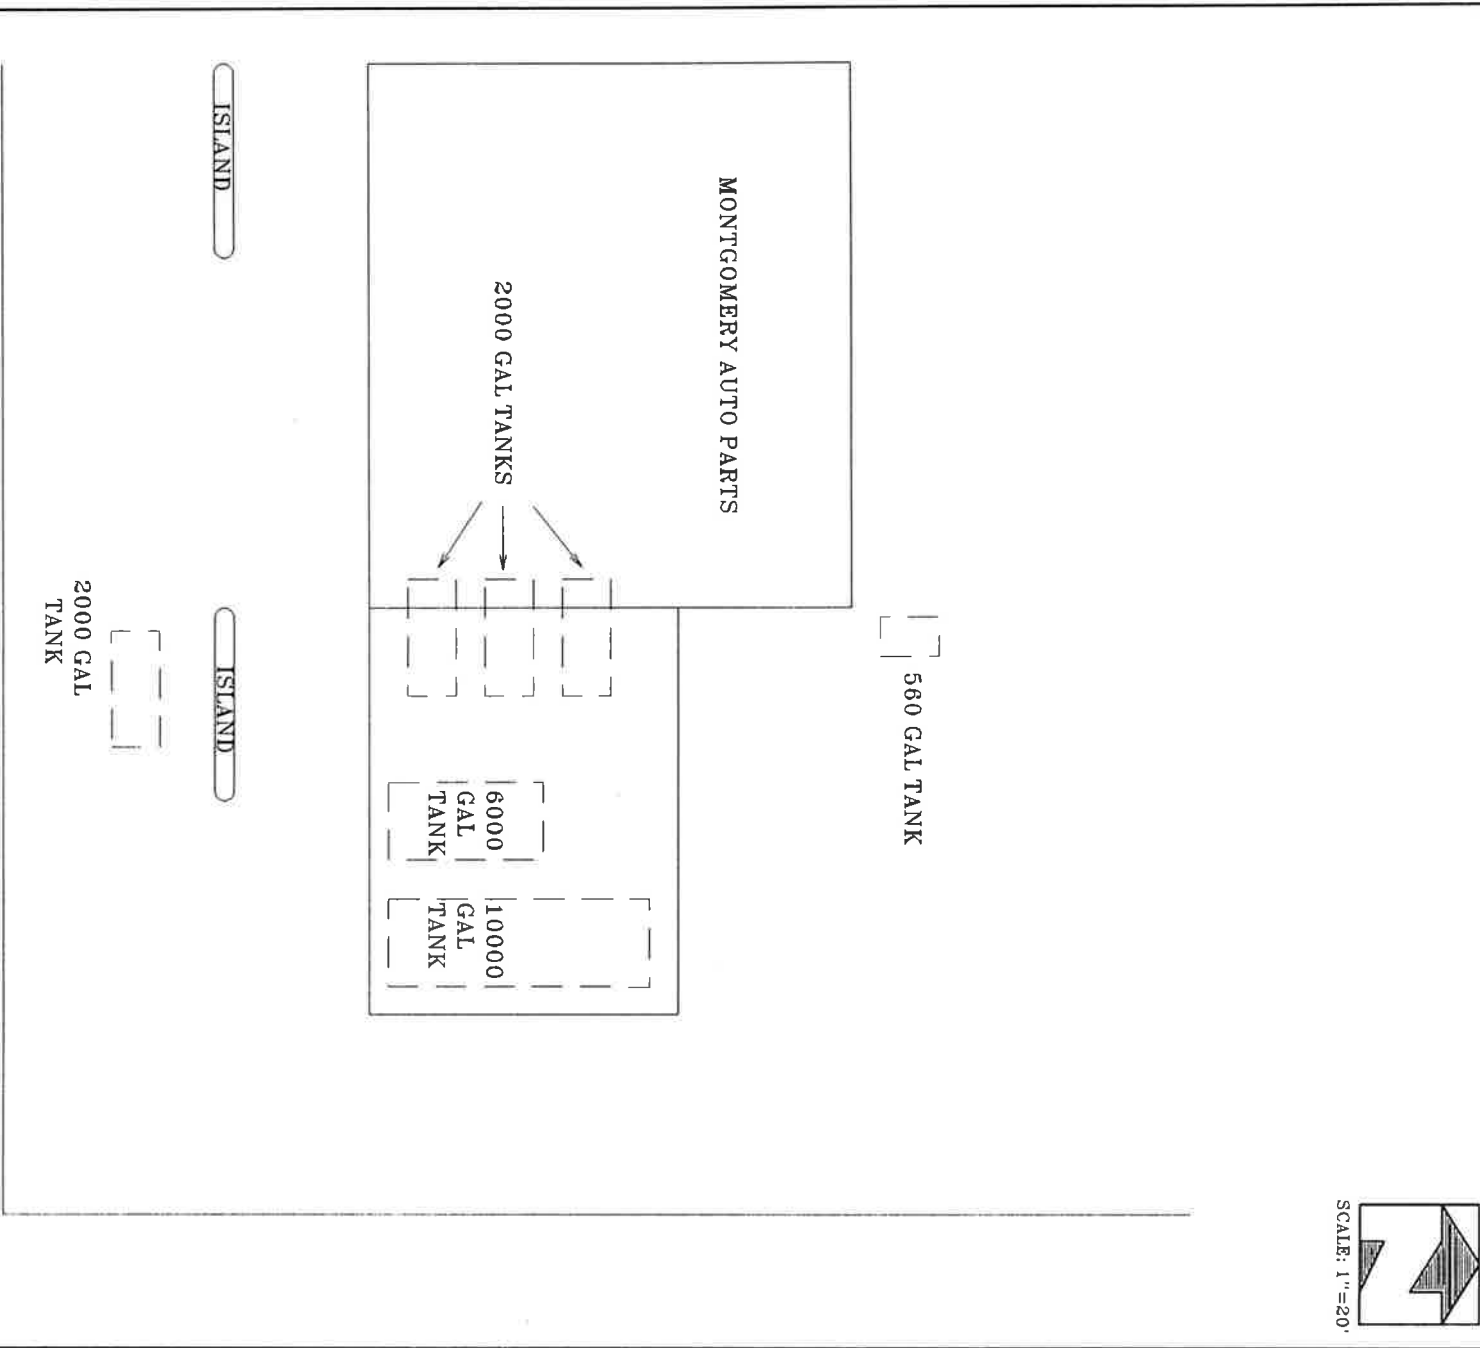
FIGURE 3
UST LOCATIONS
MONTGOMERY AUTO PARTS
SHERBURN, MN

Notes: Former UST locations are indicated on Figure 3. The UST Excavation Report is provided as Appendix A. Tanks 5-7 were located below the east wall of the building and could not be safely removed.

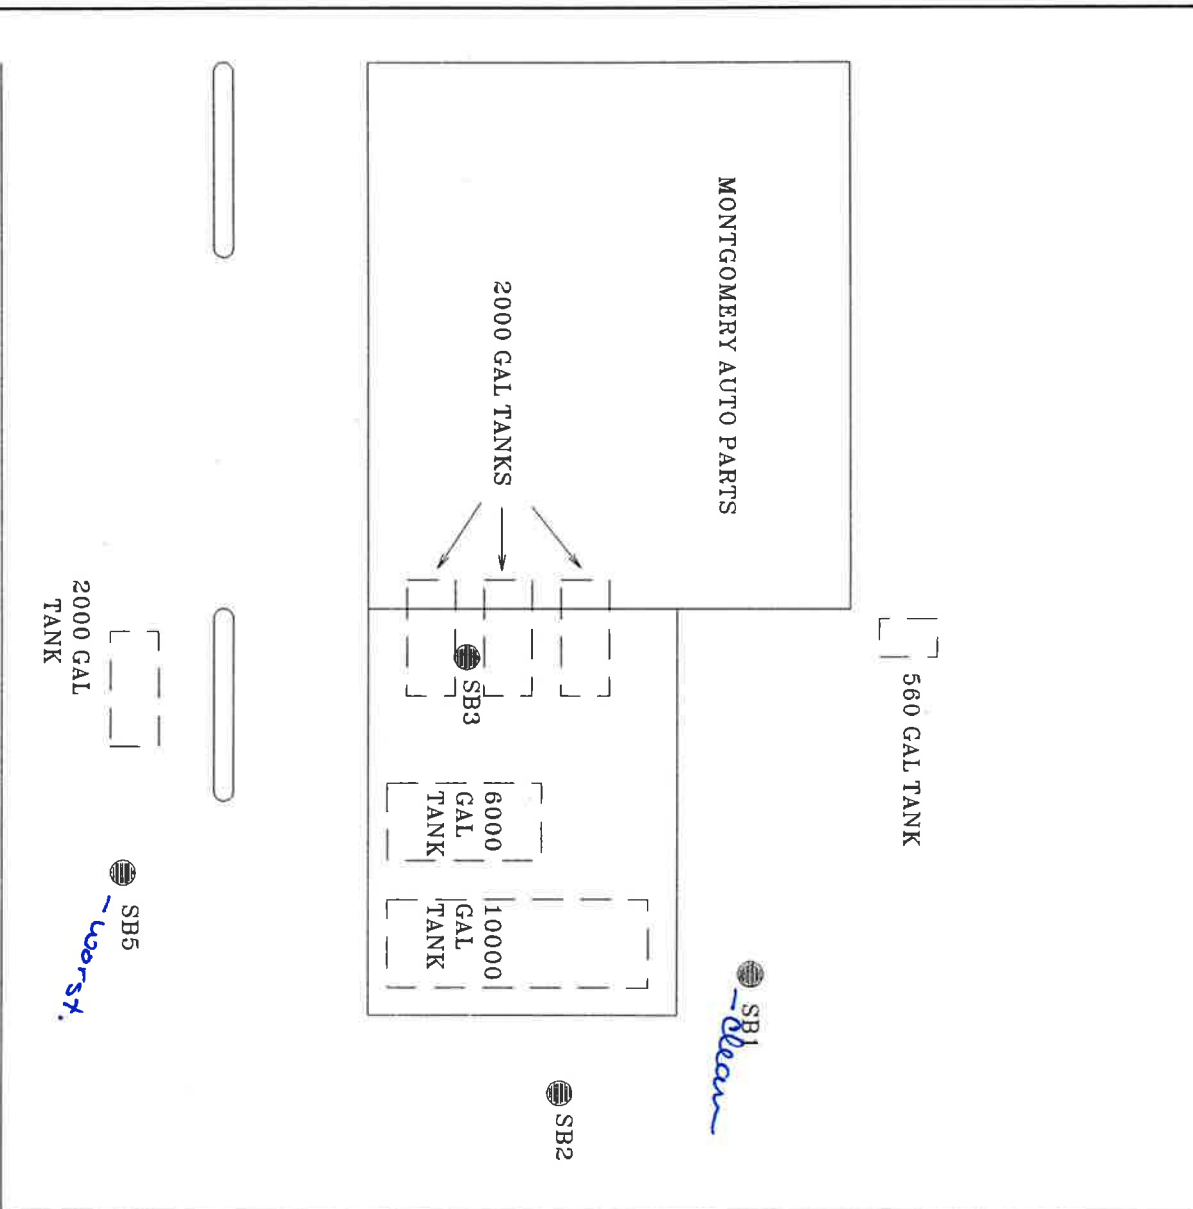
FIGURE 4
SOIL BORING LOCATIONS
MONTGOMERY AUTO PARTS
SHERBURN, MN

Soil boring locations are indicated on Figure 4.

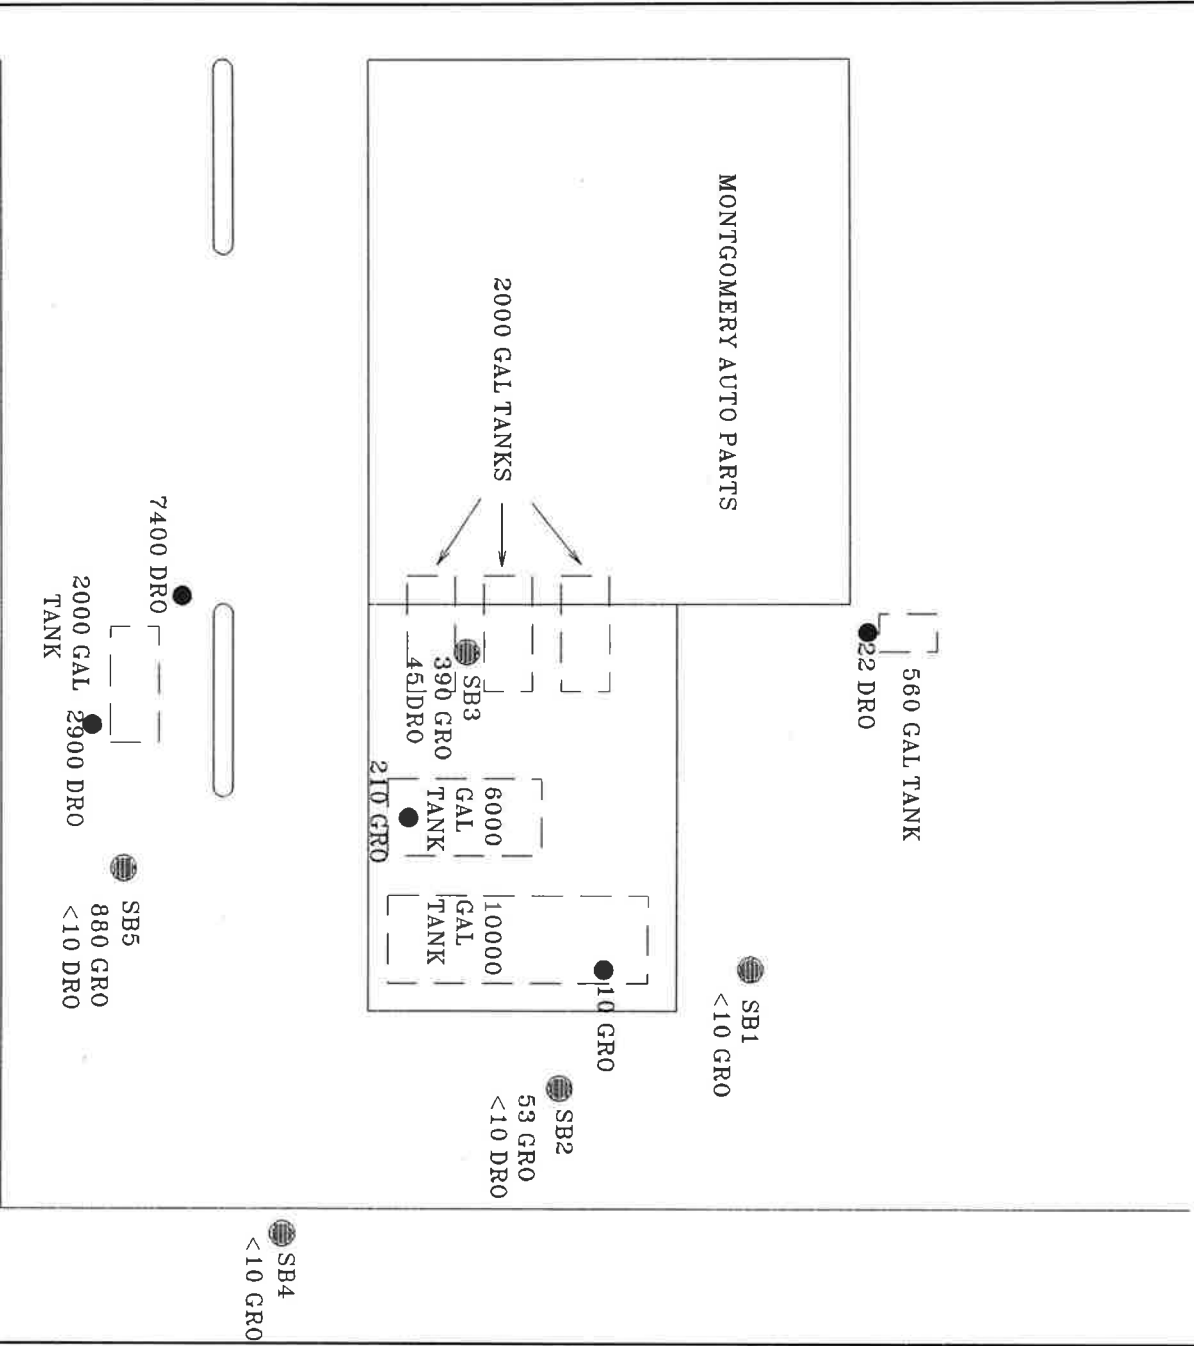
FIGURE 5
 PETROLEUM CONCENTRATIONS IN SOIL
 MONTGOMERY AUTO PARTS
 SHERBURN, MN

Soil analytical results are indicated on Figure 5.

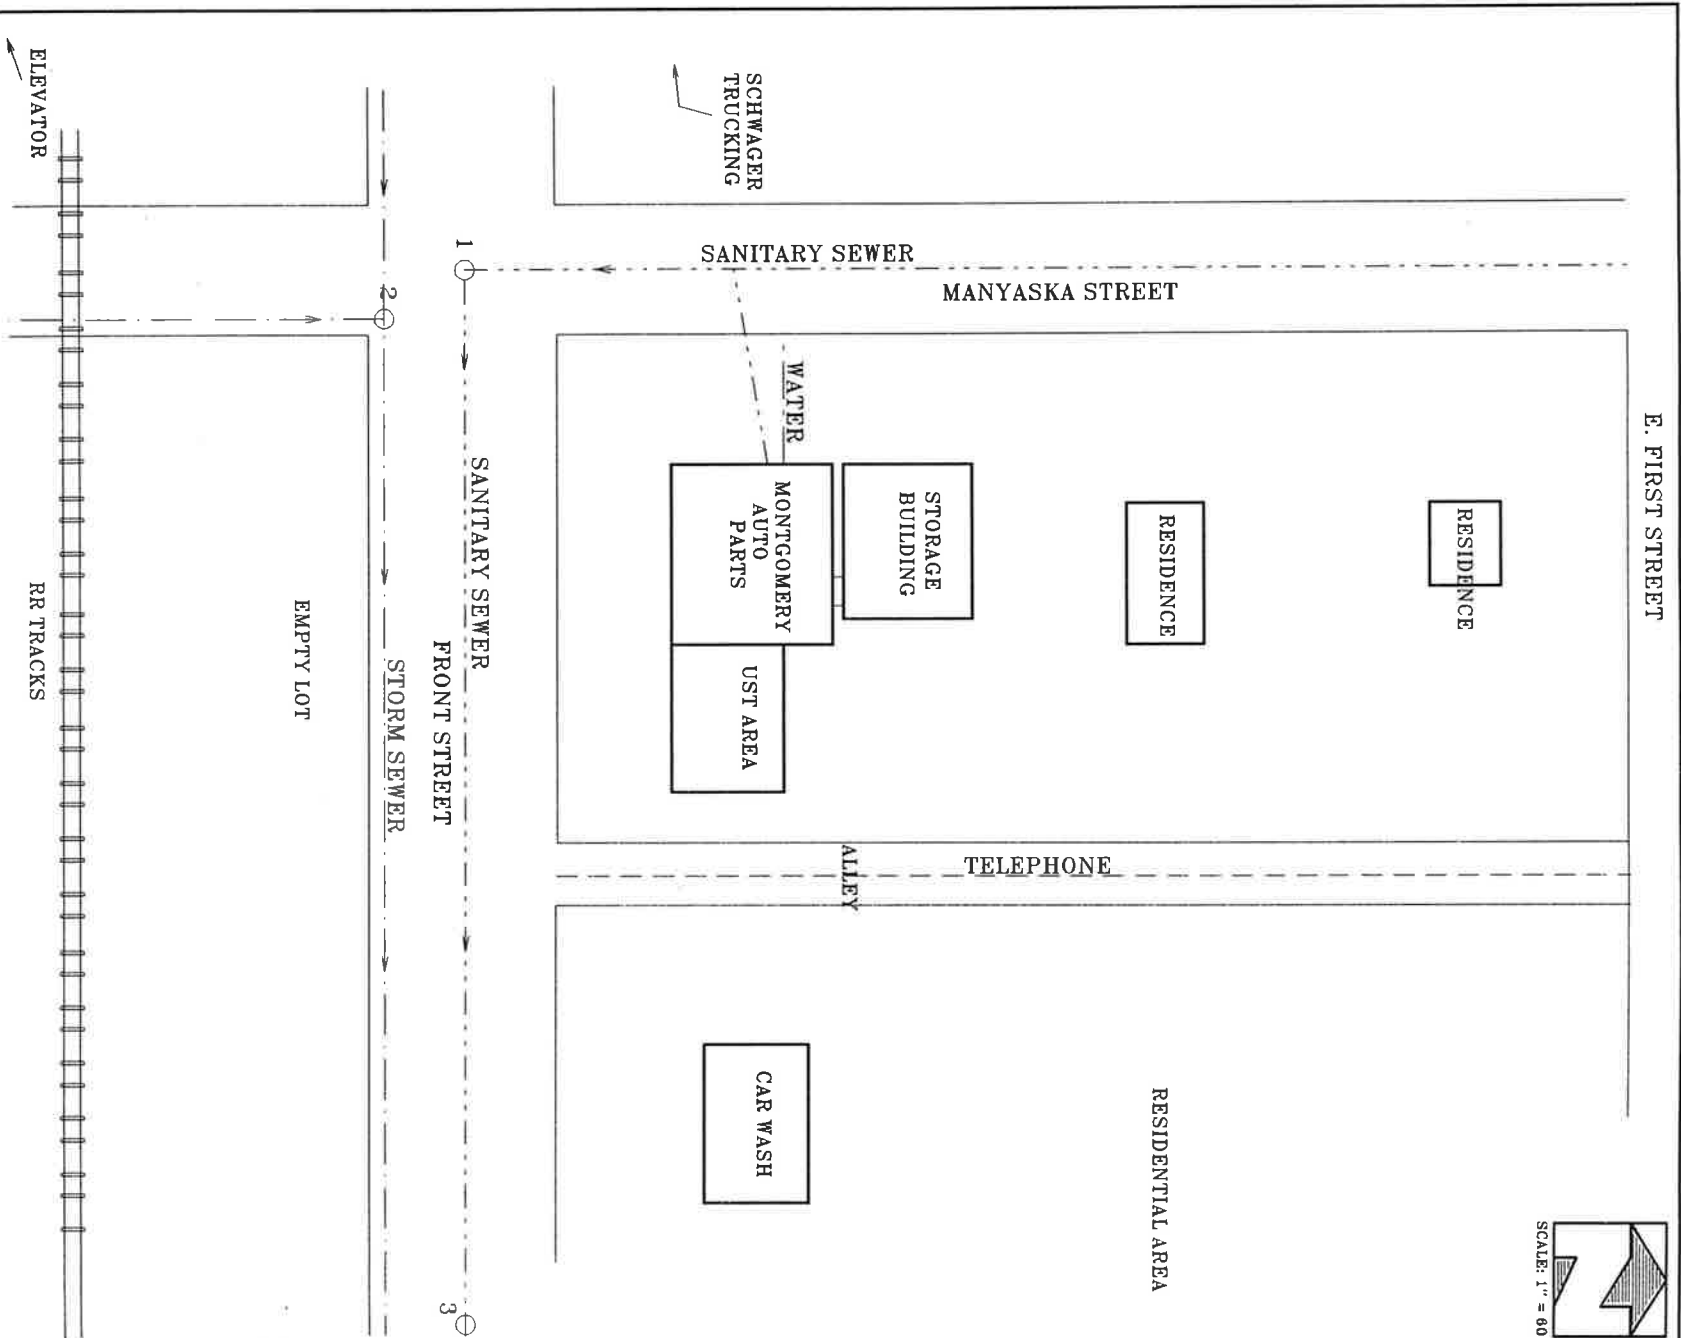
FIGURE 8

The potential for vapor migration is minimal. The nearby building is slab-on-grade. The nearest buried utility is a telephone cable in the alley east of the former UST area. The water and sanitary sewer enter the west side of the building from Manyaska Street (Figure 8).

Notes: Vapor Survey Locations are indicated on Figure 8.
