PHASE II ENVIRONMENTAL SITE ASSESSMENT

**The Transmission Shop
6958 Cedar Avenue South
Richfield, MN 55423**

File #2477B

August 27, 1997

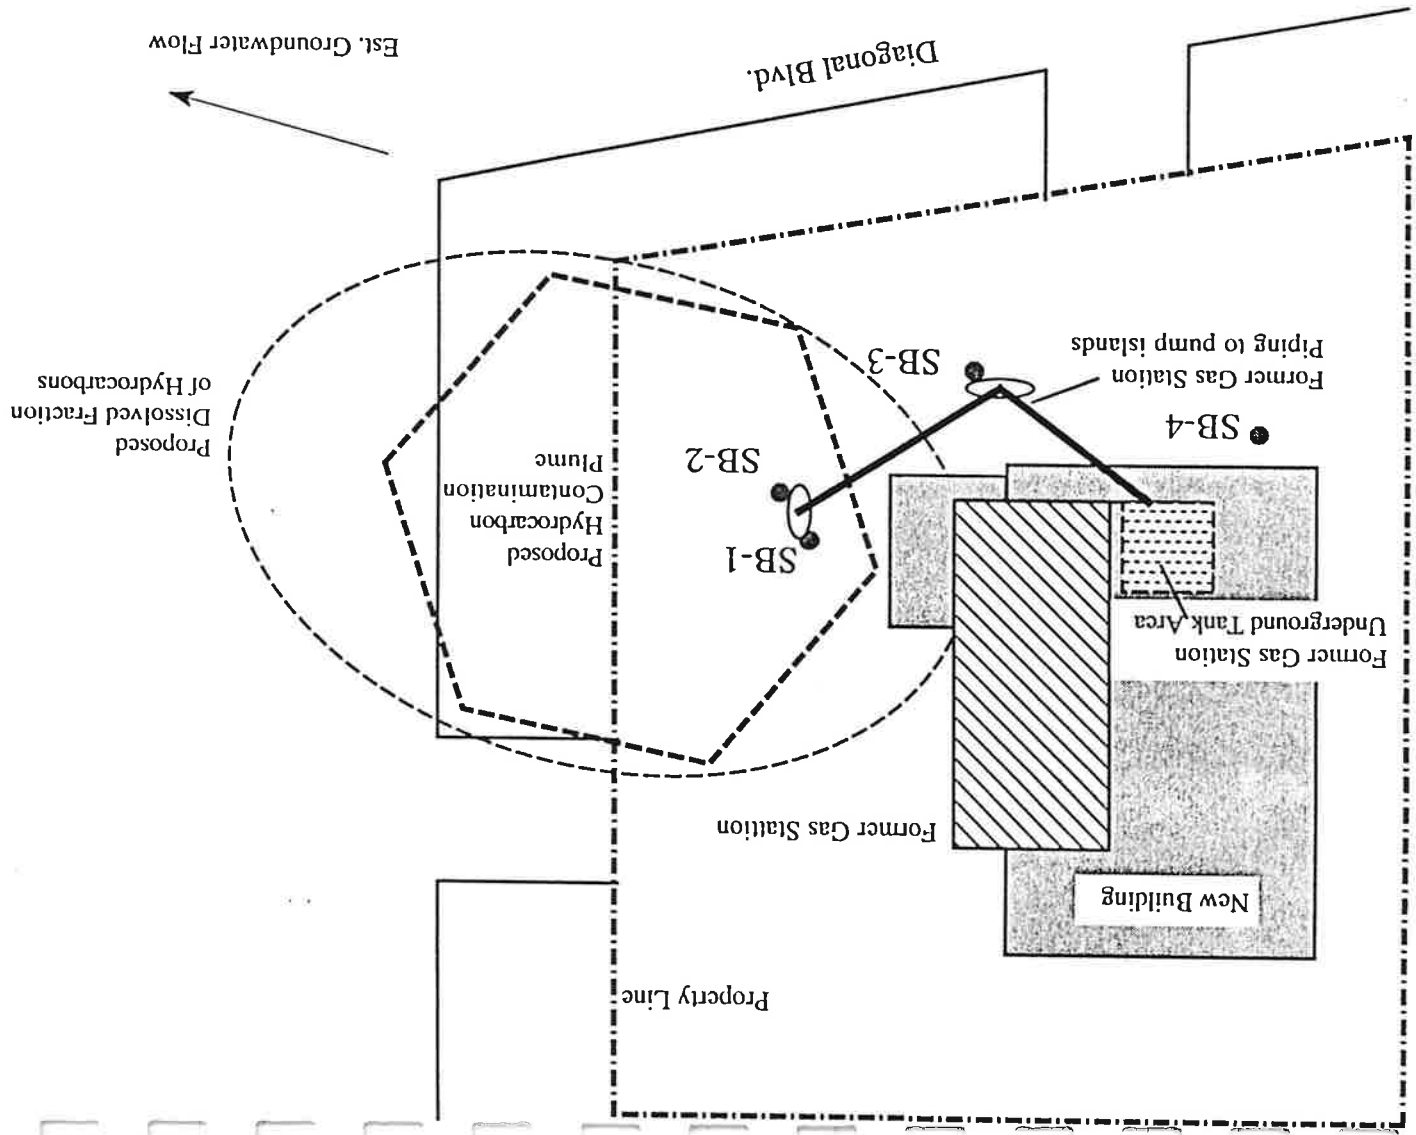
Figure 1
Soil Boring Locations
Bloomington Quadrangle
6958 Cedar Ave. South
Richfield, MN 55423

Upon completing the soil borings, the holes were backfilled and sealed. The dimensions used for locating the soil borings as indicted in Figure 1 of the appendix and were measured from the south west property corner marker.

The full extent of the contamination is not known at this time. As indicated in Figure 1, the dissolved fraction of contamination may extend underneath Cedar Avenue to the east. The plume of gasoline hydrocarbon contamination may only extend out under the right-of-way where it may be easier to remediate if required.
