RE: RI/CAD, Union Co-op Oil, Hector, MN Leak #68

REMEDIAL INVESTIGATION REPORT WORKSHEET

R/CAD
FARMERS UNION OIL COOP PROPERTY
Hector, Minnesota
LEAK#00000068

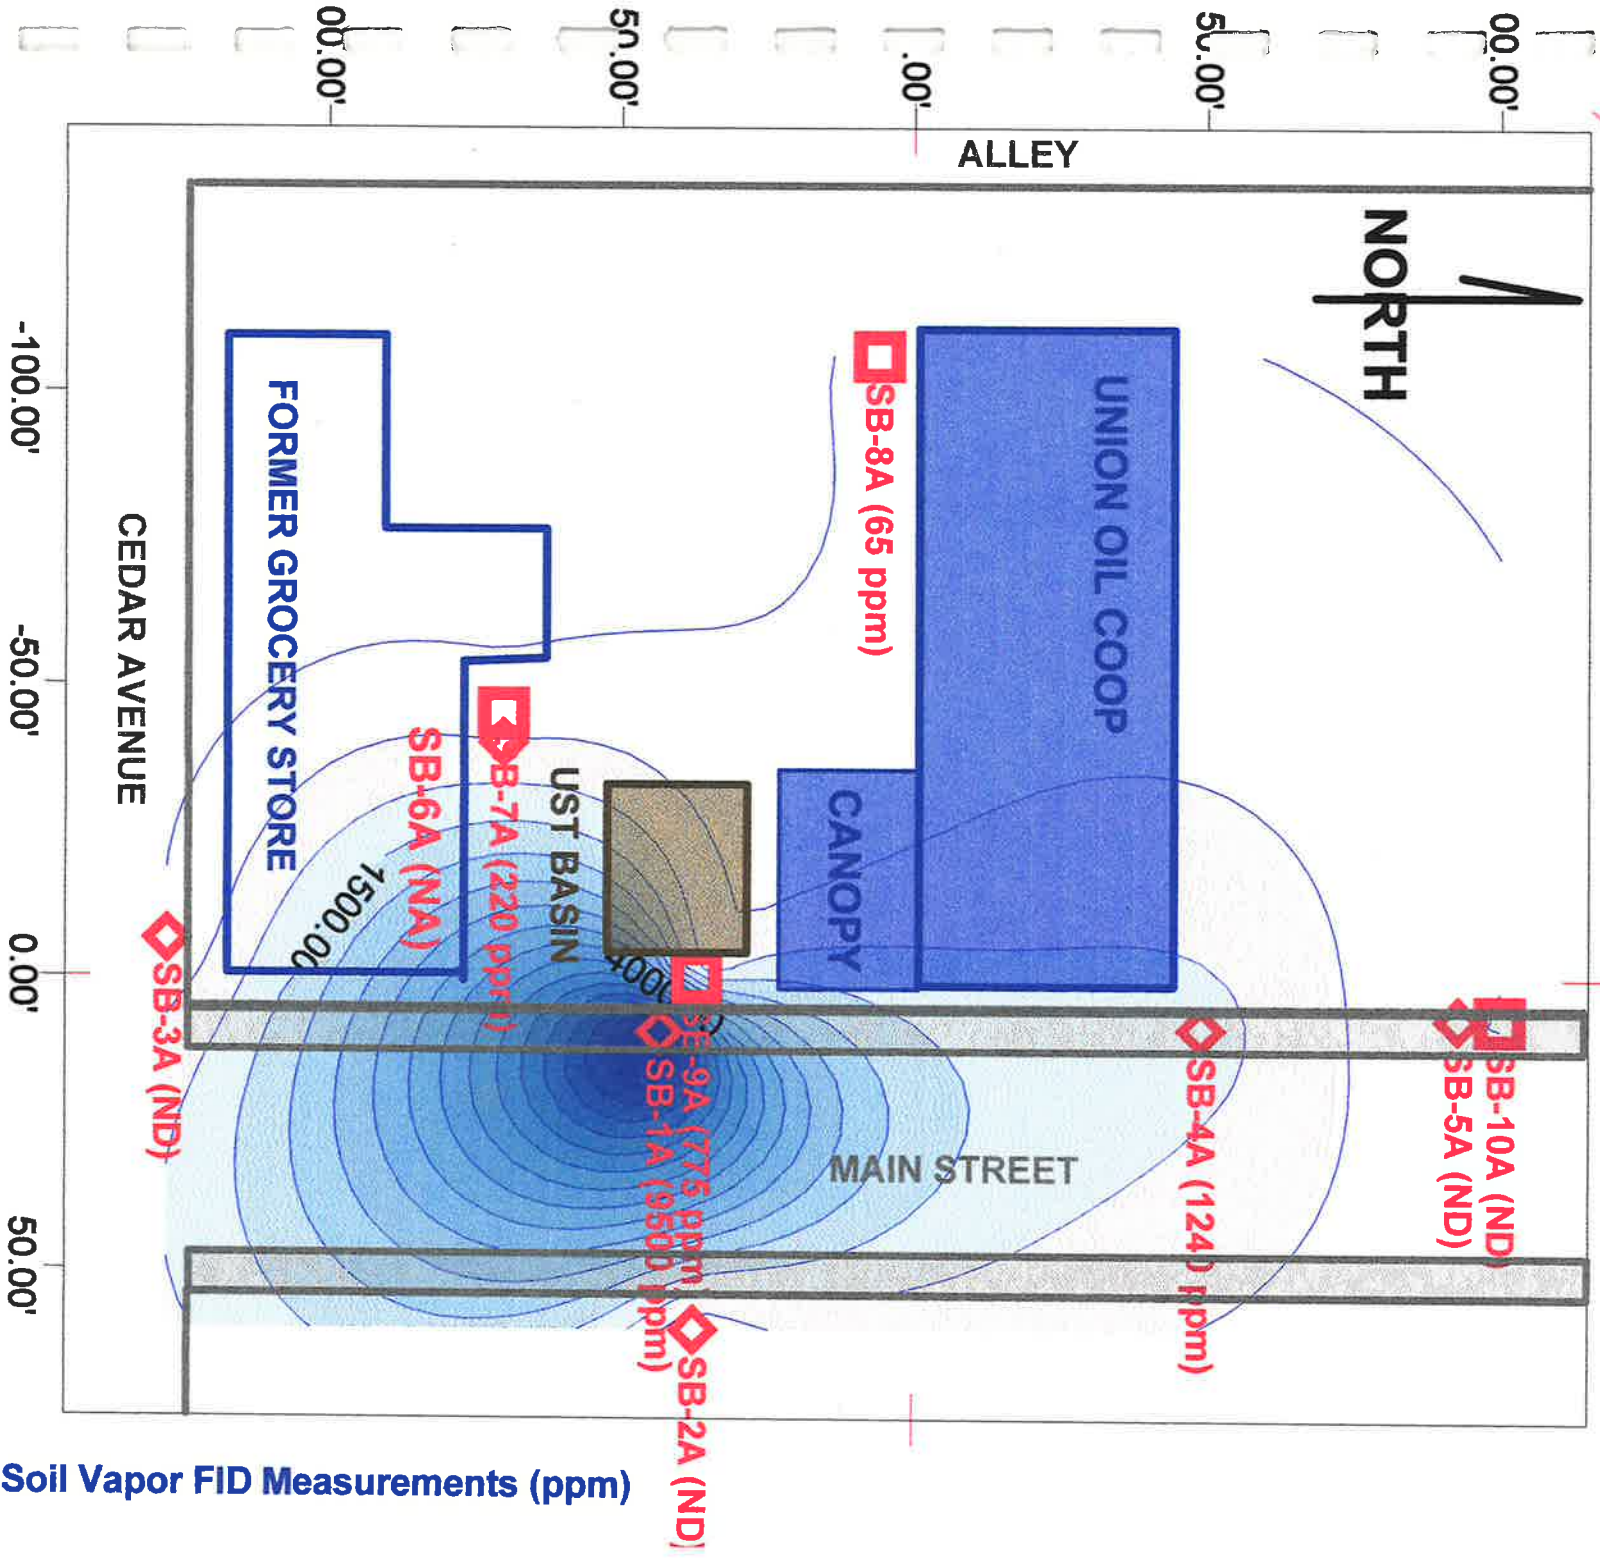
FIGURE 3 SITE MAP

Figure 3 illustrates the site (UST basin, soil borings and monitoring wells).

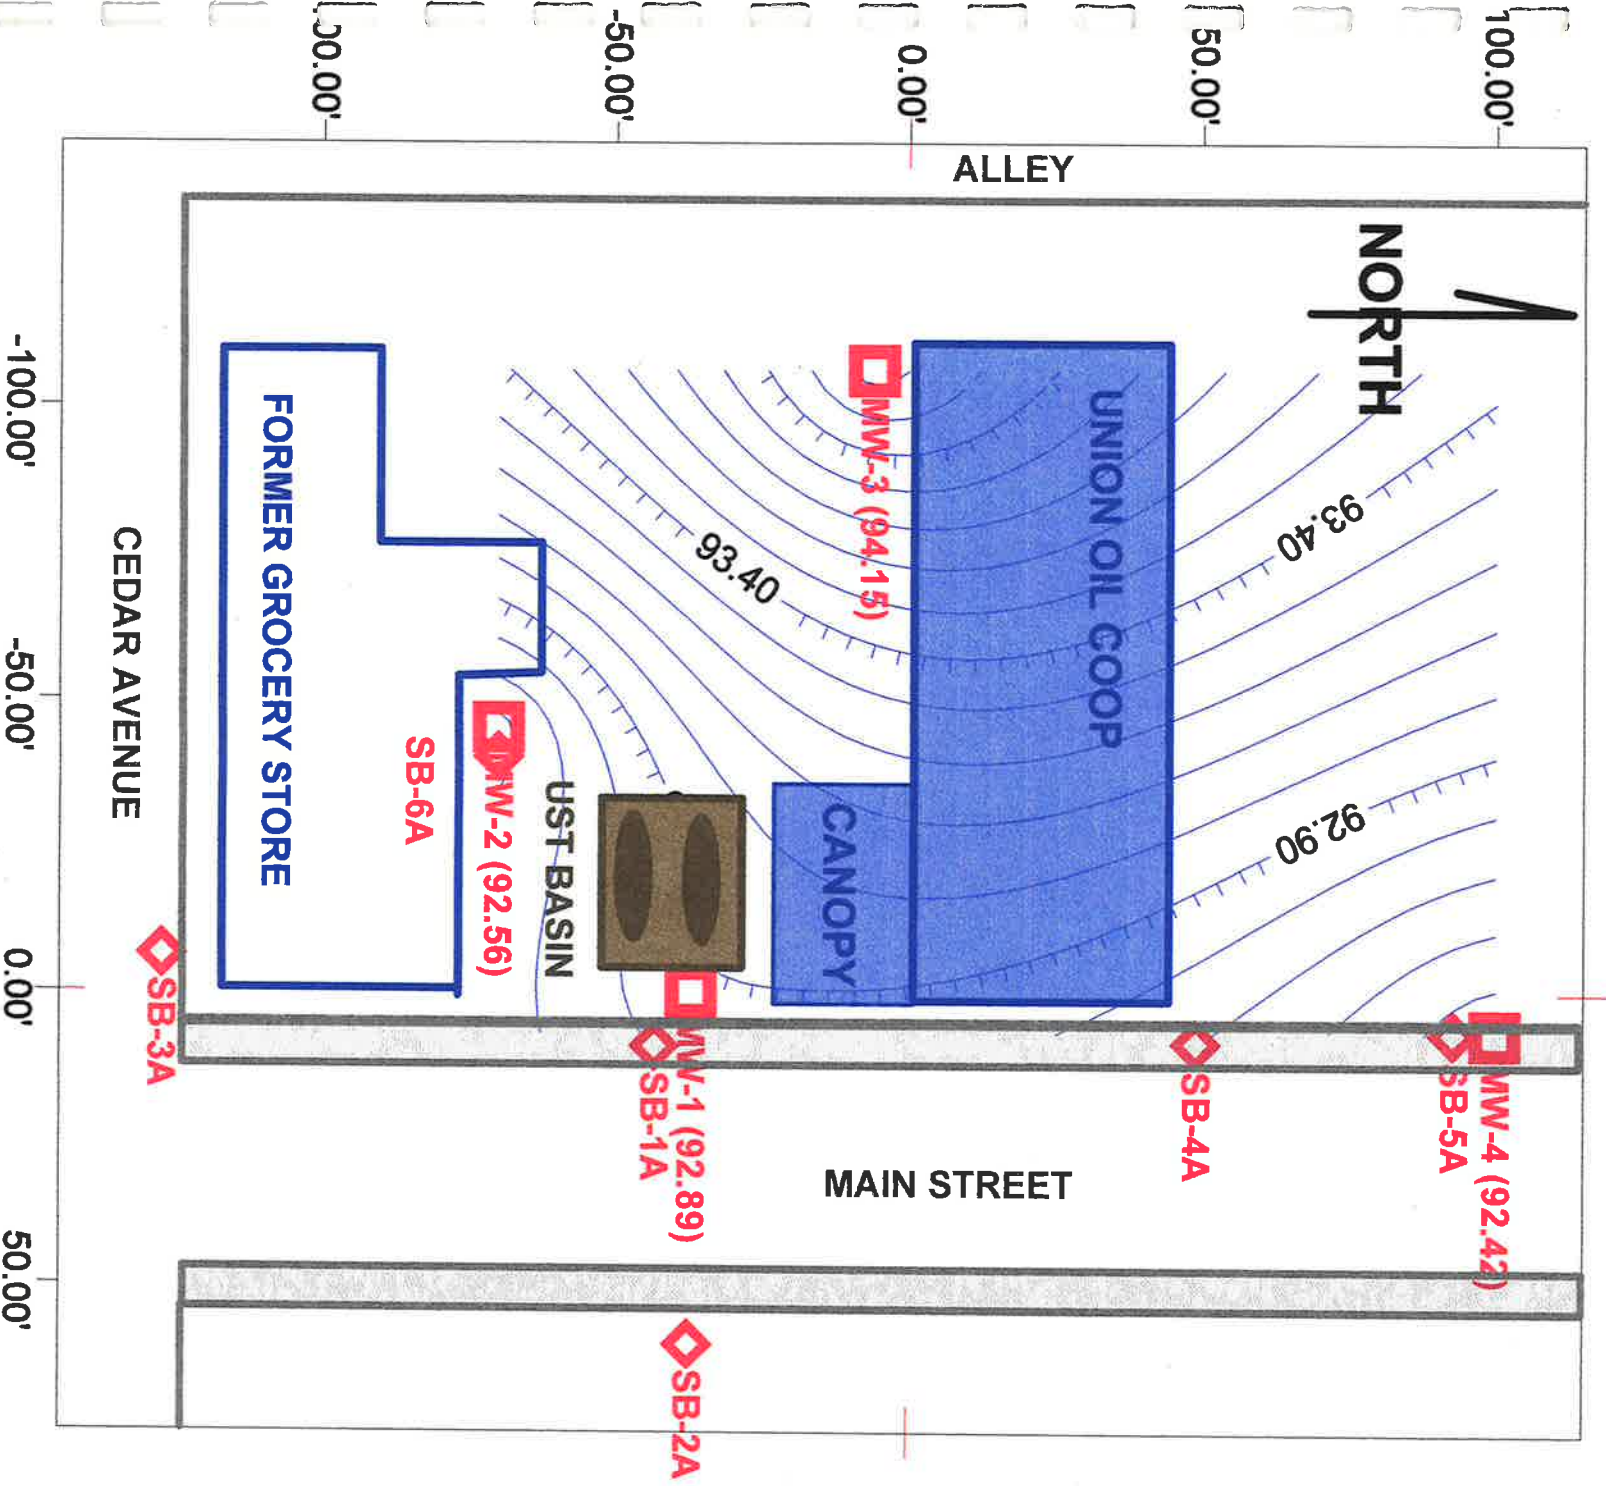
FIGURE 5 GW CONTOUR MAP - 8/23/94

Table 5 presents a summary of monitoring well survey and water elevation data; **Figure 5** illustrates ground water elevation and flow direction. **Figure 6a** illustrates the groundwater benzene concentrations.

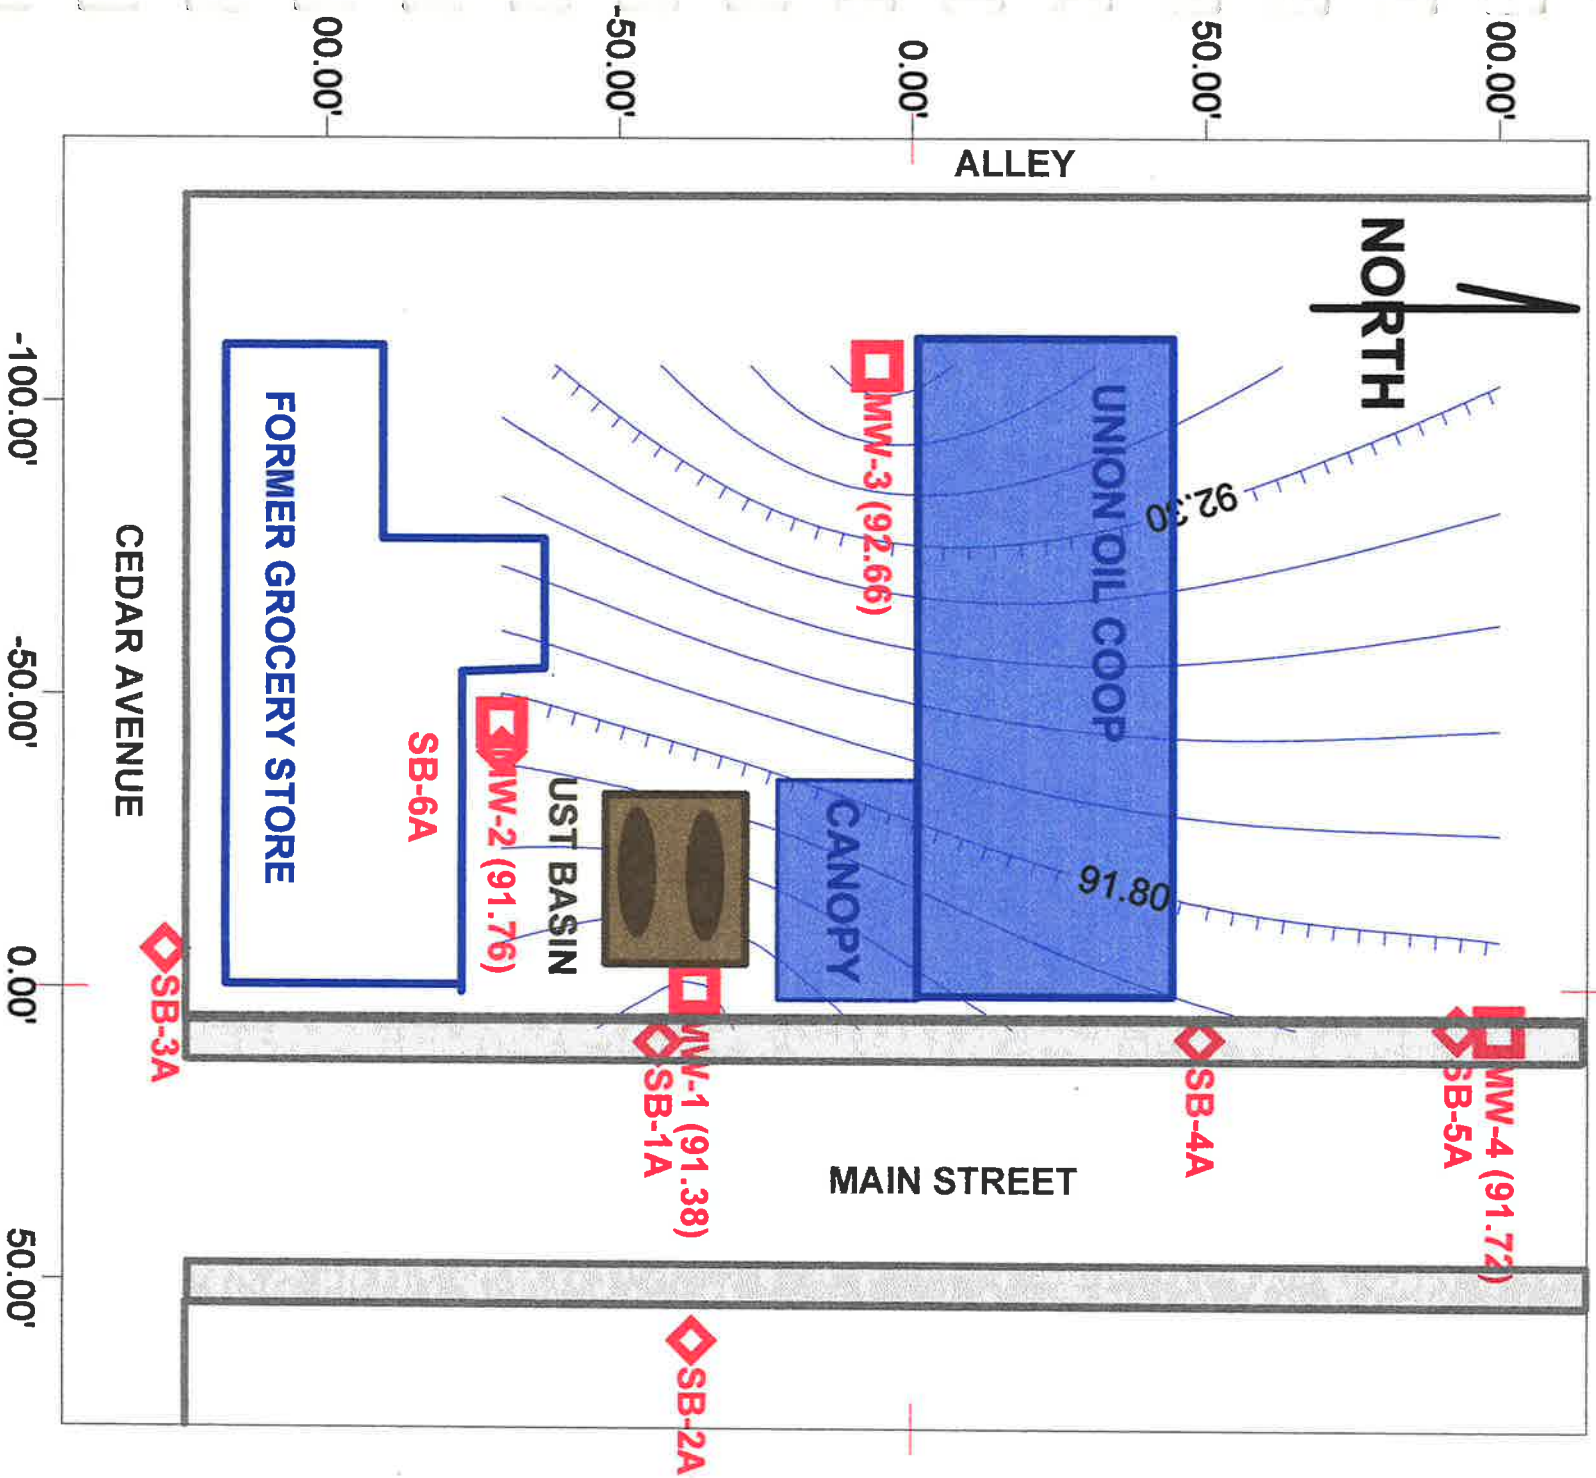
FIGURE 5a GW CONTOUR MAP - 11/11/94

Table 5 presents a summary of monitoring well survey and water elevation data; **Figure 5a** illustrates ground water elevation and flow direction. **Figure 6b** illustrates the groundwater benzene concentrations.

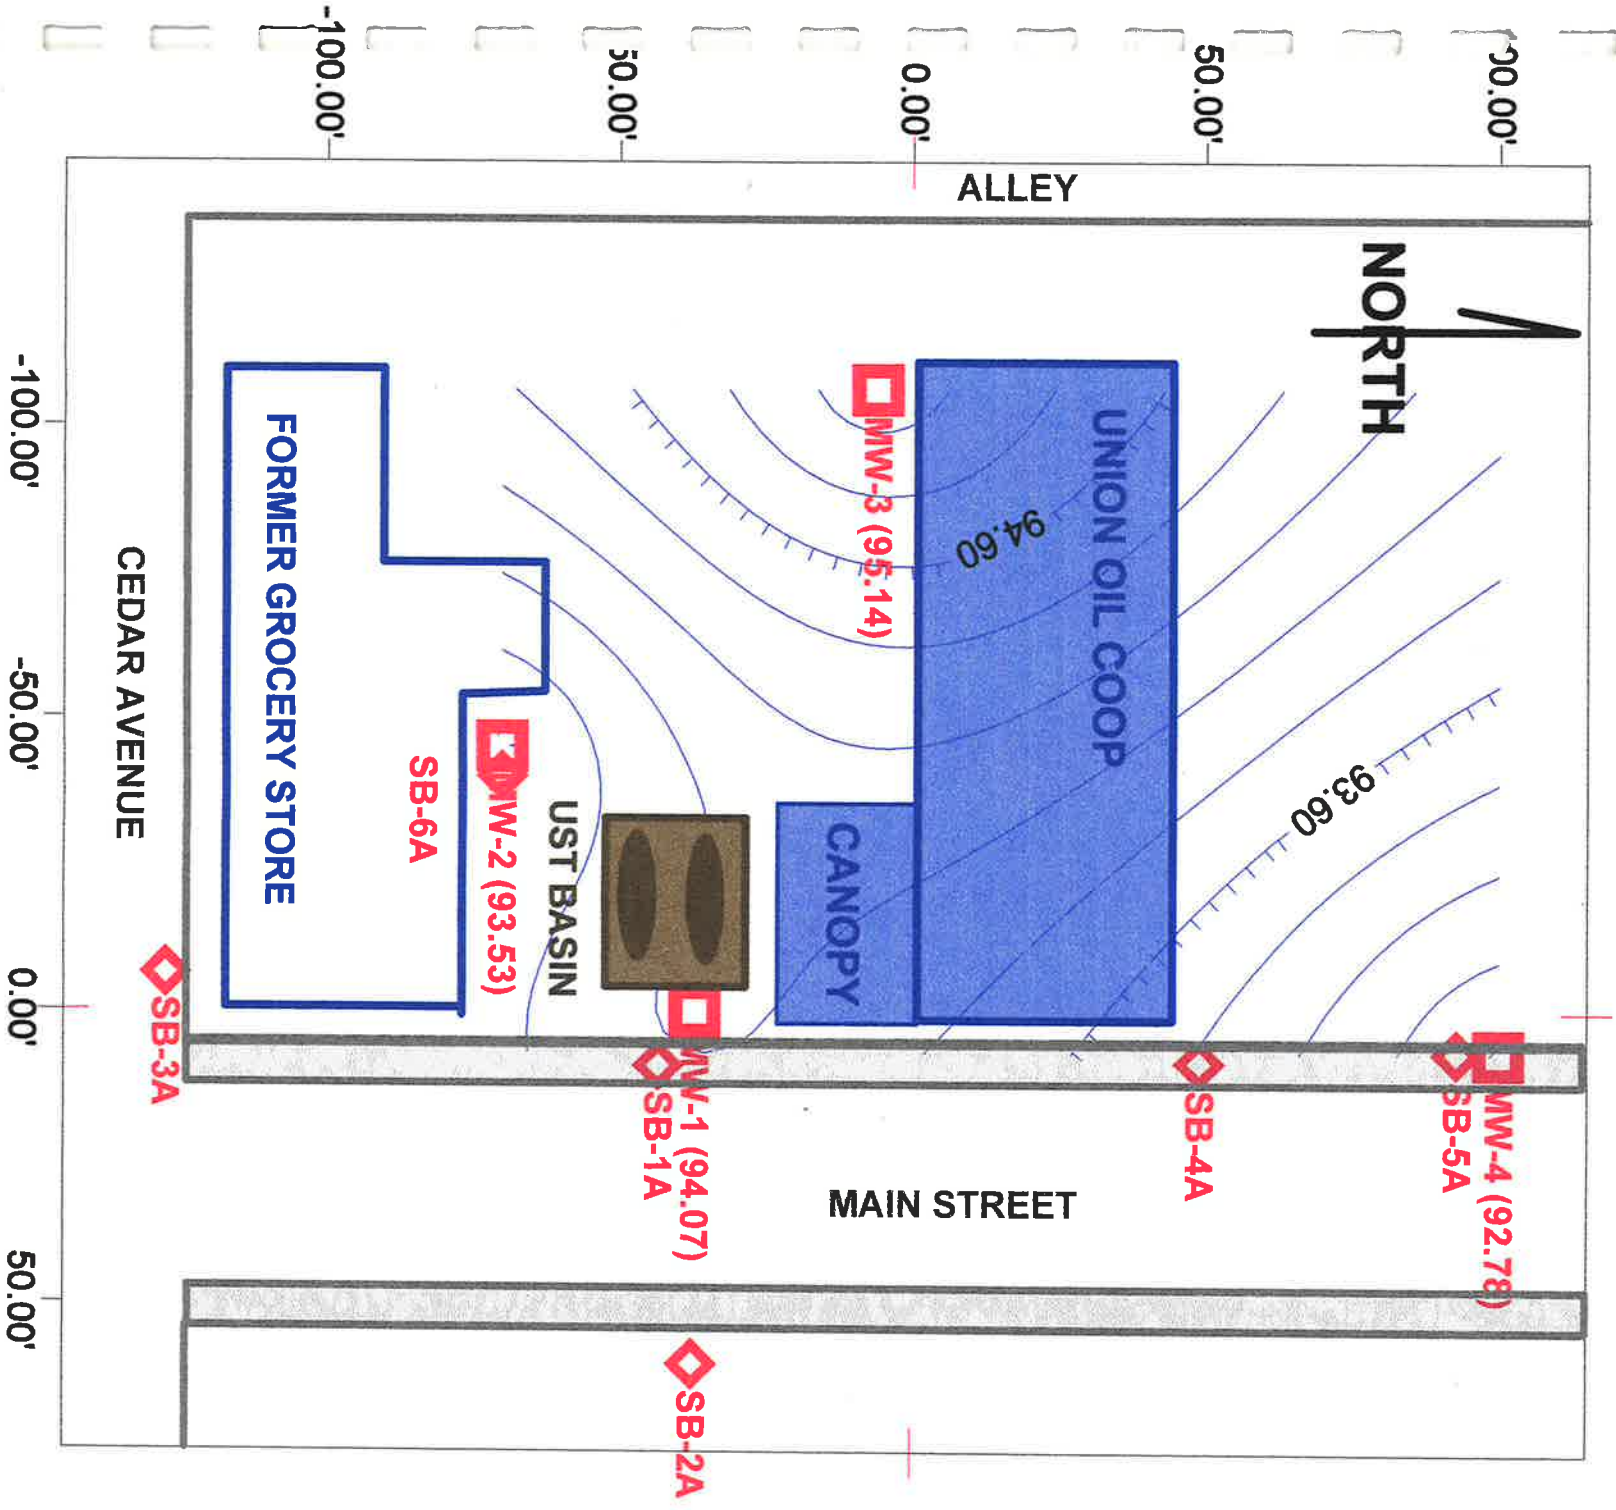
FIGURE 5b GW CONTOUR MAP - 2/8/95

Table 5 presents a summary of monitoring well survey and water elevation data; **Figure 5b** illustrates ground water elevation and flow direction. **Figure 6c** illustrates the groundwater benzene concentrations.

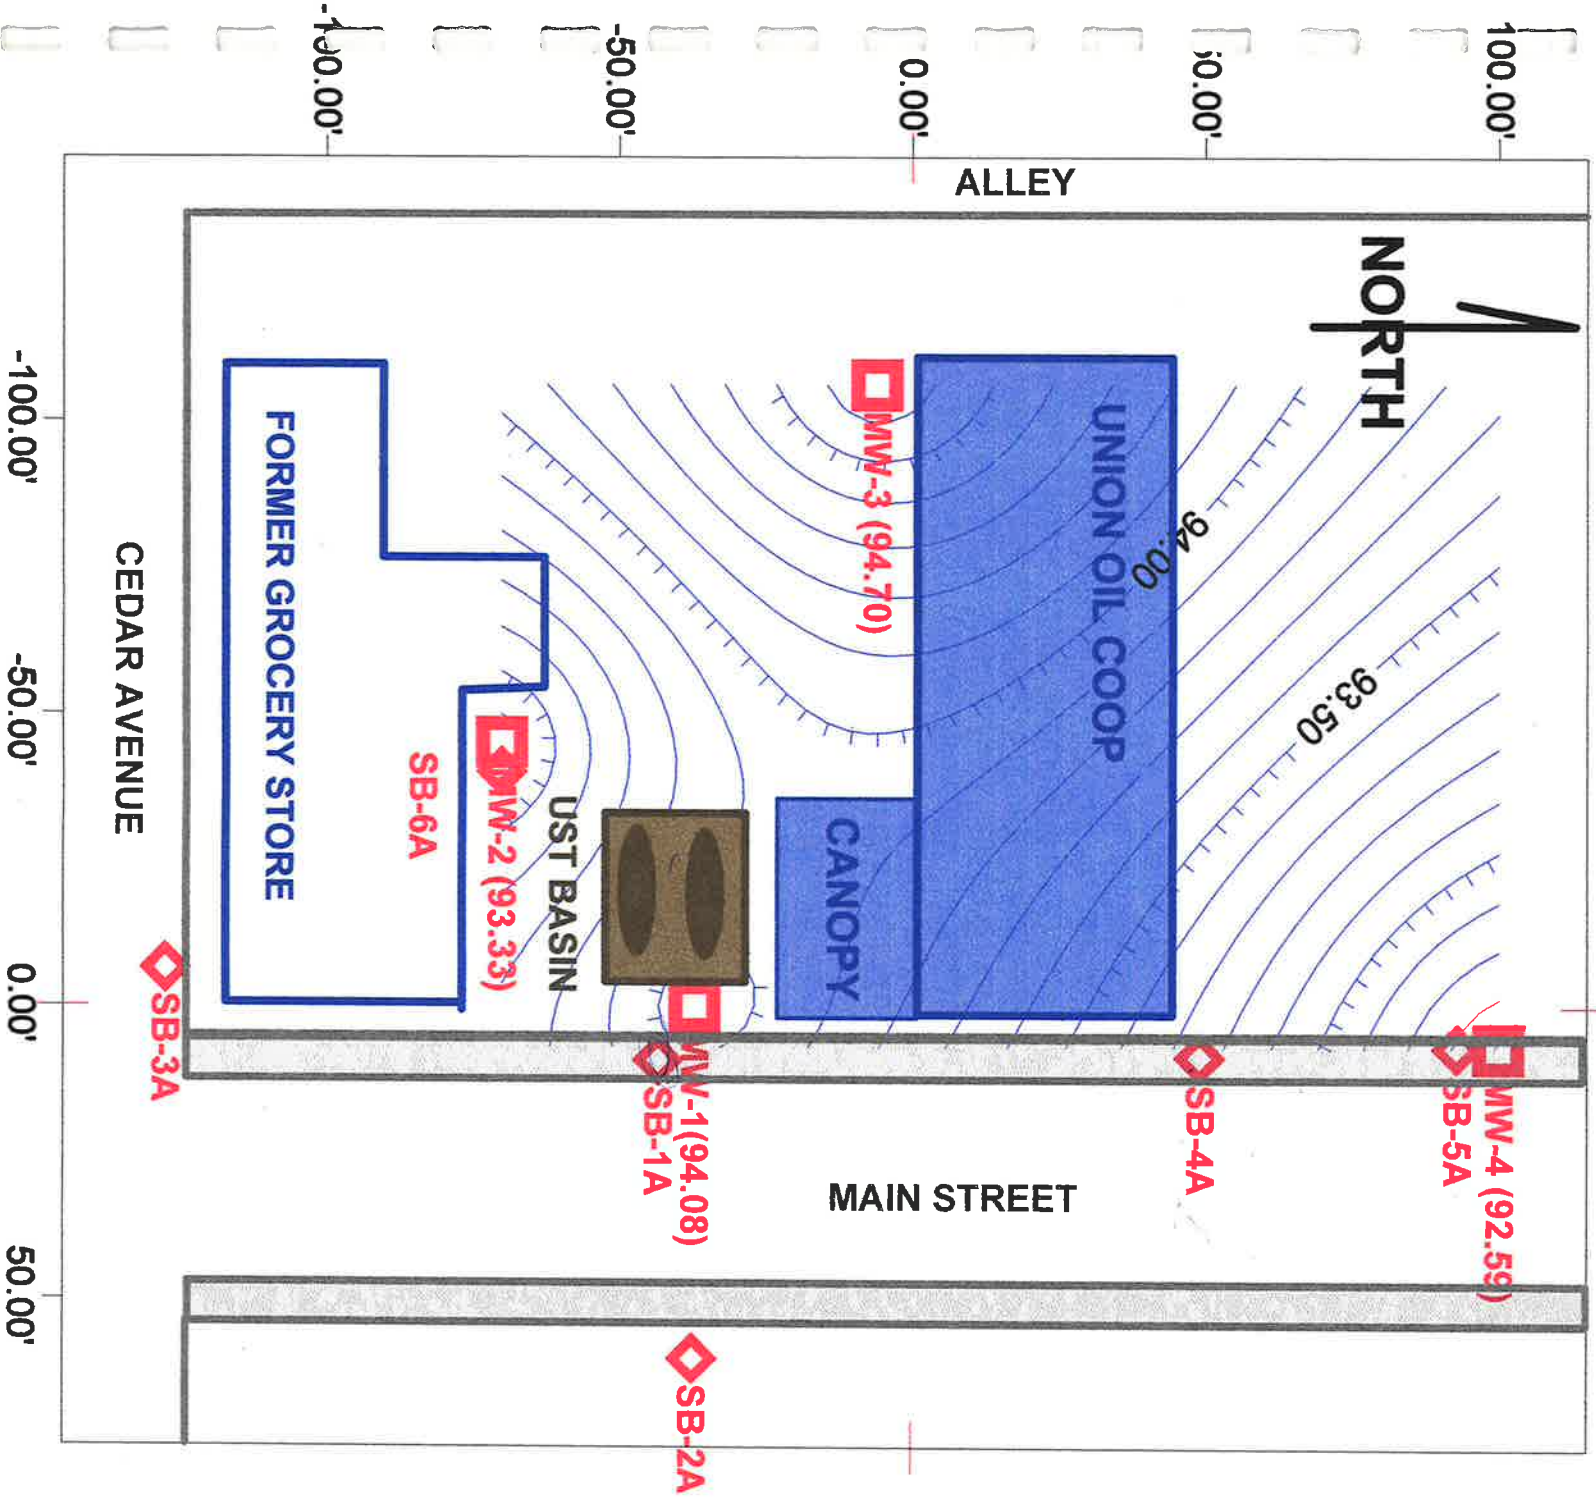
FIGURE 5c GW CONTOUR MAP - 5/8/95

Table 5 presents a summary of monitoring well survey and water elevation data; **Figure 5c** illustrates ground water elevation and flow direction. **Figure 6d** illustrates the groundwater benzene concentrations.
