Eround Water Monitoring and closure request Report.

SINCLAIR STATION - RICHFIELD, MINNESOTA

SITE LOCATION MAP SINCLAIR STATION

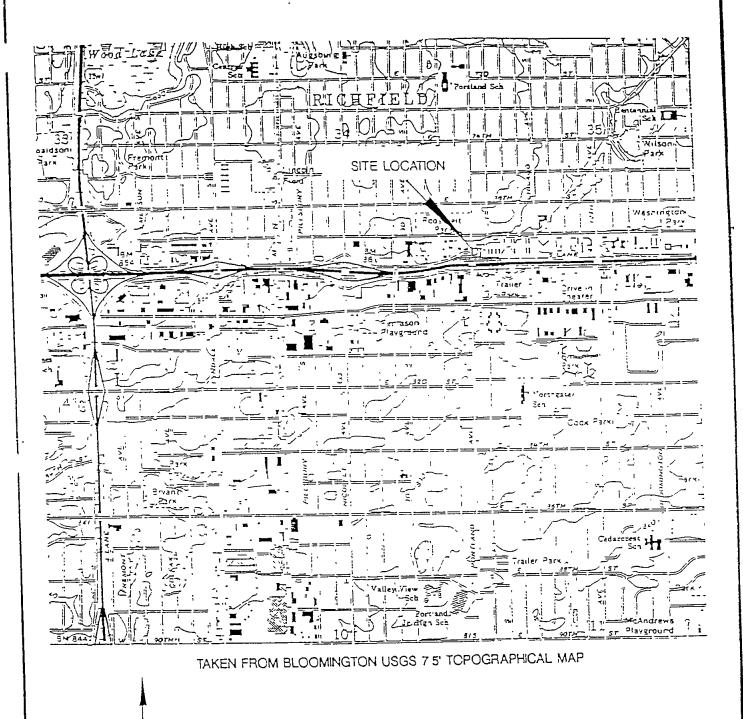
Figure No. 1

7733 PORTLAND AVENUE SOUTH

RICHFIELD, MINNESOTA
