Project reference: Alex Exhaust (LK 15,656) Project number: 04660027

Subject: Limited Site Investigation Report for Leak 15,656 at Former Alex Exhaust; AECOM Project 04660027

MPCA Site ID: Leak00**15,656** Date: ~~**February 5, 2009**~~ 2-16-09

Leak Site Name: **Former Alex Exhaust** Property Owner: **Mr. Ben Zacher**

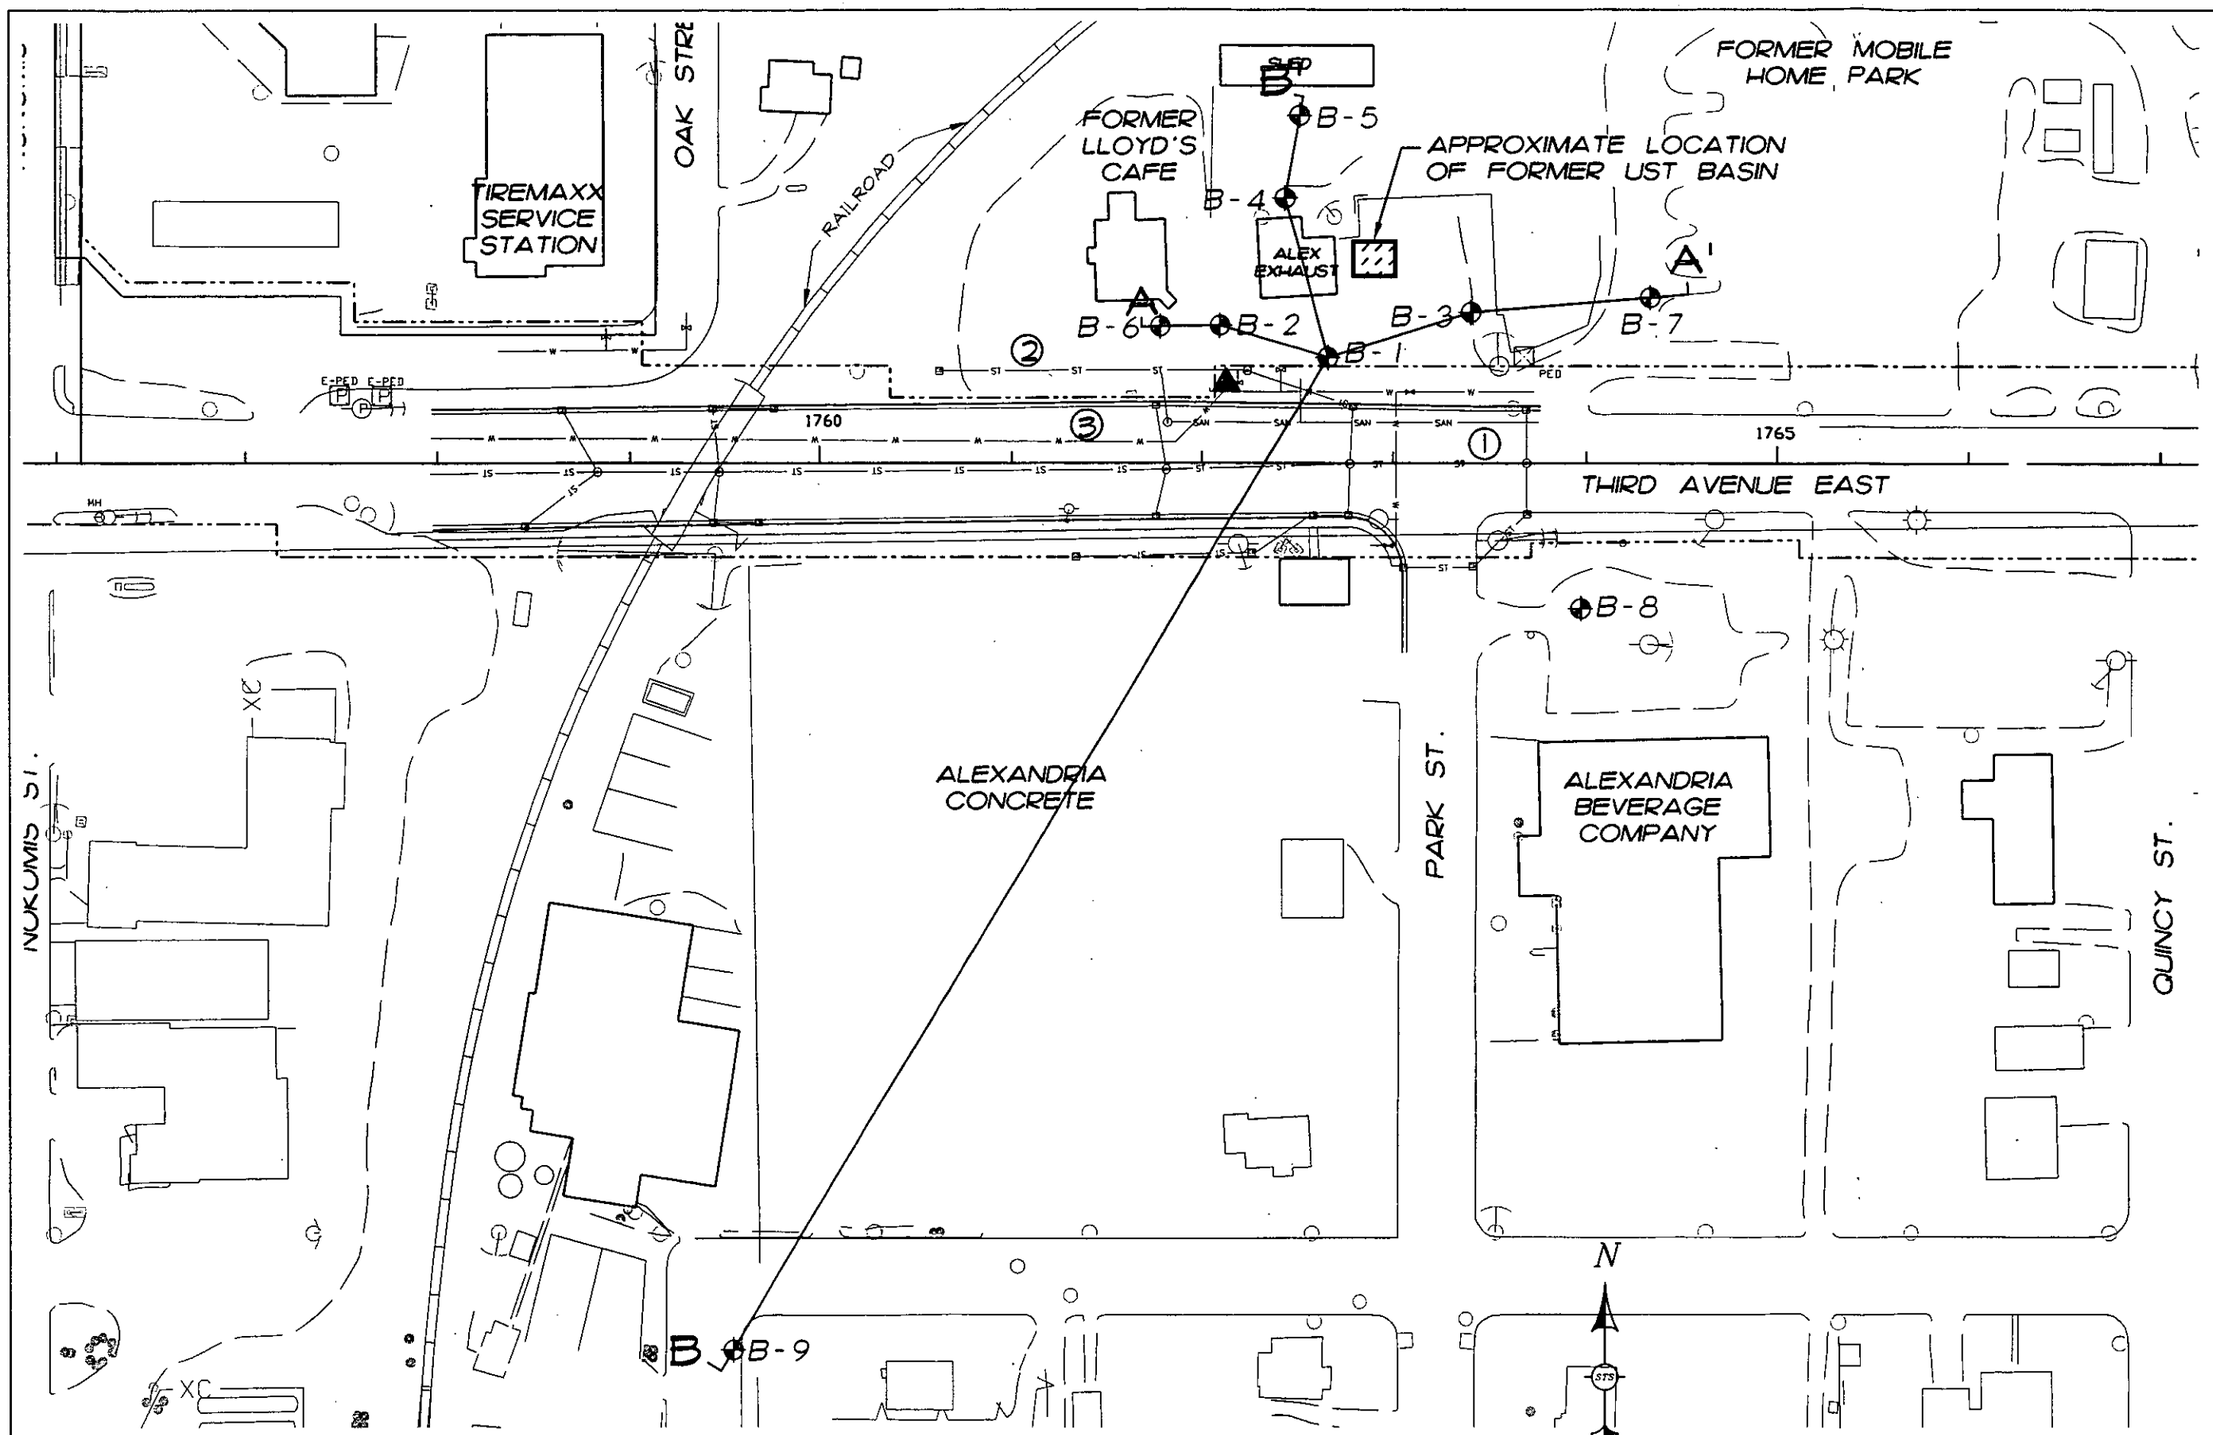
Drawn :	TAK	1/20/2009
Checked:	TJG	1/20/2009
Approved:	RLD	1/20/2009
PROJECT NUMBER	04660027	
FIGURE NUMBER	7

of these utility lines. Contaminated soil encountered during the utility line replacements was excavated and disposed of off-site. Approximately 1,200 cubic yards of petroleum contaminated soil was excavated and disposed of from Mn/DOT right of way in front of the former Alex Exhaust building. No free product was observed during the utility line replacements in the vicinity of the project site. Groundwater was not encountered in the excavations to a depth of approximately 12 feet during the utility replacement work near the project site. Groundwater levels encountered in the site soil borings generally indicate a depth to groundwater of 16 to 20 feet below ground surface. A copy of the Documentation Report for State Project 2102-50 TH 29/27 prepared by STS (dated 12/30/2005) is attached in Appendix D. Utility locations are shown on Figures 3, 7 and 7A.

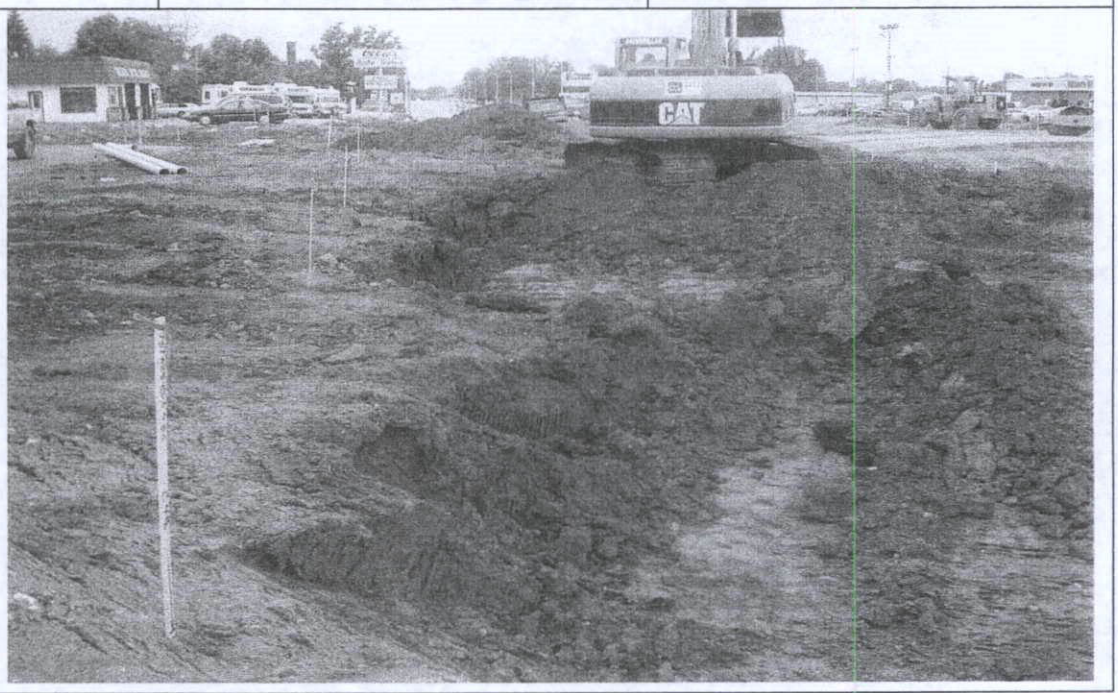
Photo No.	Date:
2	8/23/04

Excavation of petroleum impacted soil at Area 3.

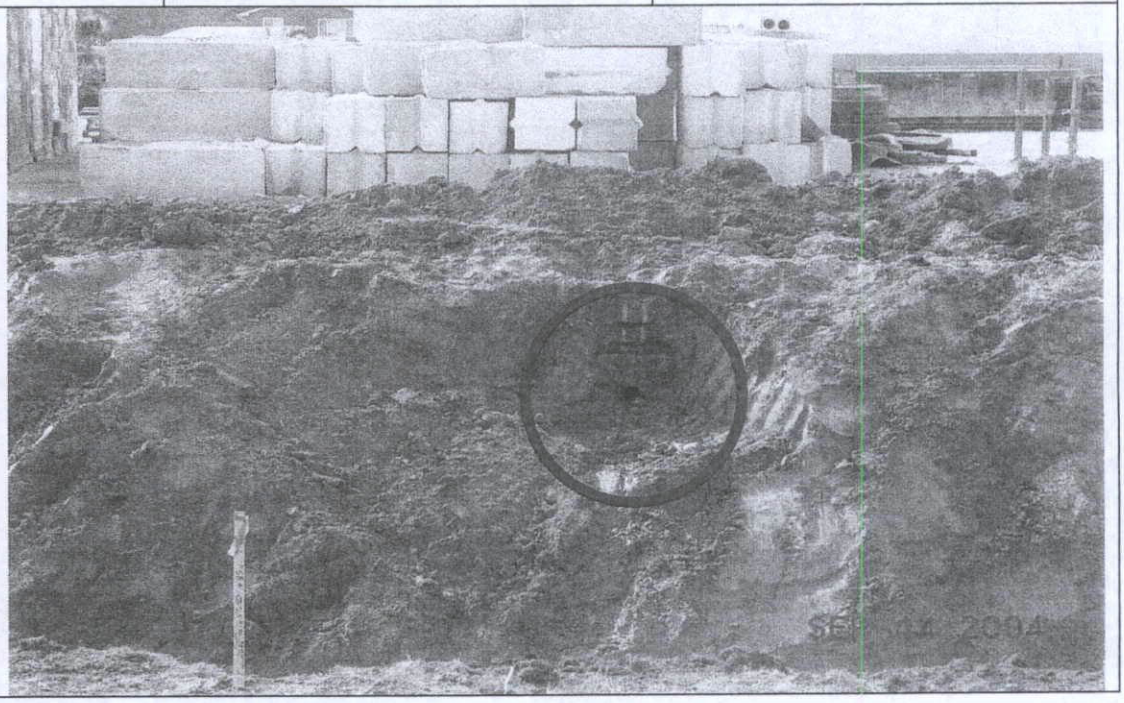
Photo No.	Date:
6	9/14/04

Four inch drain pipe identified during reconstruction activities in Area 5. Contaminated soil was identified around the pipe.

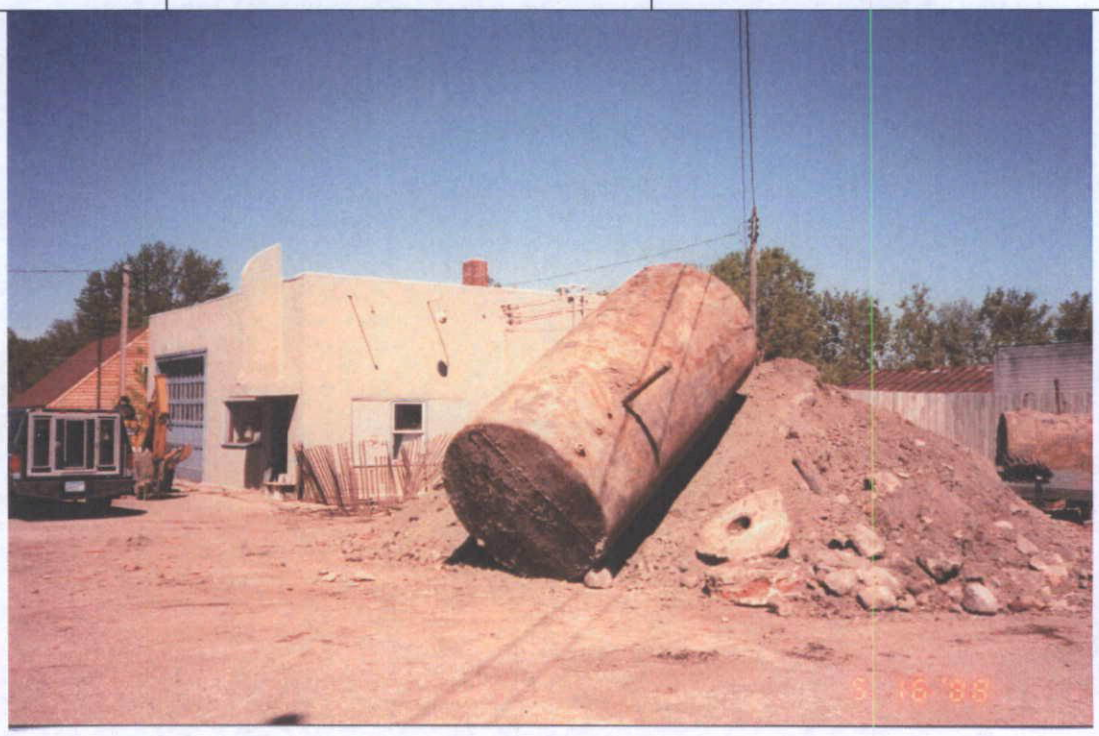
Photo No. 2	**Date:** 5/16/88

Photograph provided by Mr. Dennis Stark, City of Alexandria Fire Marshal
