## WETLAND DETERMINATION DATA FORM - Midwest Region

Project/Site: SPP		City/Count	ty: Polk			Sampling Date: 7/8/2015	
Applicant/Owner: Enbridge				Sta	te: Minnesota	Sampling Point: PO146a1U	
Investigator(s): KRG/JRT		Secti	ion, Towns	ship, Ran	nge:		
Landform (hillslope, terrace, etc.): talf			Local Relief (concave, convex, none): None				
Slope (%): 2 L	Latitude: 47.7318156324772	Longitude	95.800 -95	5262725	5947 Datu	ım: Minnesota State Plane North, NAD 83 (2011) U.S. f	
Soil Map Unit Name: 1668B						NWI Classification: PEMA	
	ditions on the site typical for this	time of year? (if i	no. explain	in Rema	arks):	1	
Are climatic/hydrologic conditions on the site typical for this time of year? (if no, explain in Remarks):  Are Vegetation , Soil , or Hydrology significantly disturbed? Are "Normal Circumstances" present?							
	, or Hydrology  naturally p	•			•	_	
Are vegetation, 30ii	, or nyurology L maturally p	problemanc: (11	neeueu, c	Xpiaiii ai	Ty diisweis iii nei	narks)

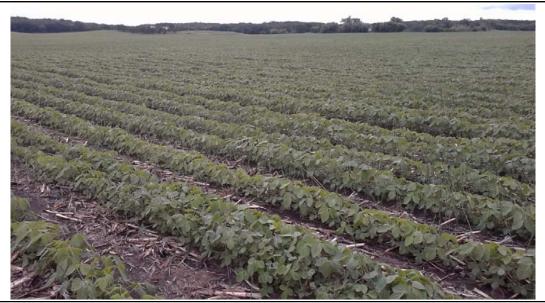
Site Photograph 1 Sampling Point: PO146a1U

Longitude:         -95.8005130291877         Circular 39:           Direction:         SE         Eggers & Reed:	Latitude: 47	7.7318056161029	Cowardin Classification:
Direction: SE Eggers & Reed:	Longitude: -9!	5.8005130291877	Circular 39:
	Direction: SE		Eggers & Reed:
