WETLAND DETERMINATION DATA FORM - Great Plains Region

Project/Site: City	/County:			Sampling Date:	2015-06-03		
Applicant/Owner:		Mini State:	nesota	Sampling Point:	u-150n39w29-c1		
LEB/BCS Investigator(s): Section, Township, Range:							
depression Landform (hillslope, terrace, etc.):		Local Relief	(concave, conv	CL vex, none):	0-2% Slope (%):		
LRR F 47.776551023195.67589919 Subregion (LRR or MLRA): Latitude: Longitude:							
Minnesota State Plane North, NAD 83 (2011) U.S. feet Datum:							
Soil Map Unit Name:				NWI Classification	PEMA on:		
Are climatic/hydrologic conditions on the site typical	•				Yes		
Yes Yes No Are Vegetation, Soil, or Hydrology	_ significantly distu	irbed? Are "N	Normal Circums	tances" present?			
Are Vegetation No	naturally problema	tic? (If need	ed, explain any	answers in Remarks)			
SUMMARY OF FINDINGS - Attach site map showi	ng sampling point l	ocations, tra	nsects, importa	ant features, etc.			
N Hydrophytic Vegetation Present?	0	Is the Sam	pled Area

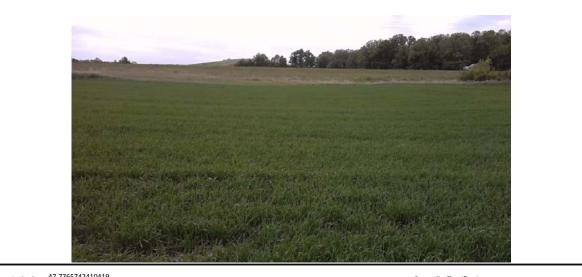
Latitude: 47.7703742410419	Cowardin Classification:
Longitude: -95.6759532541928	Circular 39:
Direction:	Eggers & Reed:
Remarks:	
US Army Corps of Engineers	Northcentral and Northeast Region – Version 2.0
Site Photograph 2	Sampling Point: u-150n39w29-c1
Latitude:	Cowardin Classification:
Longitude:	Circular 39:
Direction:	Eggers & Reed:
Remarks:
