## WETLAND DETERMINATION DATA FORM - Great Plains Region

US Army Corps of Engineers Great Plains Region – Version 2.0

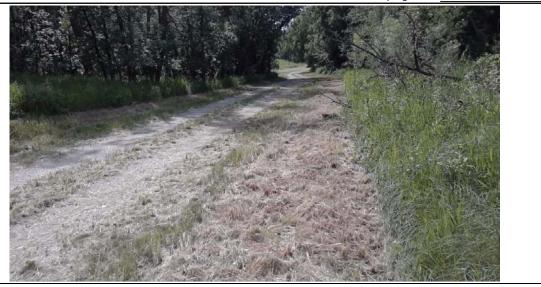
Latitude: 47.8038730519338

Longitude: -96.4789384045605

Direction: west

Cowardin Classification: PEM

Circular 39: 2

Eggers & Reed: Fresh (Wet) Meadow

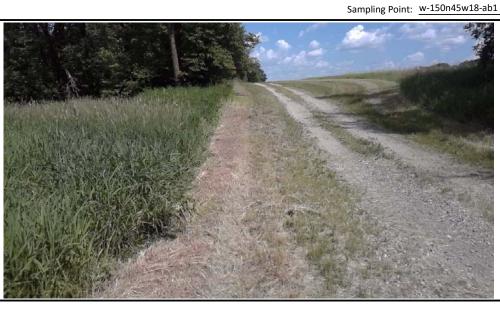
Site Photograph 2

Latitude: 47.8038744349478

Longitude: -96.4789358899896

Direction: east

Cowardin Classification: PEM

Circular 39: 2

Eggers & Reed: Fresh (Wet) Meadow
