Project/Site: SPP		City/County: Aitkin			Sampling Date: 2016-08-22		
Applicant/Owner: Enbridge			State: Minnesota		Sampling	Point: w-50n26w18-n1	
Investigator(s): ZCW, MGH			o, Range: S18, T50N,	, R26W	r c		
Landform (hillslope, terrace, etc.): De	pression		Local Relief (concav		СС	Slope (%): 0-2%	
Subregion (LRR or MLRA):	•		.8187190965	Longitude: -93.6		Datum: NAD83	
Soil Map Unit Name: 928C						sification: N/A	
Are climatic/hydrologic conditions or	the site typica	I for this time of year?	? (if no, explain in Re	emarks):		No	
Are Vegetation <u>No</u> , Soil <u>No</u> , or	Hydrology No	significantly disturb	ed? Are "Normal Ci	rcumstances" pre	esent? Yes		
Are Vegetation <u>No</u> , Soil <u>No</u> , or H	ydrology No	naturally problematic	? (If needed, explai	in any answers in	Remarks)		
SUMMARY OF FINDINGS - Attach	site man show	ing sampling point lo	rations transects in	mnortant feature	s etc

## **VEGETATION** - Use scientific names of plants.

## SOIL

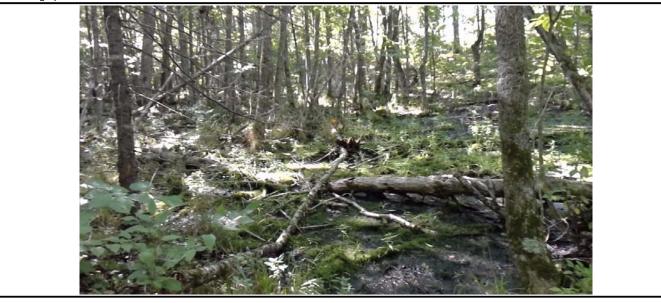
Site Photograph 1

Cowardin Classification: PFO

Circular 39: 7

Direction: South

Eggers & Reed: Hardwood Swamp/Coniferous Swamp

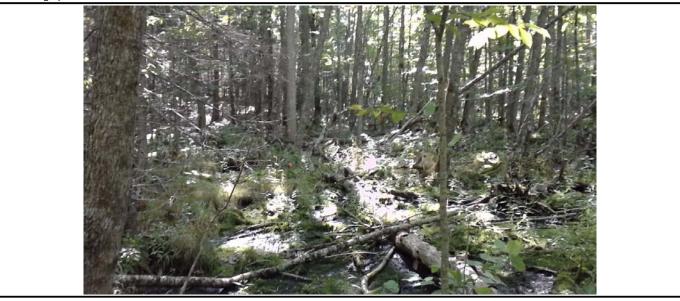
Site Photograph 2

Cowardin Classification: PFO

Circular 39: 7

Direction: East

Eggers & Reed: Hardwood Swamp/Coniferous Swamp
