**WETLAND DETERMINATION DATA FORM - North Central and Northeast Region**

Project/Site: SPP City/County: Aitkin Sampling Date: 2016-08-12  
 Applicant/Owner: Enbridge State: Minnesota Sampling Point: w-50n26w6-i1  
 Investigator(s): ZCW, MGH Section, Township, Range: S6, T50N, R26W  
 Landform (hillslope, terrace, etc.): Depression Local Relief (concave, convex, none): CL Slope (%): 0-2%  
 Subregion (LRR or MLRA): \_\_\_\_\_ Latitude: 46.8455922743... Longitude: -93.68237634... Datum: NAD83  
 Soil Map Unit Name: 292 NWI Classification: N/A  
 Are climatic/hydrologic conditions on the site typical for this time of year? (if no, explain in Remarks): No  
 Are Vegetation No, Soil No, or Hydrology No significantly disturbed? Are "Normal Circumstances" present? Yes  
 Are Vegetation No, Soil No, or Hydrology No naturally problematic? (If needed, explain any answers in Remarks)

**SUMMARY OF FINDINGS - Attach site map showing sampling point locations, transects, important features, etc.**

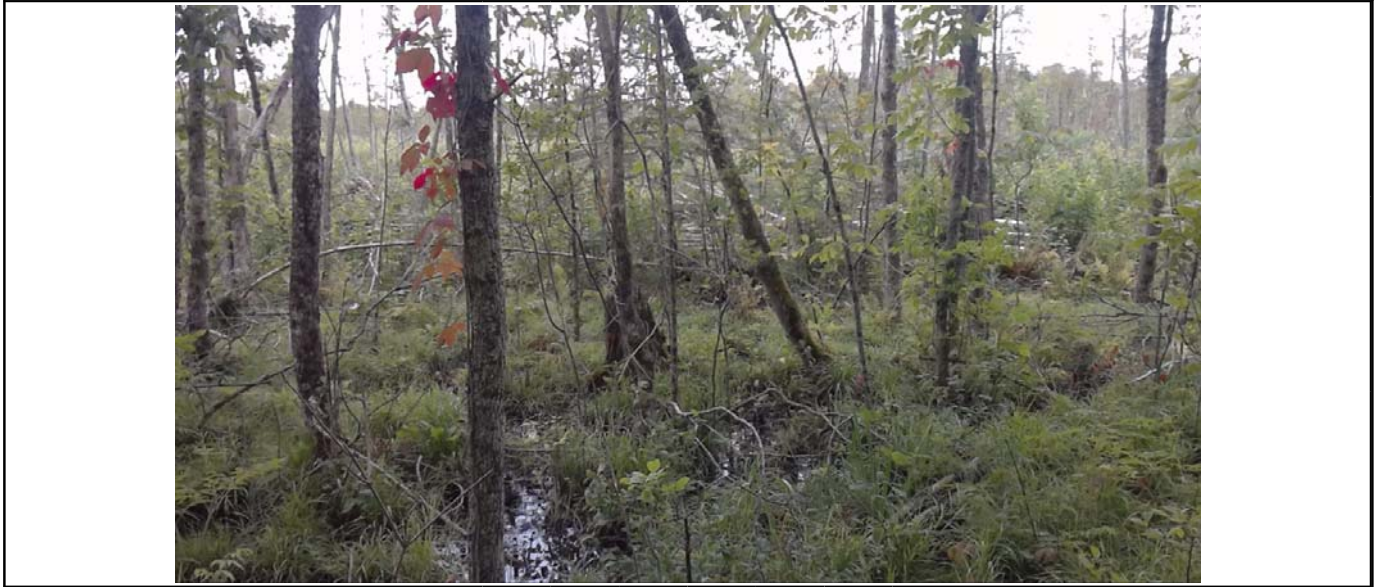
Site Photograph 1

Sampling Point: w-50n26w6-i1

Latitude: 46.8455892149795

Cowardin Classification: PFO

Longitude: -93.6823526211955

Direction: West

Eggers & Reed: Hardwood Swamp/Coniferous Swamp

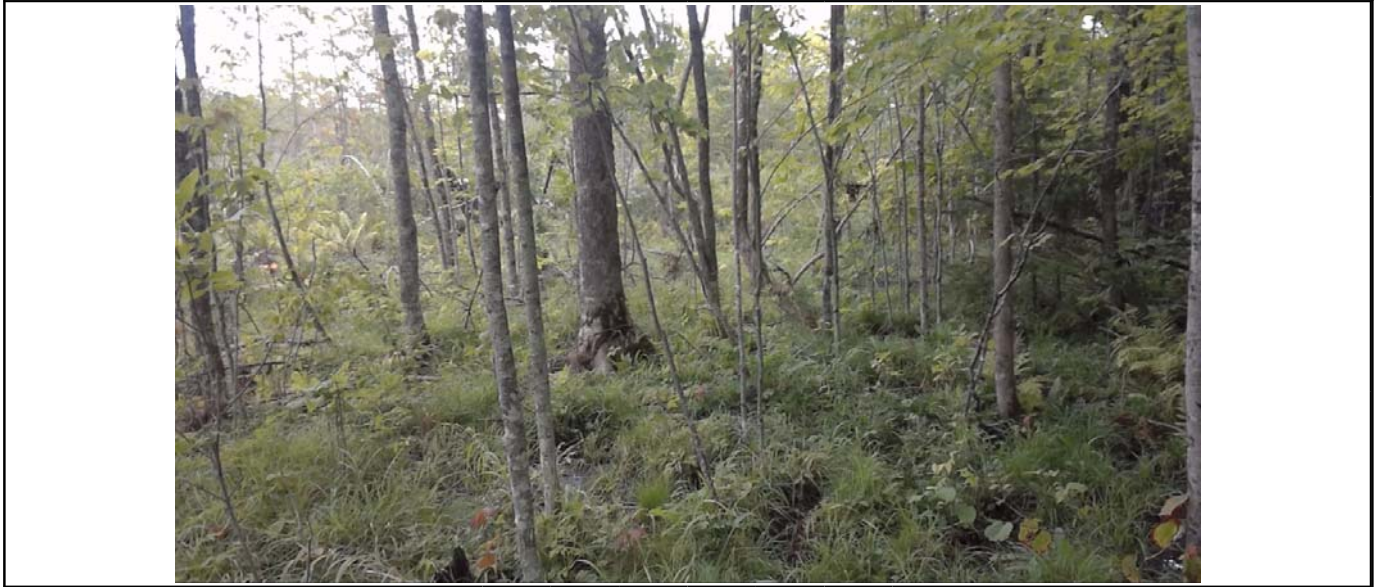
Site Photograph 2

Sampling Point: w-50n26w6-i1

Latitude: 46.8455938250263

Cowardin Classification: PFO

Longitude: -93.6823721510299

Direction: South

Eggers & Reed: Hardwood Swamp/Coniferous Swamp
