**WETLAND DETERMINATION DATA FORM - North Central and Northeast Region**

Project/Site: SPP City/County: Aitkin Sampling Date: 2016-08-12  
 Applicant/Owner: Enbridge State: Minnesota Sampling Point: w-50n26w6-j1  
 Investigator(s): ZCW, MGH Section, Township, Range: S6, T50N, R26W  
 Landform (hillslope, terrace, etc.): Depression Local Relief (concave, convex, none): CC Slope (%): 0-2%  
 Subregion (LRR or MLRA): \_\_\_\_\_ Latitude: 46.8420411972... Longitude: -93.68282318... Datum: NAD83  
 Soil Map Unit Name: 204B NWI Classification: N/A  
 Are climatic/hydrologic conditions on the site typical for this time of year? (if no, explain in Remarks): No  
 Are Vegetation No, Soil No, or Hydrology No significantly disturbed? Are "Normal Circumstances" present? Yes  
 Are Vegetation No, Soil No, or Hydrology No naturally problematic? (If needed, explain any answers in Remarks)

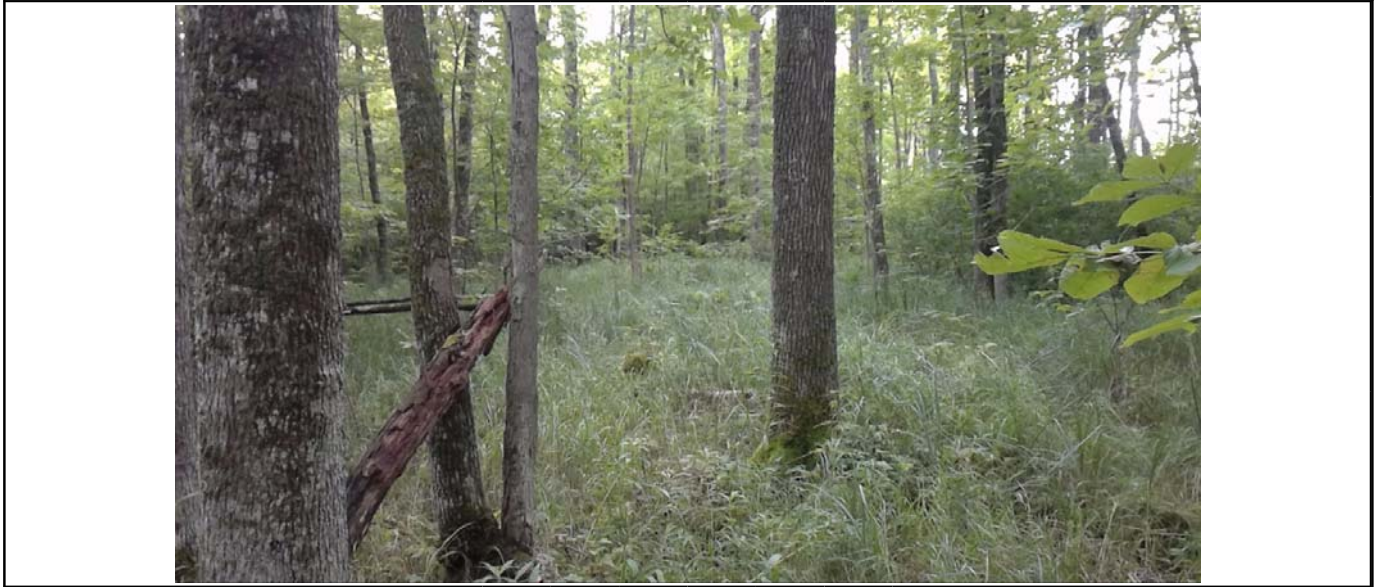
Site Photograph 1

Sampling Point: w-50n26w6-j1

Cowardin Classification: PFO

Direction: East

Eggers & Reed: Hardwood Swamp/Coniferous Swamp

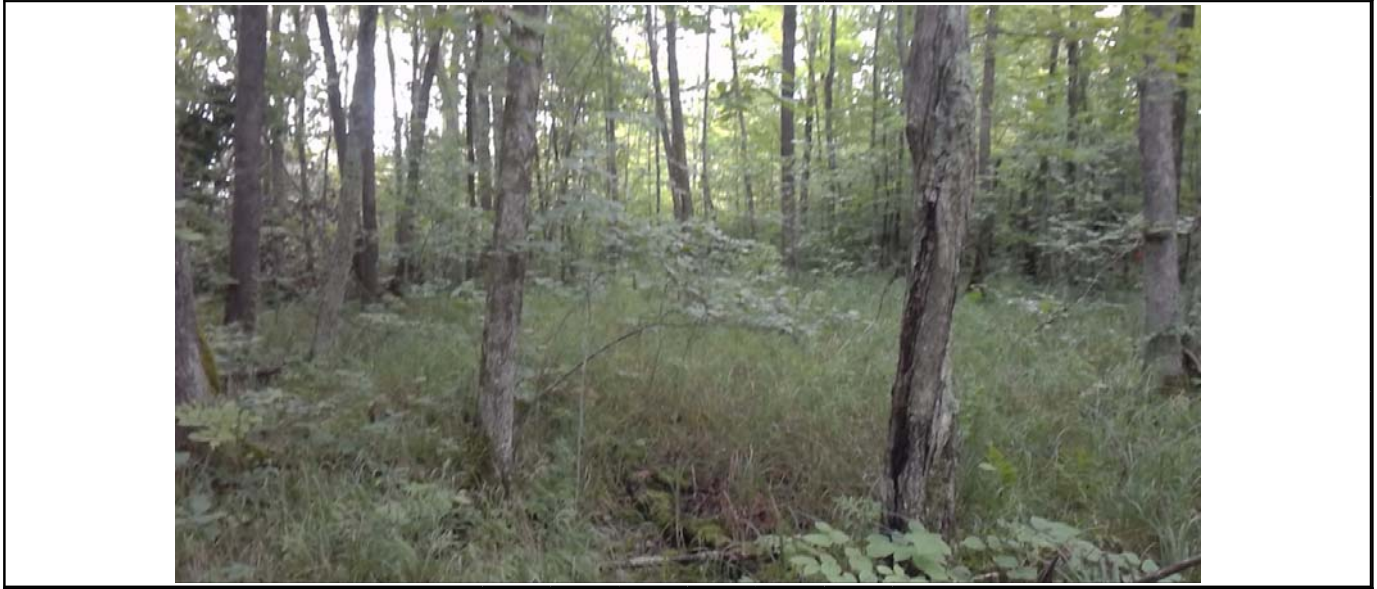
Site Photograph 2

Sampling Point: w-50n26w6-j1

Cowardin Classification: PFO

Direction: North

Eggers & Reed: Hardwood Swamp/Coniferous Swamp
