WETLAND DETERMINATION DATA FORM - North Central and Northeast Region

Project/Site: SPP City/County: Aitkin Sampling Date: 2016-08-17
 Applicant/Owner: Enbridge State: Minnesota Sampling Point: w-50n26w7-l1
 Investigator(s): ZCW, MGH Section, Township, Range: S7, T50N, R26W
 Landform (hillslope, terrace, etc.): Depression Local Relief (concave, convex, none): CC Slope (%): 0-2%
 Subregion (LRR or MLRA): _____ Latitude: 46.8406626256... Longitude: -93.68056023... Datum: NAD83
 Soil Map Unit Name: 292 NWI Classification: N/A
 Are climatic/hydrologic conditions on the site typical for this time of year? (if no, explain in Remarks): No
 Are Vegetation No, Soil No, or Hydrology No significantly disturbed? Are "Normal Circumstances" present? Yes
 Are Vegetation No, Soil No, or Hydrology No naturally problematic? (If needed, explain any answers in Remarks)

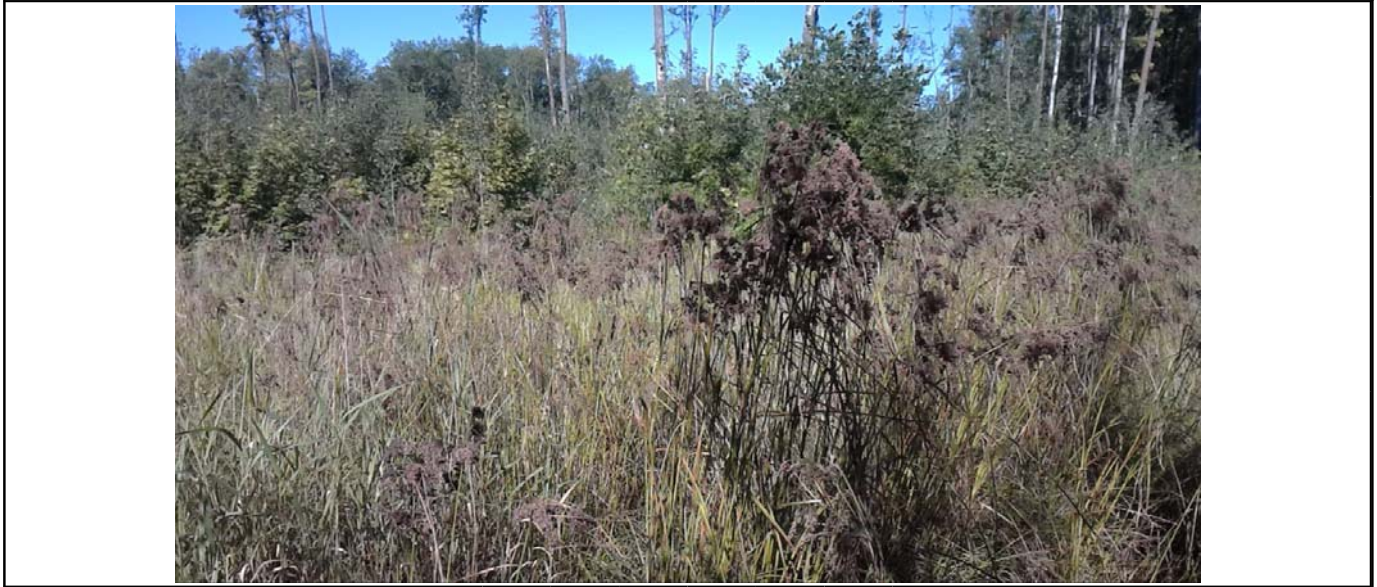
Site Photograph 1

Latitude: 46.8406489631597

Cowardin Classification: PEM

Longitude: -93.6805863865592

Circular 39: 2

Direction: West

Eggers & Reed: Fresh (Wet) Meadow

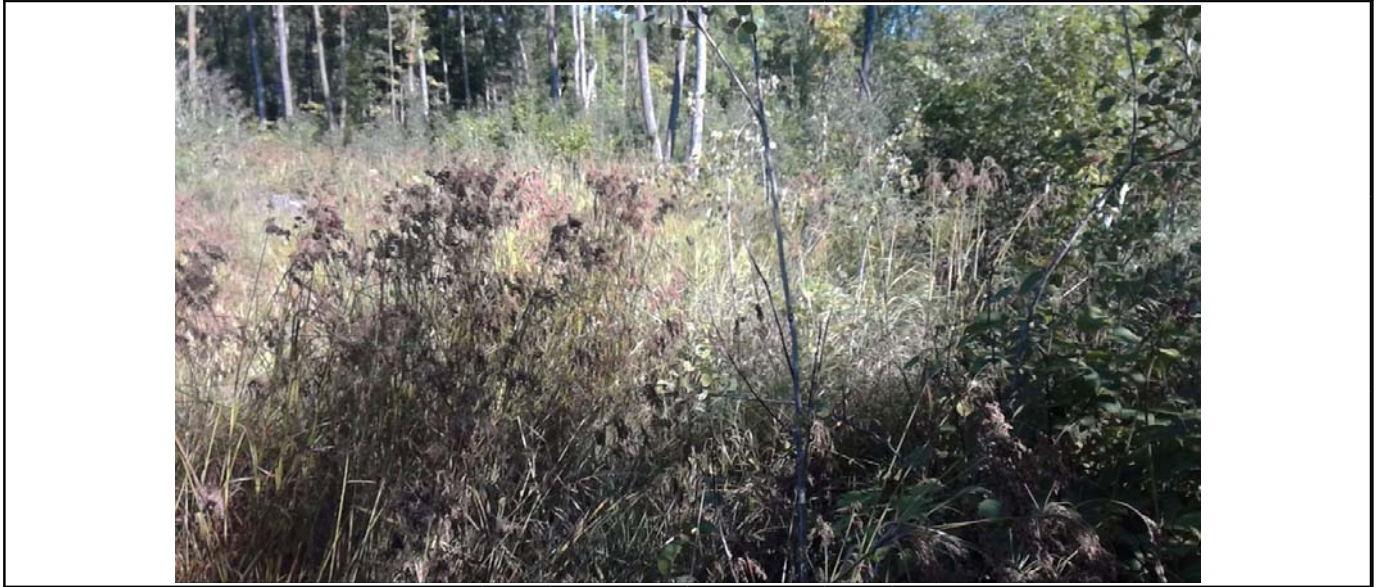
Latitude: 46.8406489631597

Cowardin Classification: PEM

Longitude: -93.6805863027402

Circular 39: 2

Direction: North

Eggers & Reed: Fresh (Wet) Meadow
