al and Northeast Region			
Project/Site: SPP	City/County	י: <u>Aitkin</u>	Sampling Date: 2016-08-08			
Applicant/Owner: Enbridge		State: Minnesota	Sampling Point: w-51n26w31-ab1			
Investigator(s): ZCW, MGH	Sectio	ion, Township, Range: <u>S31, T51, R26W</u>				
Landform (hillslope, terrace, etc.):	Depression	Local Relief (concave, convex,	none): CLSlope (%): 0-2%			
Subregion (LRR or MLRA):		Latitude: 46.8588161096 Longitude	e: -93.68321293 Datum: NAD83			
Soil Map Unit Name: 625			NWI Classification: PFO1B

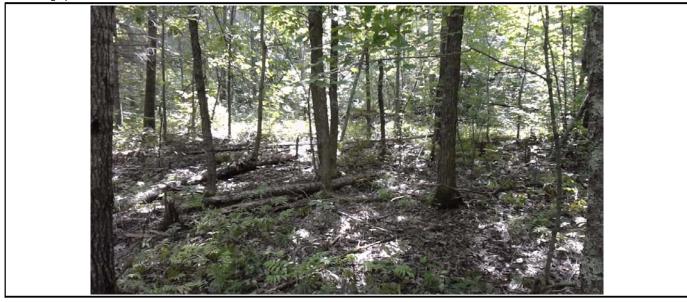
Site Photograph 1

Latitude: 46.8588981684734

Longitude: -93.6833376624563

Cowardin Classification: PFO

Circular 39: 7

Direction: East Remarks: Eggers & Reed: Hardwood Swamp/Coniferous Swamp

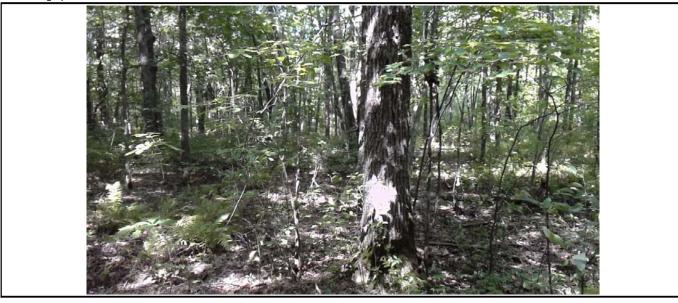
Site Photograph 2

Latitude: 46.8588982942019

Longitude: -93.6833373271801

Cowardin Classification: PFO

Circular 39: 7

Direction: West

Eggers & Reed: Hardwood Swamp/Coniferous Swamp
